# **Safety Investigation Final Report**

**Accident File No. 3-25**

## **Complete Engine Power Loss after Takeoff and Execution of a Belly Landing**

| <b>Aircraft Registration</b> | <b>4X-HYX</b> |

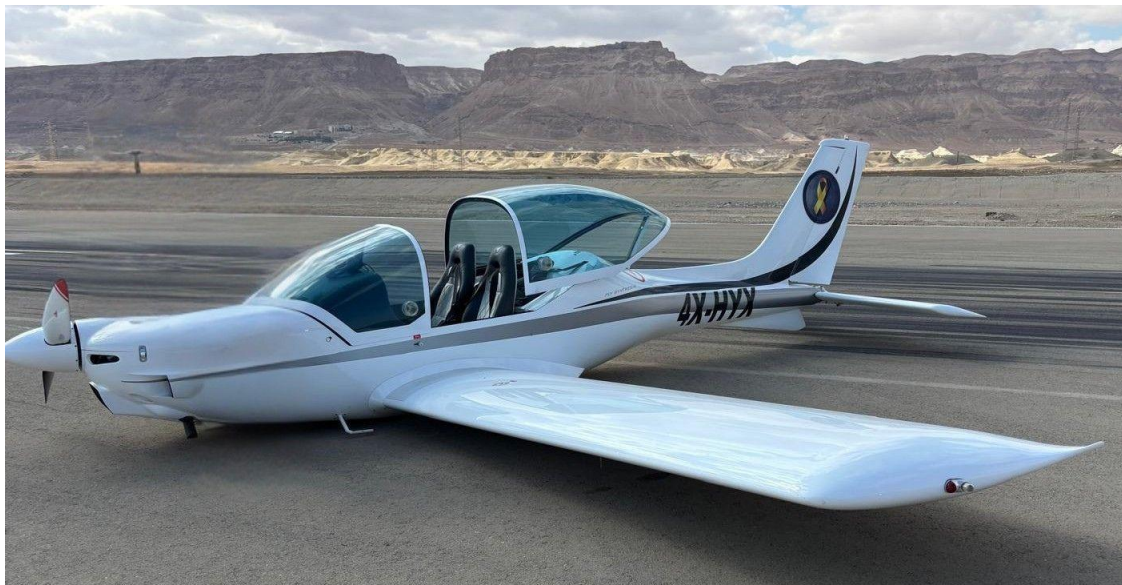
Picture 1 – The final aircraft position after the accident

- a) Abrasions were caused to the underside of the tail assembly, wheel fairings, and exhaust.
- b) The transponder and voice communication (COM) antennas were broken.
- c) The right landing gear leg torque link was broken.
- d) The nose landing gear tire was damaged and required replacement.

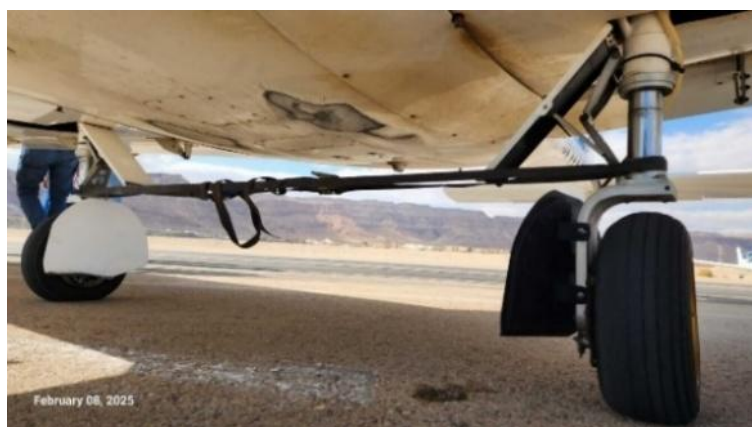
Following the AIAI director authorization, the passenger gathered several people who were at the airfield at that time, and they assisted in lifting the aircraft into the air in order to lower the landing gear, which was then extended and lowered. After lowering the landing gear, the pilot and passenger identified damage to the right landing gear leg.

Picture 4 - Securing the landing gear using tie-down straps and a ratchet

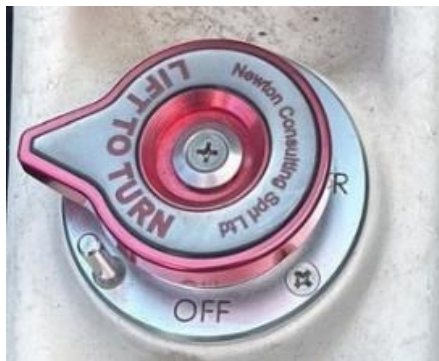
From the data collected by the investigation team, it appears that prior to the flight, the pilot refueled only the left fuel tank, and throughout the accident flight, the fuel tank selector was and remained on the left fuel tank.

Picture 5 - Fuel tank selector position as found after the accident

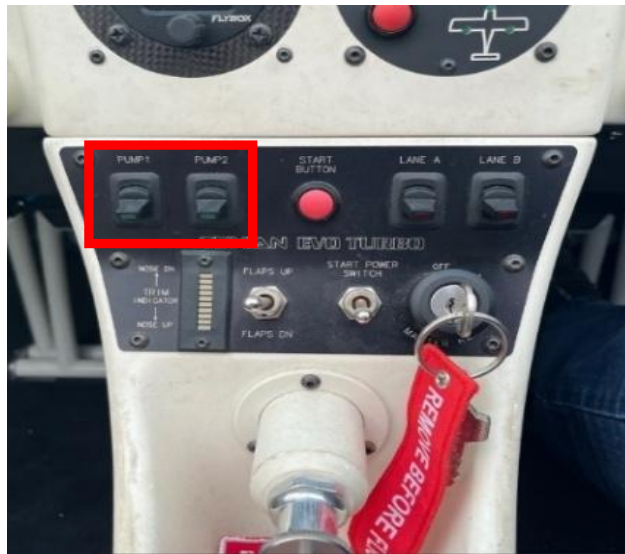
According to the pilot, both fuel pump switches at the time of the accident were in the ON position.

Picture 6 – Location of the fuel pump switches on the aircraft center console

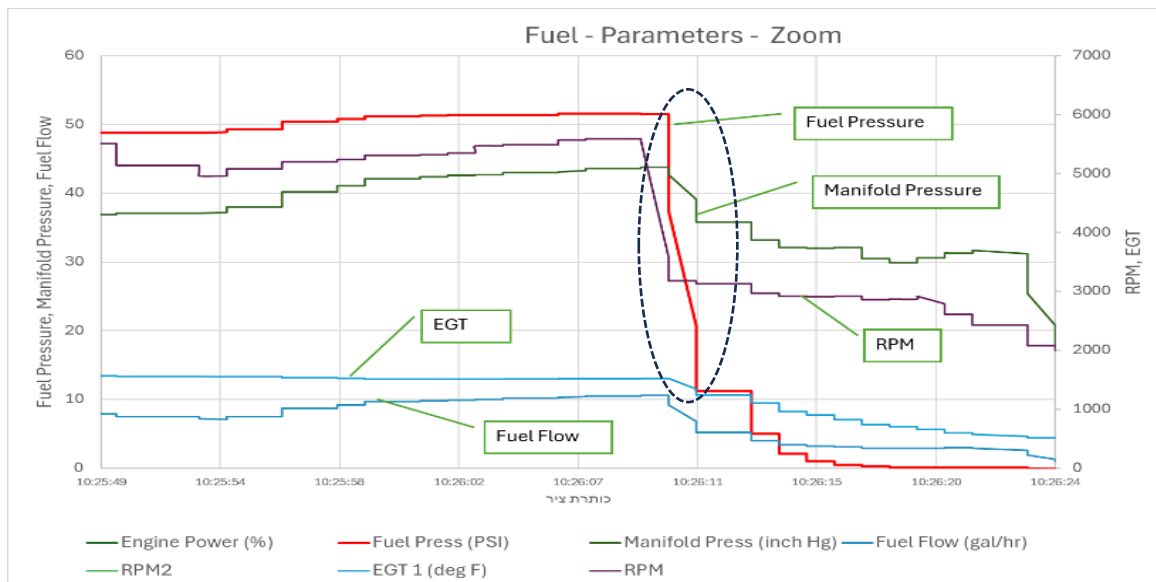
Graph 1 - Engine and fuel data at the time of the occurrence

The data shows a sharp, steep, and nearly simultaneous drop in engine RPM and fuel pressure at the time of the accident.

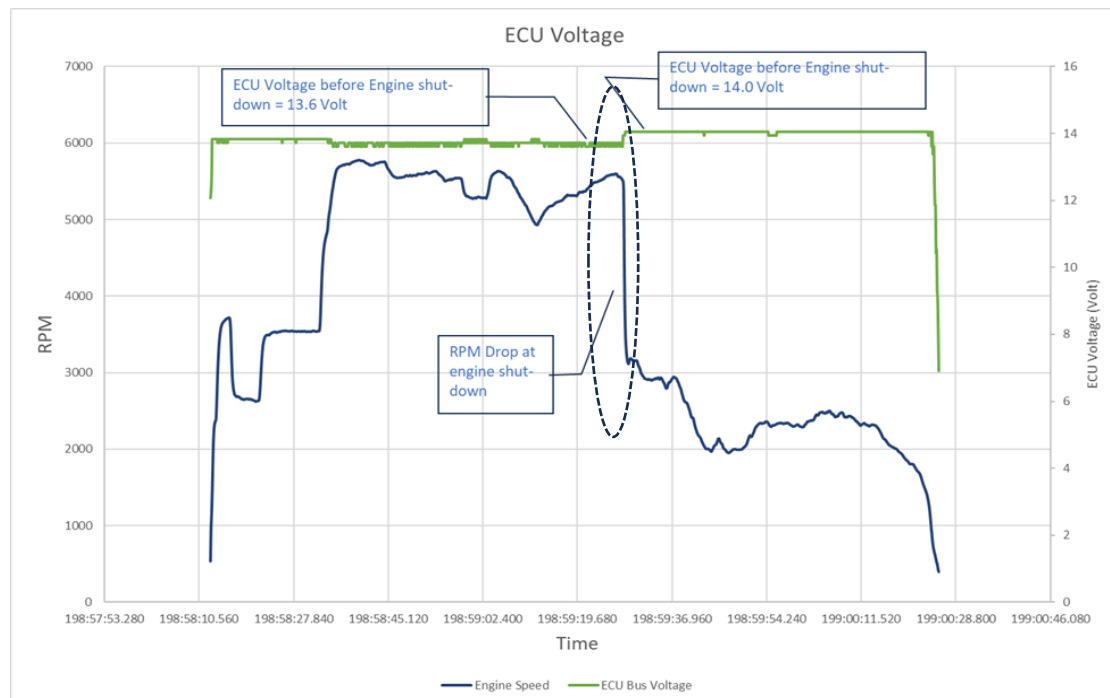
- a) At the time of the accident, the generators were operating as expected in normal flight mode, with generator B charging the battery and generator A serving as the electrical voltage source for the EMS.
- b) The electrical voltage available in the electrical system prior to the accident was approximately 13.6 volts, and at the time of the fuel pressure drop, the available electrical voltage rose to approximately 14.0 volts. This indicates that one or more electrical consumers were disconnected from the system.

Graph 2 - ECU BUS Voltage

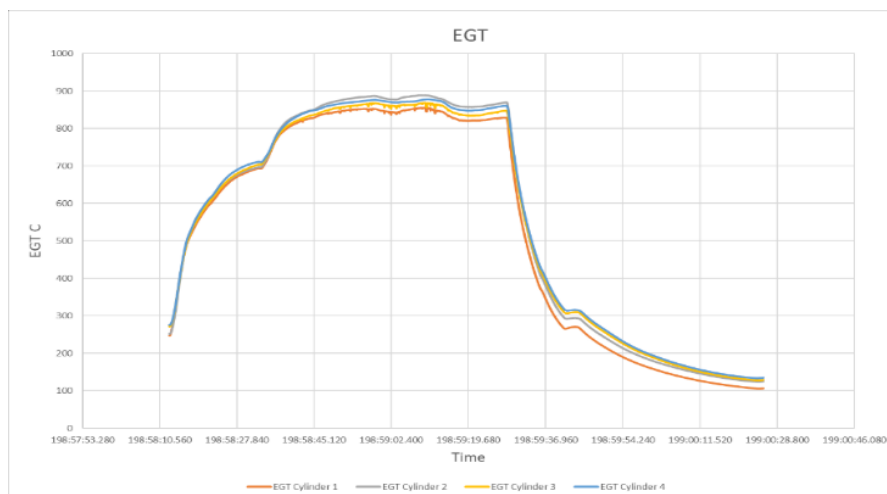
- The engine changes the amount of air/fuel mixture injected into the engine and the ignition timing in order to try to compensate for the RPM decrease.
- The EGT decrease rate behavior in all four cylinders after the engine shutdown was similar. This indicates **uniform operation** of the cylinders and the absence of fuel combustion in them.

**Graph 3 - EGT Data**

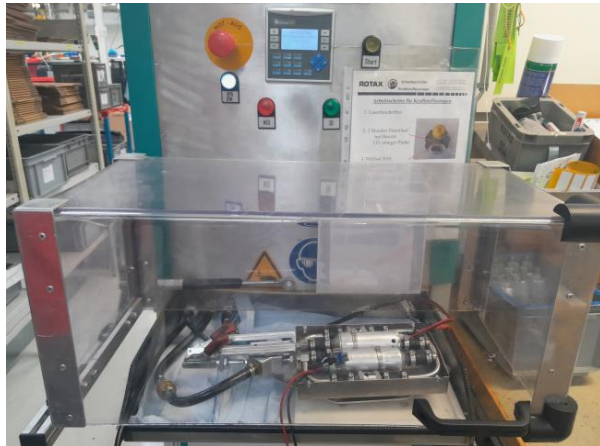
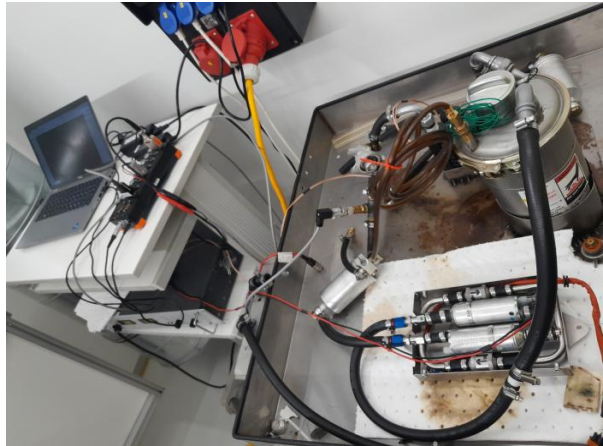
Picture 7 - Fuel Pumps in Durability Test

**That is, in the various laboratory tests, the engine manufacturer found no evidence of failure in the fuel pumps.**

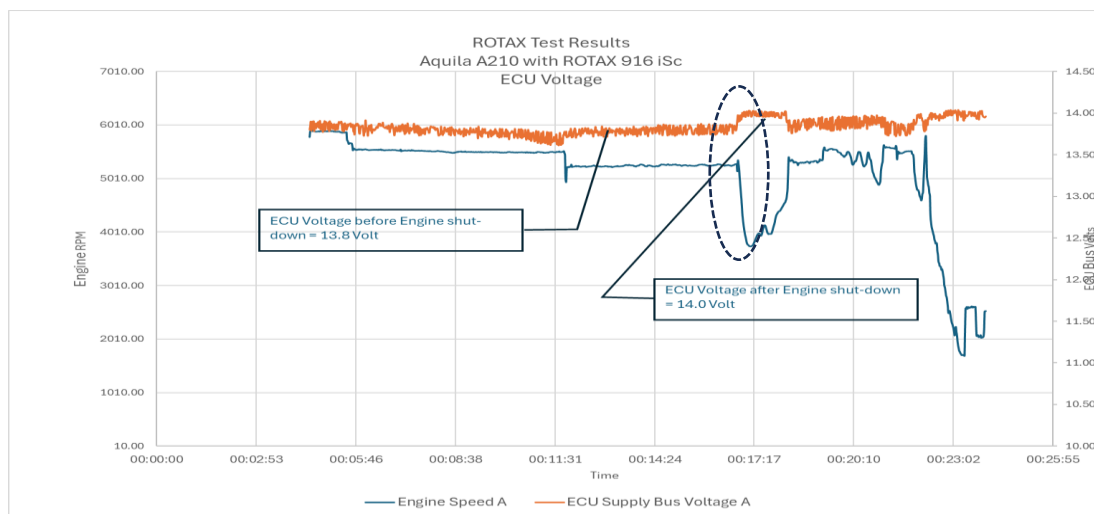
Graph 4 - ECU data during the test flight

The voltage measurements taken in the electrical system during the intentional shutdown of the fuel pumps by the test pilot showed an increase in the ECU BUS voltage, the characteristics of which are identical to those that occurred during the engine shutdown of the Texan aircraft involved in the accident (see Graph 2 in section 1.16.2 above).

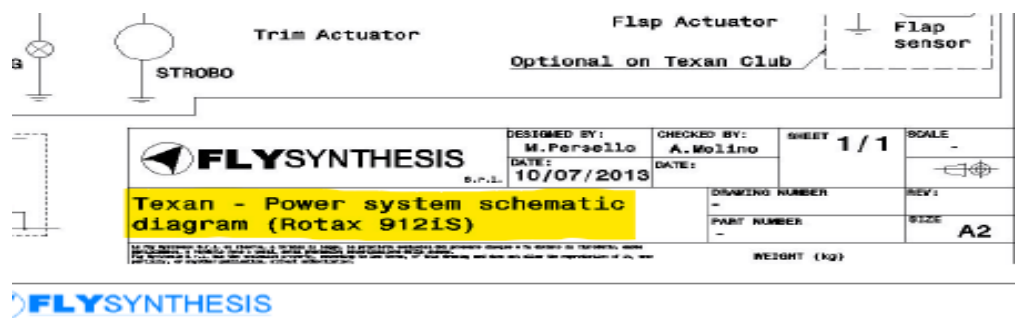
The electrical system diagram presented in chapter 7.11 of the Aircraft Flight Manual (AFM) is a diagram suitable for an aircraft with a Rotax 912iS engine. The aircraft involved in the accident has a 915iS engine. No electrical system diagram suitable for this engine model was found in the Aircraft Flight Manual.

Picture 9 – **Electrical system diagram from the AFM**

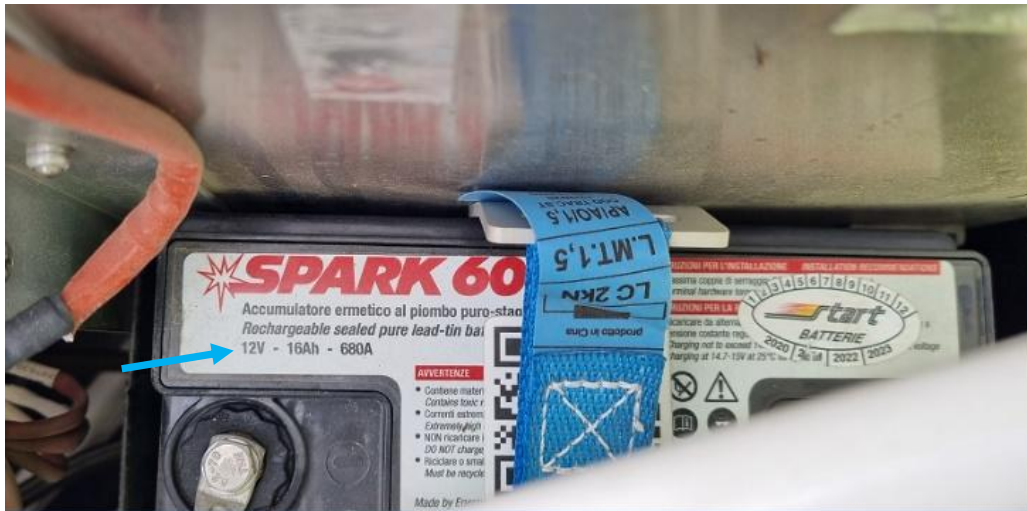
Upon inspection of the aircraft after the accident, it was found that the aircraft had a 12-volt, 16 amp-hour sealed lead-tin battery installed, which was also the battery **that was installed in the aircraft when the regulator issued the aircraft its initial airworthiness certificate.**

Picture 10 – The battery found in the aircraft after the accident

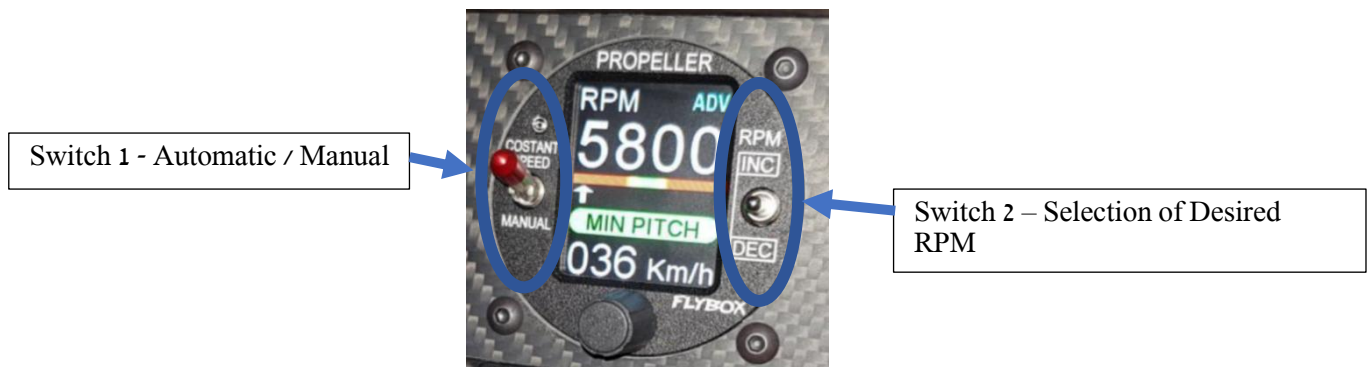
Picture 11 – **Propeller Governor**

It should be noted that the investigation team found that the propeller system installed in the aircraft **does not** meet the regulatory requirements detailed in the Type Certificate and the AFM, as the manual control of the propeller controller was not removed, as required.

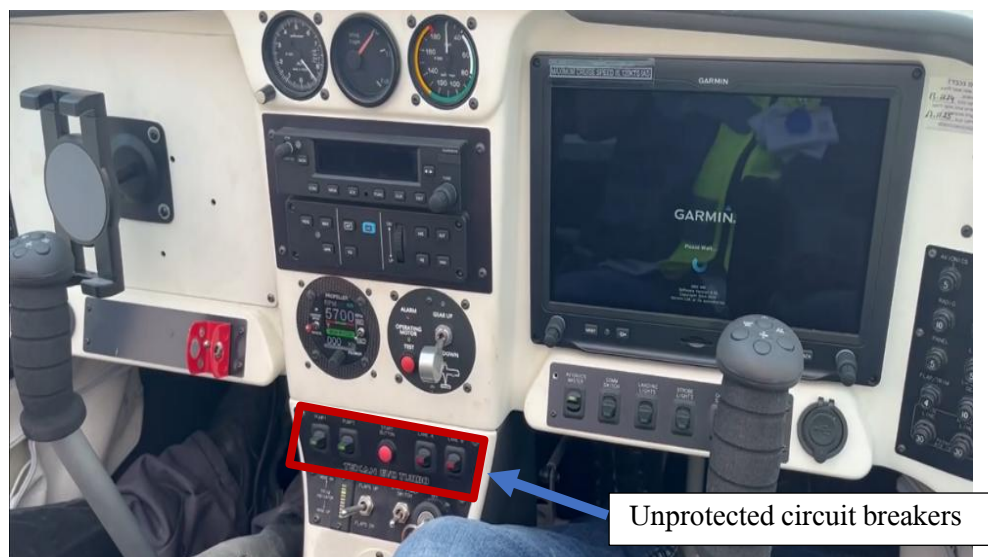
Contrary to the image shown in the AFM, the aircraft was found to have only a single GDU46X screen, and the red guards were removed from above the fuel pump switches and the ECU module switches - Lane A and Lane B.

Picture 14 - The aircraft cockpit

Due to the fact that no guards were found on the switches as stated and no mention was found in the AFM of the potential hazards in their absence, the AIAI issued an

emergency safety recommendation in March 2025 (see Appendix A). In the emergency safety recommendation, the AIAI requested that the CAAI immediately prohibit the operation of Texan aircrafts that have a fuel-injected engine, two electric fuel pumps operated by two switches located adjacent to each other in the cockpit, and that are not protected by appropriate guards.

*Note: Following the emergency safety recommendation, the CAAI engaged with the aircraft manufacturer holding the Type Certificate. The manufacturer issued a Mandatory Service Bulletin (Mandatory SB) on 21/07/2025 (see Appendix B), following which, on 07/08/2025, the CAAI issued an Airworthiness Directive (AD) (see Appendix C). This directive requires, among other things, the installation of safety guards for the fuel pump switches, the ECU module switches - Lanes A & B, and the master switch prior to the next flight.*

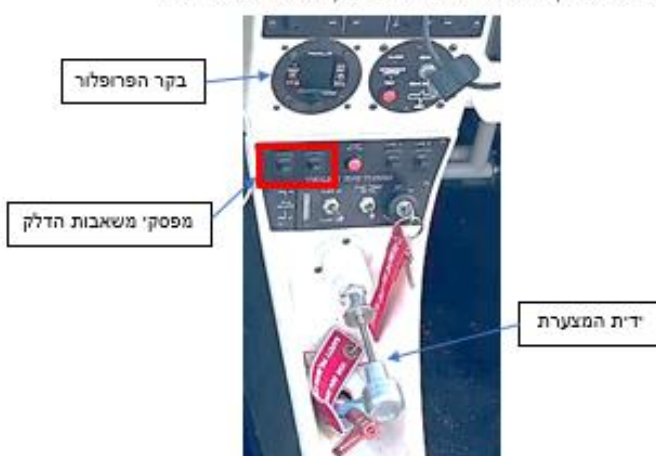
ג. מיקום מפסקי המשאבות בתא הטייס – המשאבות ממקומות בקונסולה המרכזית בין בקר הפרופלור המצוי מעליהן למצערת שמתחת להן (ראה תמונה 2).

תמונה 2 – הקונסולה המרכזית בתא הטייס של מטוס נשוא האירוע

ד. מפסקי משאבות הדלק החשמליות מצויות בצמידות אחת לשנייה (ראה תמונה 2).

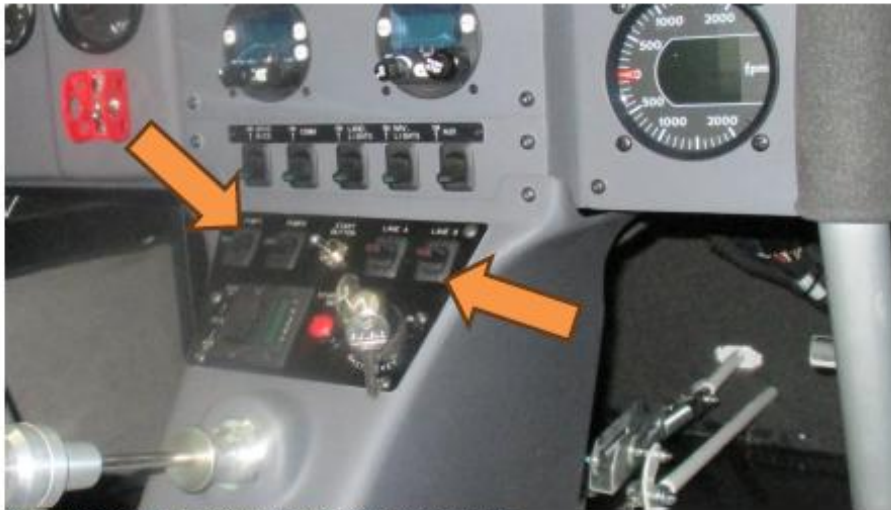
It has been found that not all the Texan aircraft are equipped with the correct set of safety guards for unintended operation of the switches related to:

- Master switch
- Fuel pumps switches (main and backup)
- ECU lanes switches (Lane A and Lane B).

Figure-1 : example of configuration with safety guards missing
