State of Israel
Ministry of Transport and Road Safety
Aviation Incidents and Accidents Investigation

Safety Investigation Report
(Final Report)

Ground Accident No. 7-12

Severe structural failure in main landing gear in preparation for flight

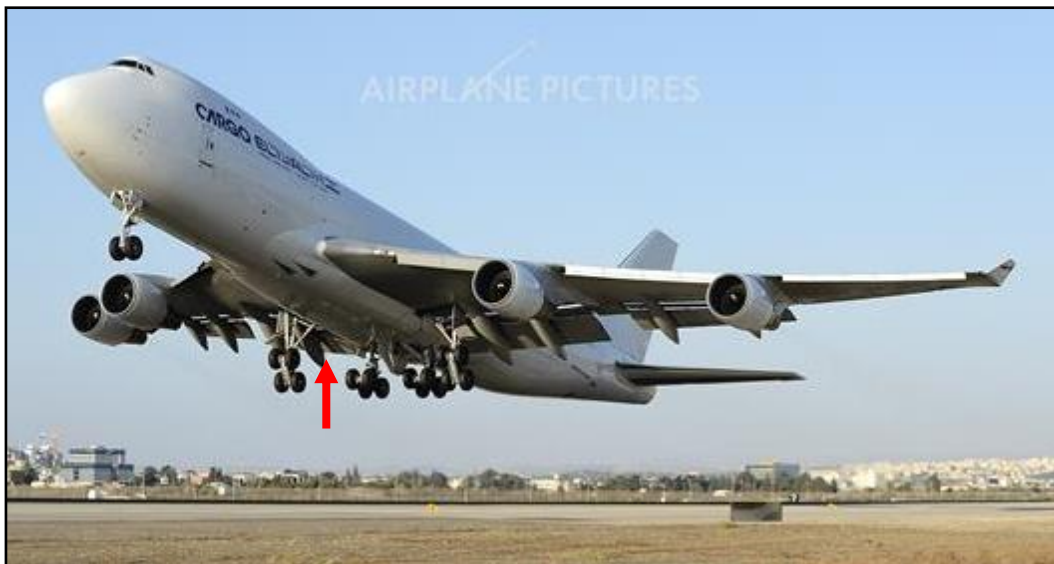
The aircraft which was involved in the accident
(the arrow points to the failed landing gear)

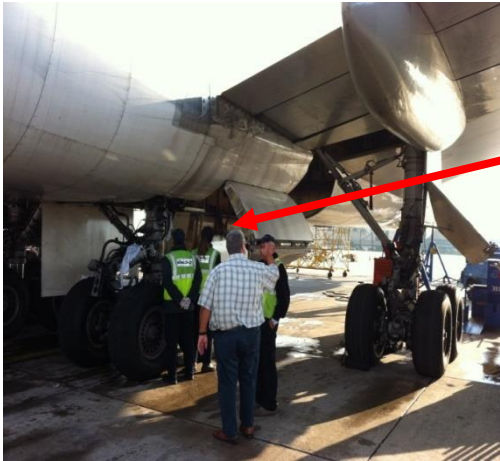
**The landing gear
in which the failure
was detected**

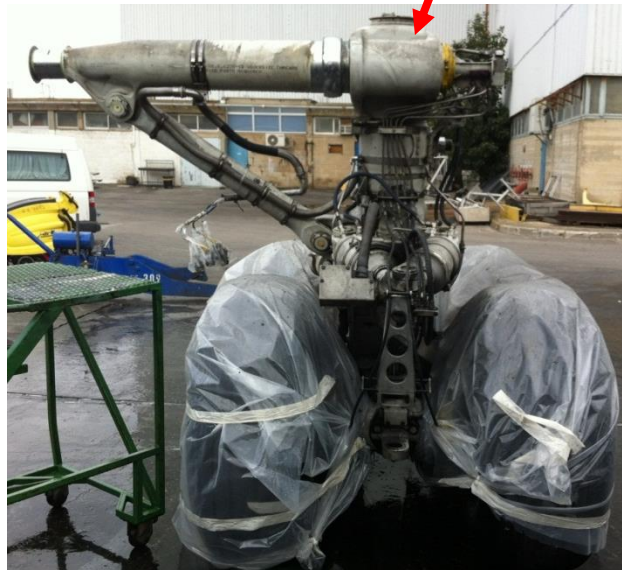
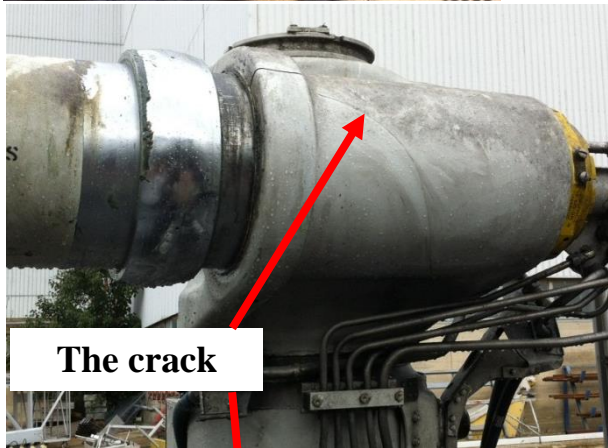
The crack

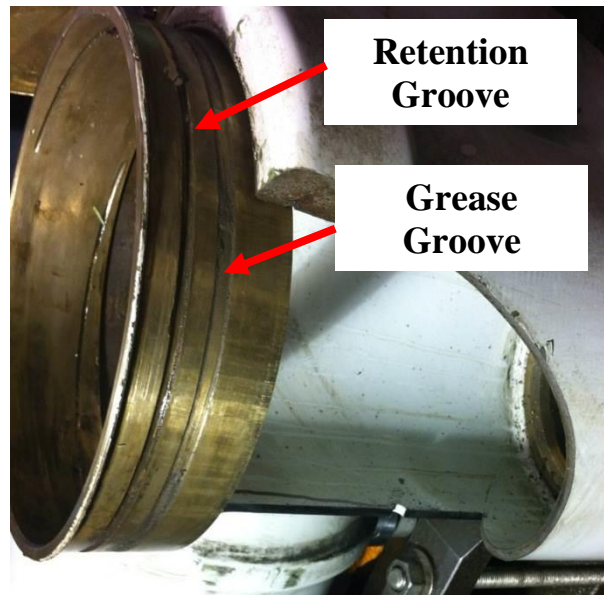
**Retention
Groove**

**Grease
Groove**

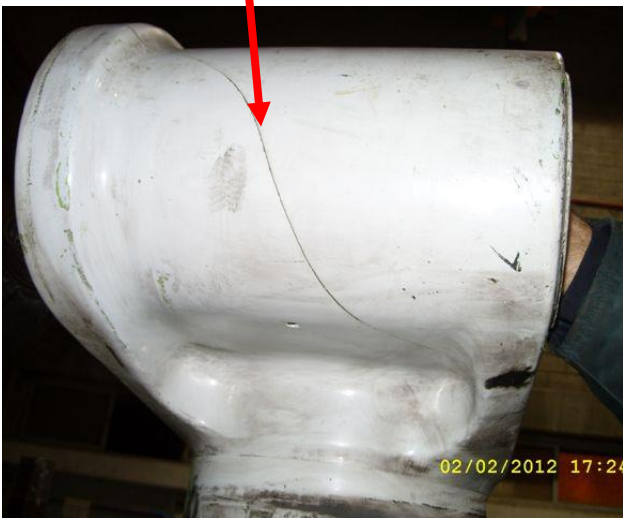
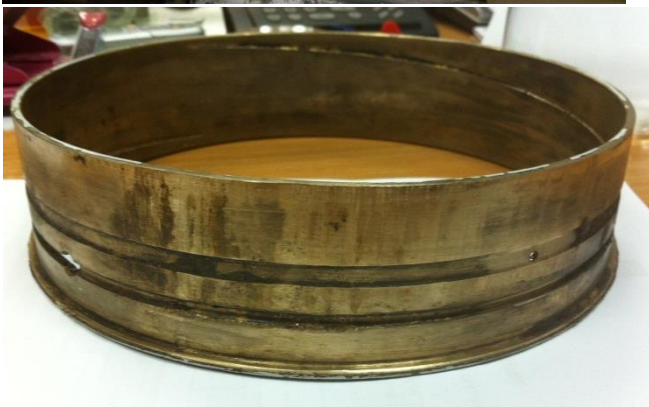
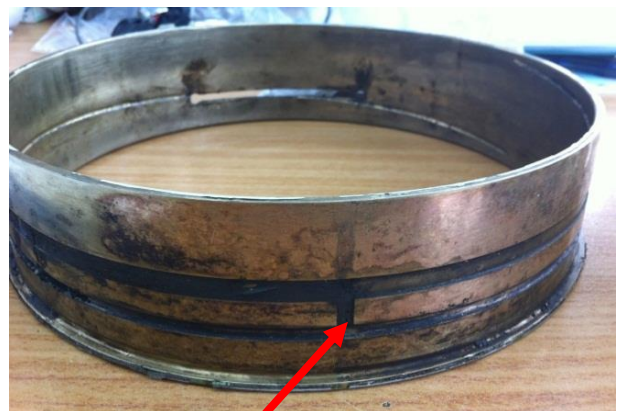
Blocked Grease Groove

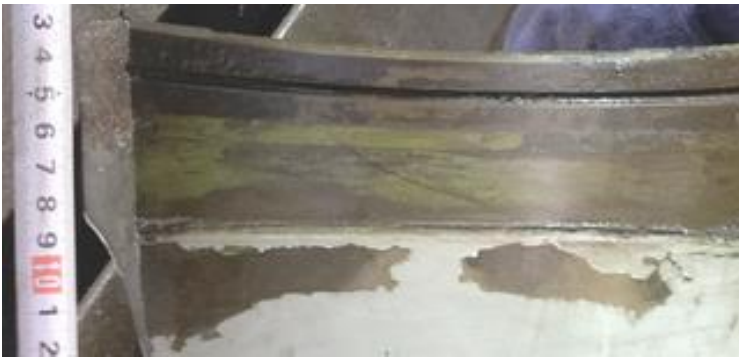
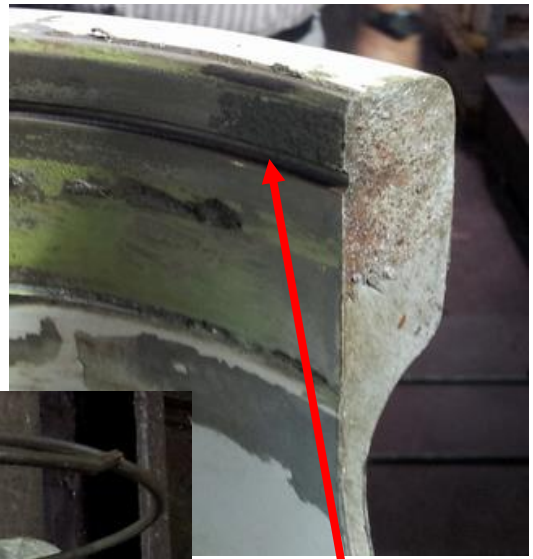
Bushing of Retention Groove

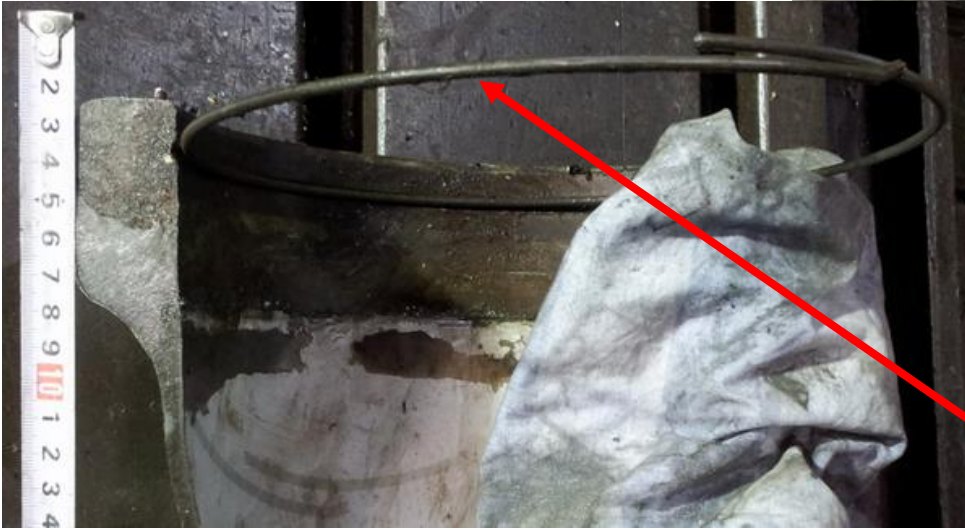
Bushing Spring

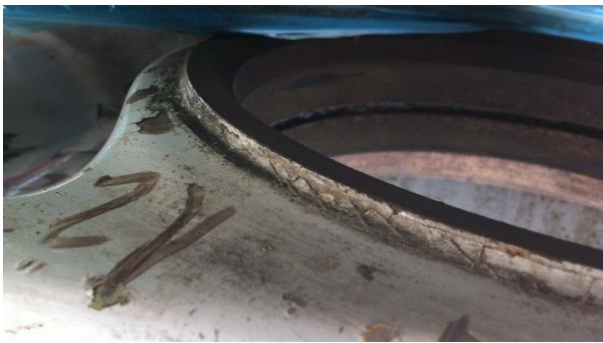
Confirmation of Bushing Movement

2.3 To instruct the relevant repair stations to conspicuously mark those items and components the relative displacement between which is prohibited, in order for such displacement to be discovered while it may still be rectified and to undertake the maintenance work required in such a situation in accordance with the manufacturer's instructions.

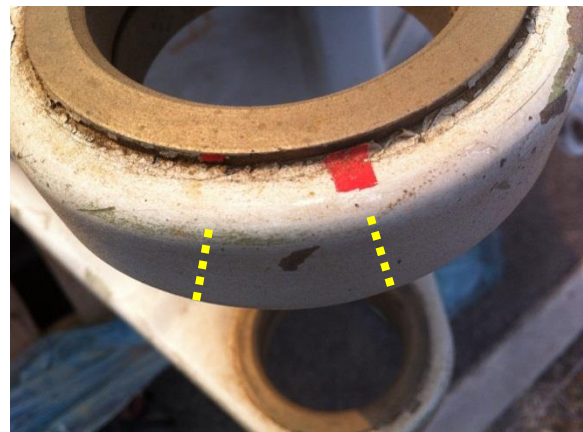
Example of Bushing Movement

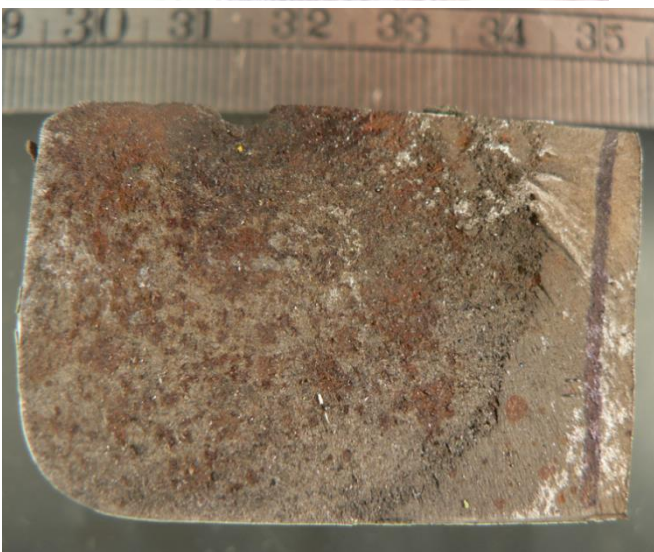
Surface of the crack
