# **Interim Statement**

**Accident File No. 19-23**

## **Ground Accident During Pushback**

| <b>Aircraft</b> | <b>B747-400F &amp; B757-200F</b> |

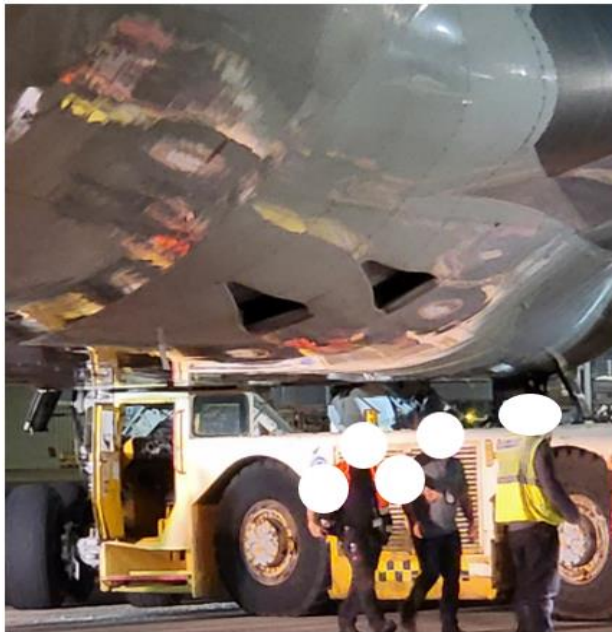
The tug was pushed by the aircraft in a rotary motion, the towbar shear pins broke, and the tug hit the aircraft's main undercarriage underneath the fuselage before it came to a complete stop.

Tug underneath the pushed-back aircraft

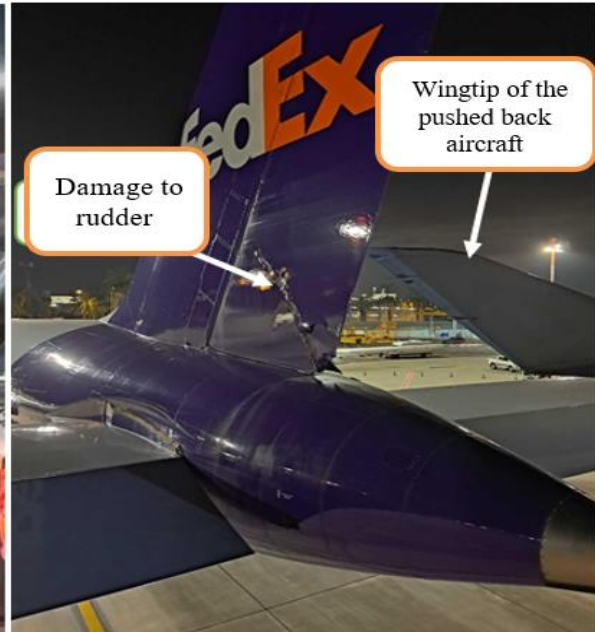
The Boeing 747-400 aircraft moved in an uncontrolled, rightward rotating motion, during which its left winglet struck the rudder of a parked FedEx Boeing 757-200 cargo plane.

Rudder damage of the parked FedEx aircraft
