Ministry of Transport and Road Safety  
Aircraft safety Investigation Authority of Israel (AIAI)

# **Safety Investigation Report**

**Accident File No. 19-23**

**Ground accident during pushback while  
engine starting**

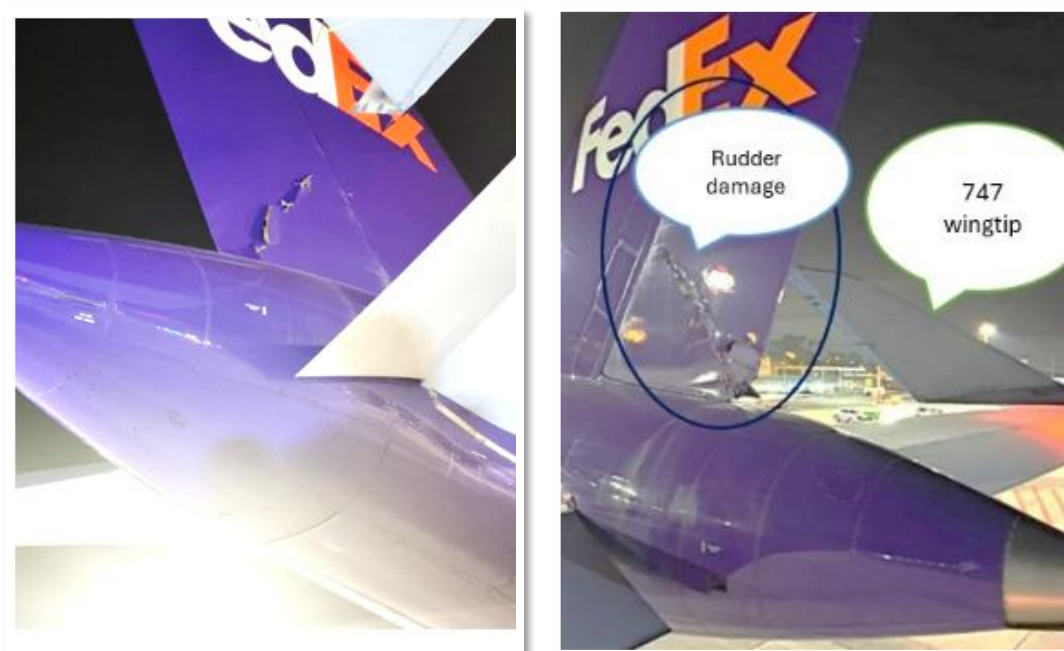
Figure 2 - Rudder of the 757-200F, wingtip of the 747, and impact marks

- 1.3.1 The aircraft sustained damage to the doors and tires of the main landing gear (Body Gear), the underside of the fuselage, the left wingtip, and the housing and bulb of the left navigation light.
- 1.3.2 The parked aircraft sustained damage to the rudder and the aft cone of the fuselage.

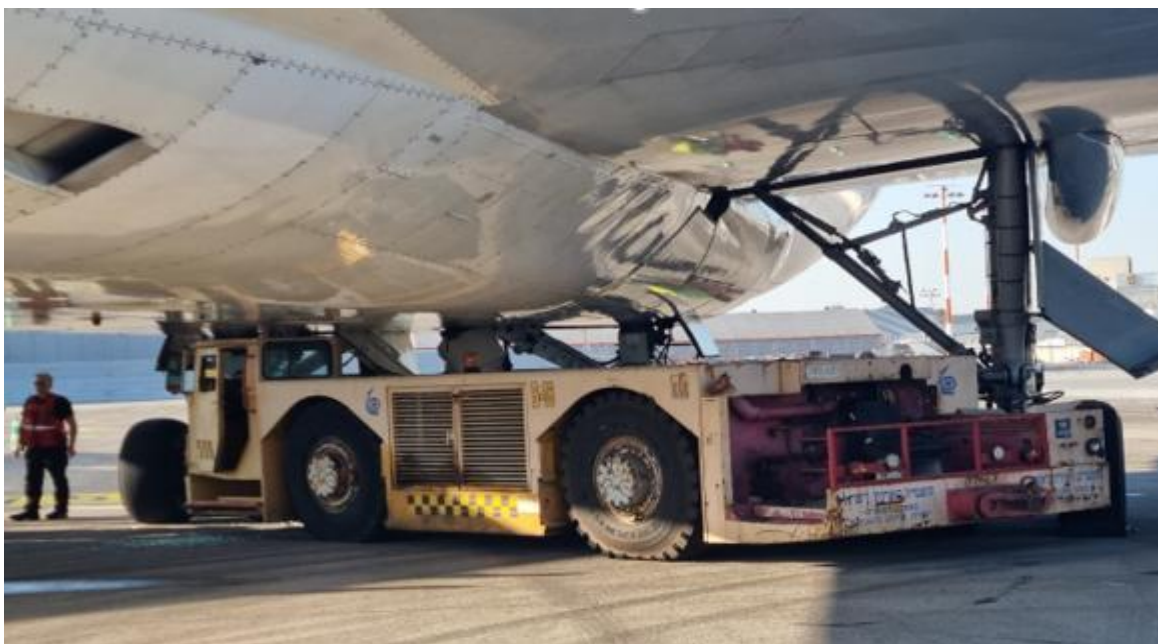
Figure 3 - T-500 tug, landing gear, and belly of the cargo aircraft

1.4.1 Damage to the T-500 tug - The driver's cabin was crushed as a result of impact with the aircraft's landing gear door.

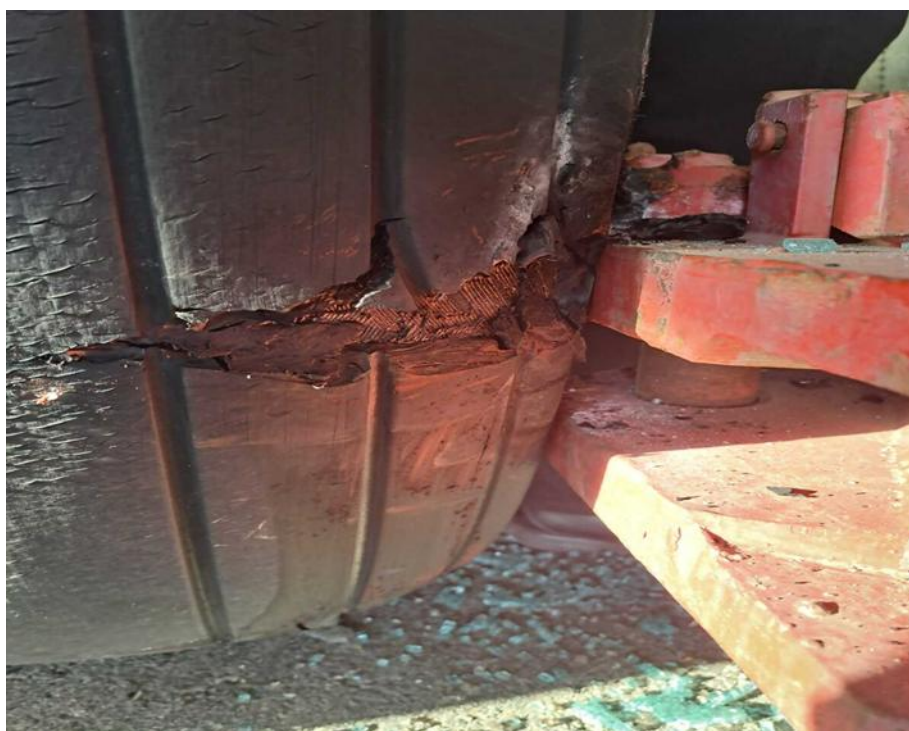
Figure 4 - Cargo aircraft tire and portion of the tug

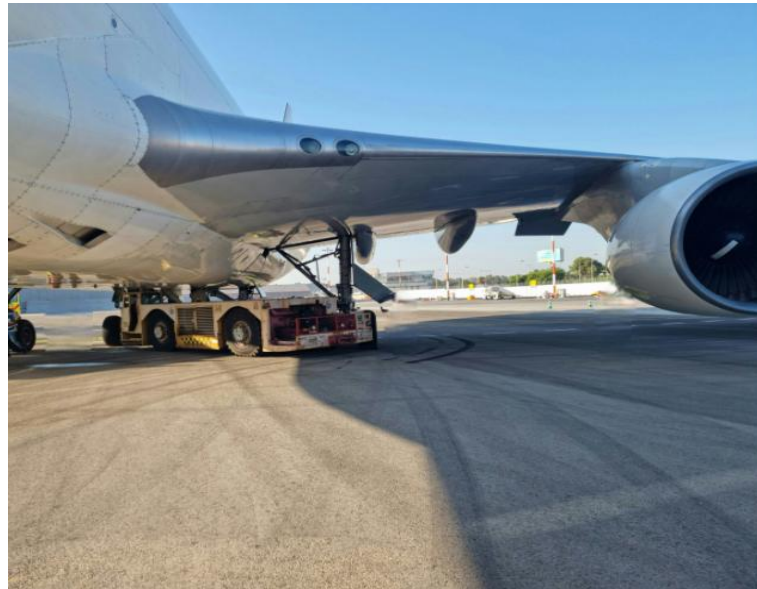
Additional findings included: drag marks on the left tires, impact marks on the right side and front of the tug, wear marks on the parking brake discs, a broken wheel axle, and a jammed control selector. The tug was permanently decommissioned by IAI.

Figure 8 - Tug position and tire marks

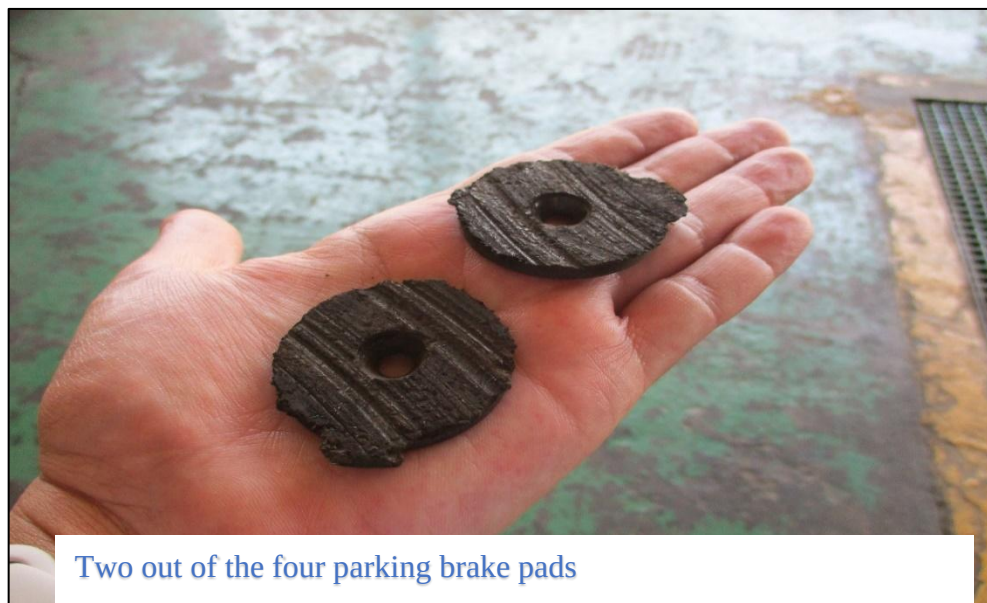
Two out of the four parking brake pads

- **The contact area of the parking brake pads is less than 2% of the main brake pad area.** This substantial difference in braking capability is reflected both in the placement of the pads and in the fact that the main system pads grip the wheels. The parking brake discs were found worn and scored after the accident.

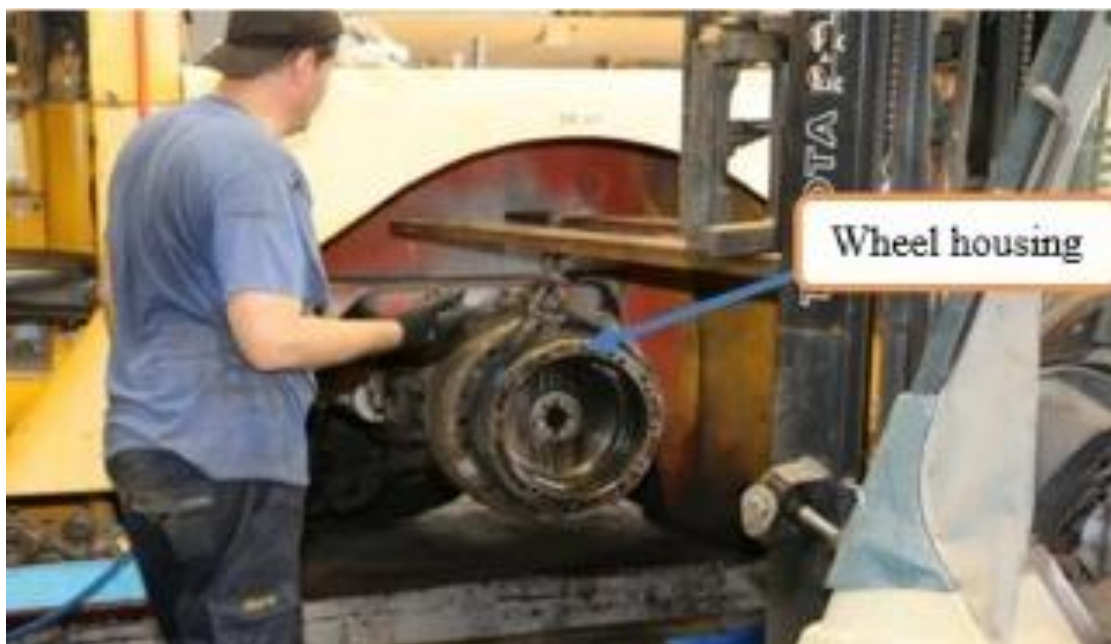
*Figure 13 - Wheel housing*

- Each wheel is mounted on a planetary gear system within a special housing—the "wheel housing." Only disassembly of the wheel housing and planetary system allows visual access to the brake pads. Therefore, inspection of the main brake pads (noted in the periodic serviceability report, Appendix 3) requires removal of all 4 wheels and their housings. The ground services garage lacks a dedicated lifting tool for this task, creating significant difficulty in execution and requiring improvisation, such as hanging the wheel housing (after removing the wheel) using a heavy-duty fabric strap from a forklift tine in order to lower it from the tug and set it aside.

- According to professional personnel, the last main brake pad inspection was **performed approximately 15 years ago**.
- In Appendix 3 of the periodic inspection reports, the inspection task "brake pad condition" was recorded as having been ostensibly performed during each inspection.

- Based on the findings, no visual brake pad inspection was performed during the last 15 years.
- Parking brake documentation: No record of periodic parking brake pad inspection was found.

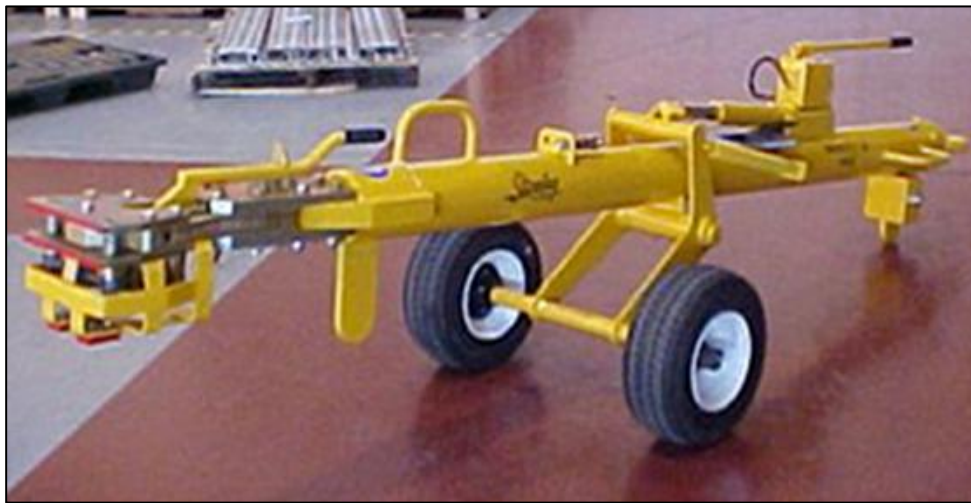
Figure 14 - **Towbar**

1.4.2 Damage to towbar - Both shear pins were sheared and the towbar head disconnected from the towbar body (the towbar-tug connector was not yet inspected for damage to the spring and discs).

*Note: Shear pins were found that did not match manufacturer's specifications.*

- Tug connection - spring and washers found intact.
- Shear pins - remnants of a 7/8" bolt were found, whereas according to manufacturer specifications there should be a 3/4" shear pin with bushings (inner dimension 3/4" and outer dimension 7/8").

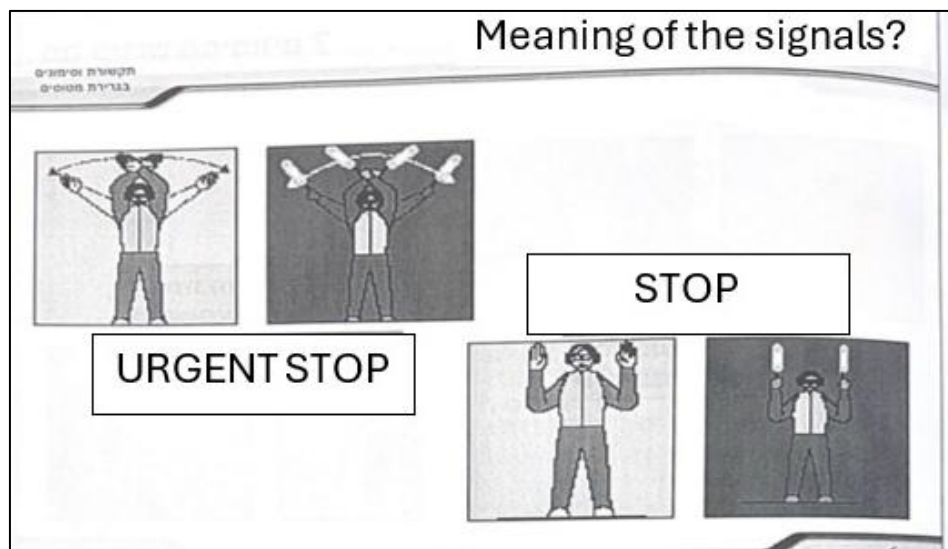
- In Figure 16, the **"stop" signal does not display hand signals that meet international and national requirements.**
- In Figure 17, correct signaling is presented on an image of a person without representative clothing/reflective vest.

Figure 16 - The stop signal does not conform to international and national requirements

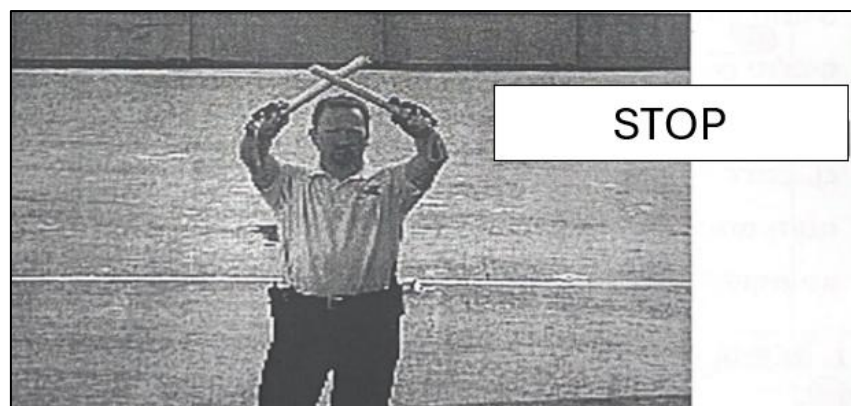
Figure 17 - Correct signaling with non-standard appearance of the marshaller

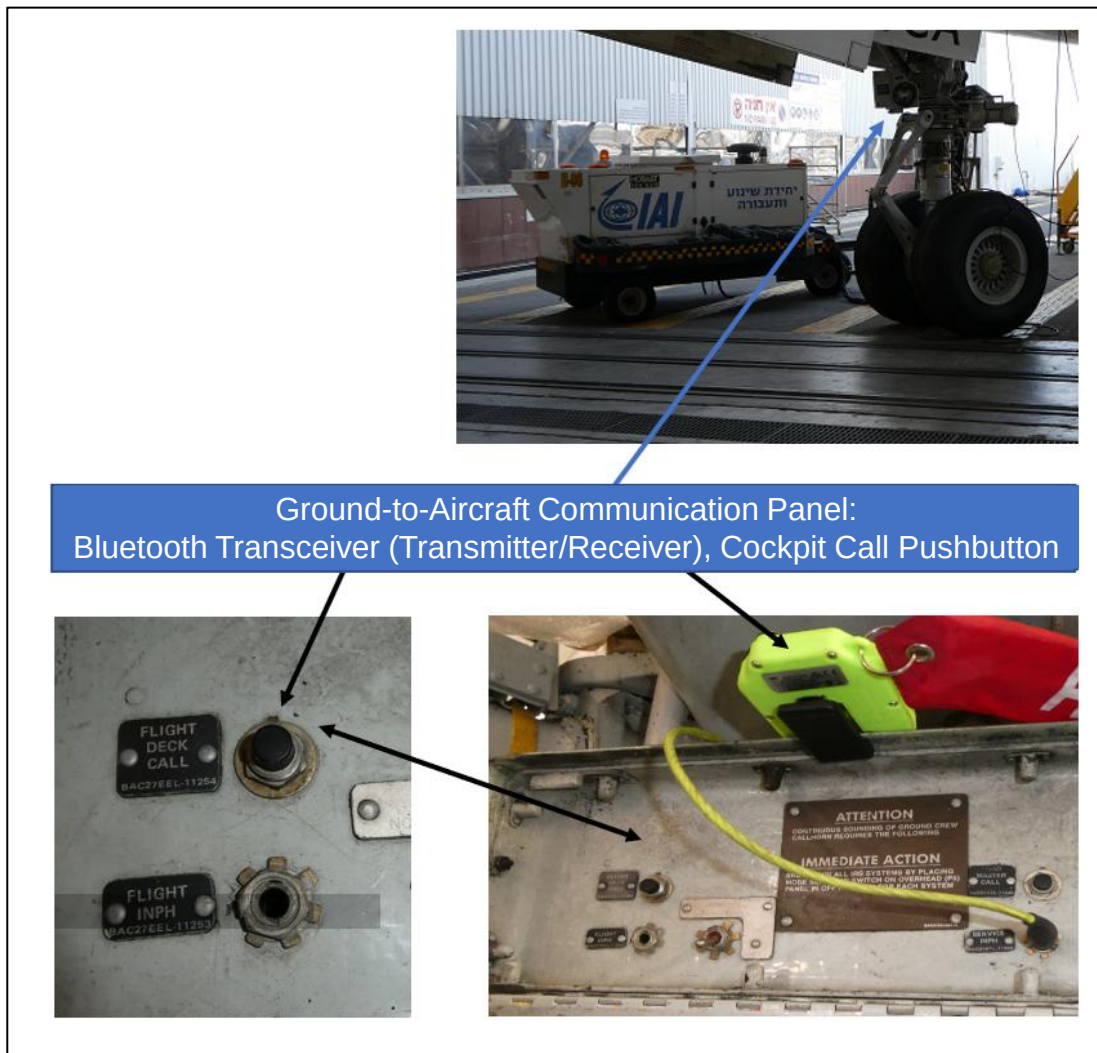
Figure 21 - Ground to Aircraft communication panel

The pilot call button is a small spring-loaded button located on the nose gear strut. Attempting to press this button while the cargo aircraft is moving poses a risk of a ground crew member being run over.

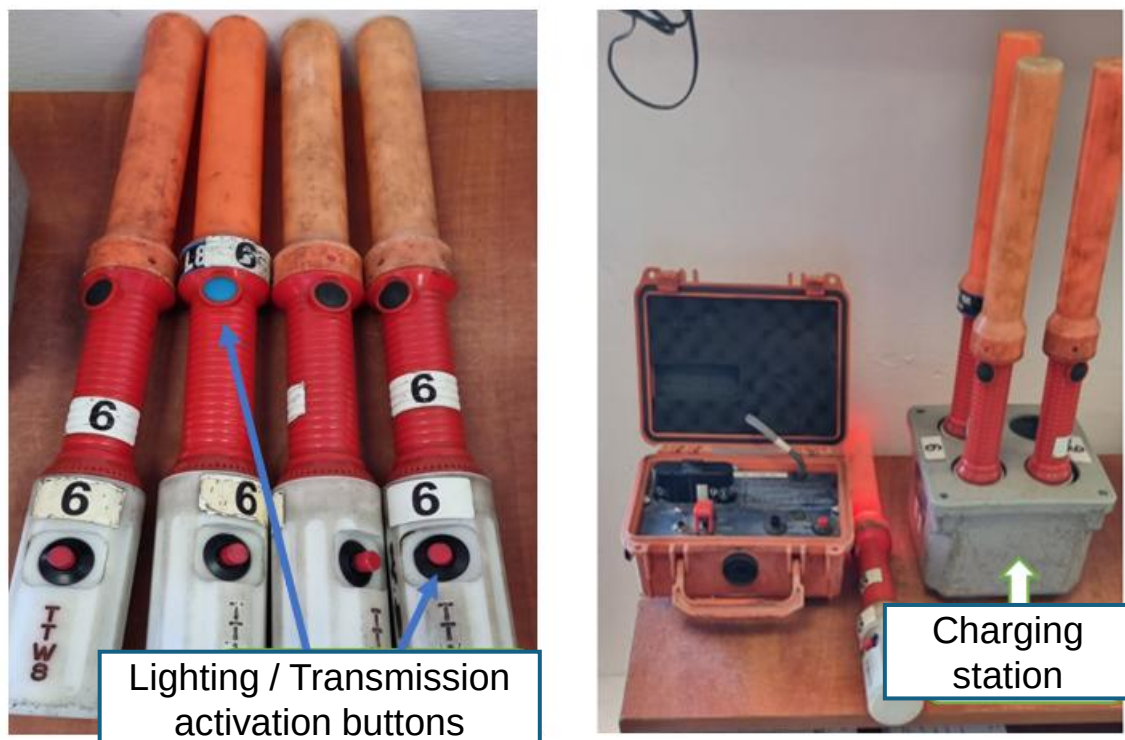
Figure 22 - Marshalling/Guidance Wands

*Note: The kit of 4 illuminated guidance wands with wireless communication to a portable horn magnetically mounted ad hoc on the tug is not suitable for the task due to a missing wand and due to coding, that does not allow operational flexibility in the event of a transmission malfunction between the guidance device held by the ground crew member and the horn/light mounted on the tug (see Appendix 1).*

Each one of these alert units has individual coding between the "flashlights" and the horn. Pressing the alert button on a flashlight belonging to a different kit will not activate the horn on the unit in question.
