Safety Investigation Report - Final

Serious Incident File No. 25-23

Engine failure and belly landing

Date	8.9.2023
Aircraft	TEXAN Top Class 2 RG
Registration	4X-HYT
Location of event	Near Hatzor Air Force Base

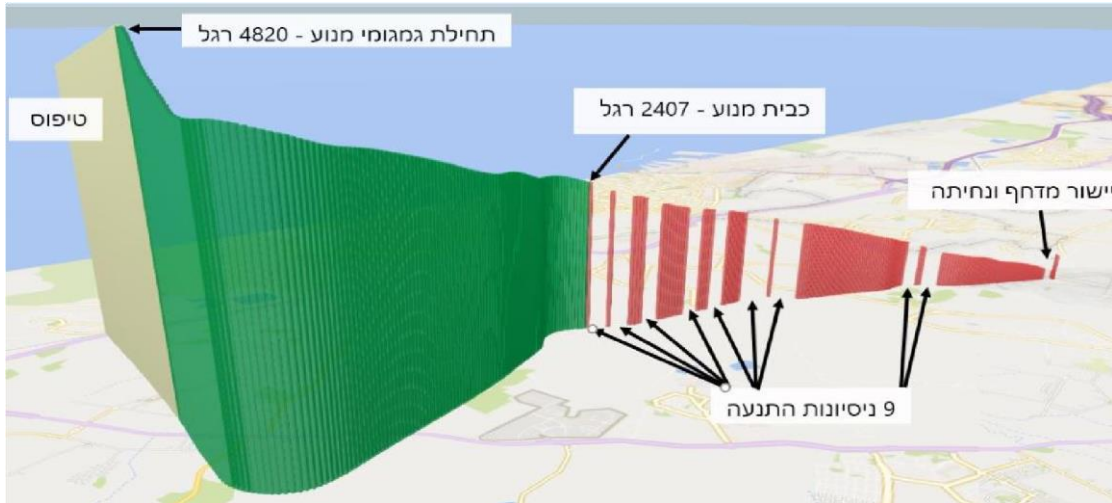
Figure 4 - Flight Profile and Start Attempts Characterized by Loss of GARMIN Data (Electrical) During Use of Starter

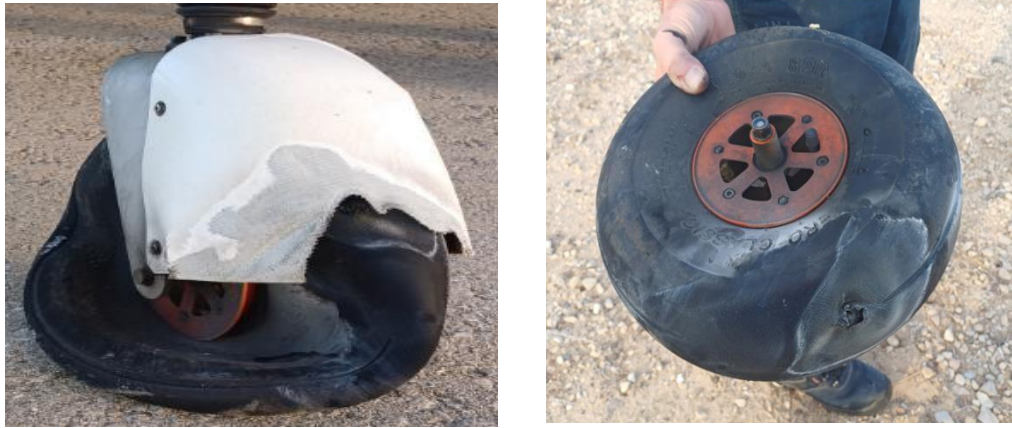
- The pilot exited the aircraft unharmed. Following the belly landing, the aircraft sustained minor damage to the front wheel tire and slight abrasions on the tips of the flaps.

Front tire torn. Light abrasion on the wing tips. Light abrasion on the fuselage and exhaust tip.

Figure 6 - Damaged Front Wheel

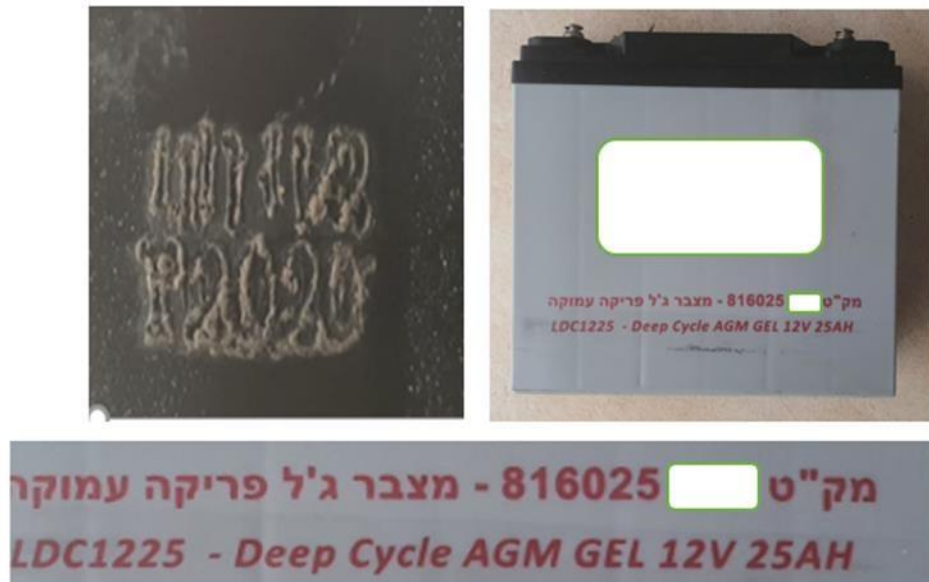
•
installed in the aircraft after the incident was a **12V-25AH deep-discharge gel battery**, which is not a "starter battery" but rather a backup deepdischarge battery. The battery in this aircraft serves primarily for starting and as a backup power source in case of electrical failure.

- After the incident, the battery was tested at the manufacturer's facility, and it was found to have low capacity - fully discharged within about 4-5 minutes.

Figure 7 - The battery found in the aircraft

- The battery was tested by the manufacturer and found to be "unserviceable."

According to the manufacturer, who inspected the battery after the incident, it was found to be very weak.

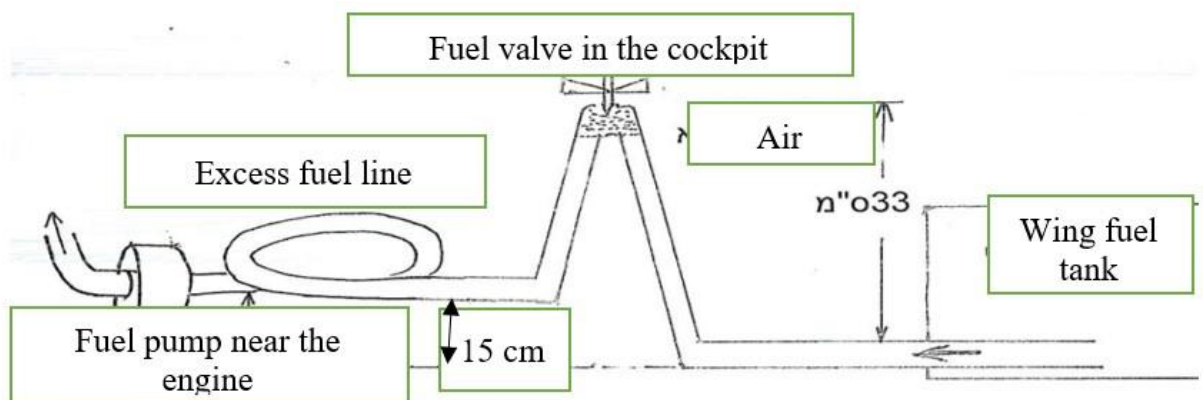
The fuel supply pipe from the tanks to the pumps is about half a meter in excess, coiled around itself.

- The fuel pump openings are higher than the tank exit openings.
- The fuel valve is located inside the cockpit and is positioned higher than the tank exit openings in the wing and the fuel intake openings for the pumps.
- The pumps **draw** fuel from the aircraft's tanks.
- A schematic diagram (Figure 8) of the fuel system routing to the engine. The fold in the upper part of the pipe near the fuel valve (reverse siphon) and the excess pipe above the fuel pump intake openings create an "air trap" when such exists in the system.
- When the fuel boils, fuel vapor bubbles are created, causing engine stuttering. If the bubbles accumulate, a blockage can form in the fuel system, which may lead to engine failure (see Figure 8).

Figure 8 - Schematic Diagram of the Fuel Flow Pattern

- The configuration of the fuel system, including differences in fuel line placement and bends, facilitates the accumulation of air, which, if present in the line, can be drawn into the pumps. Vapor formation, induced by the fuel boiling due to environmental conditions, can lead to the formation of air within the system.

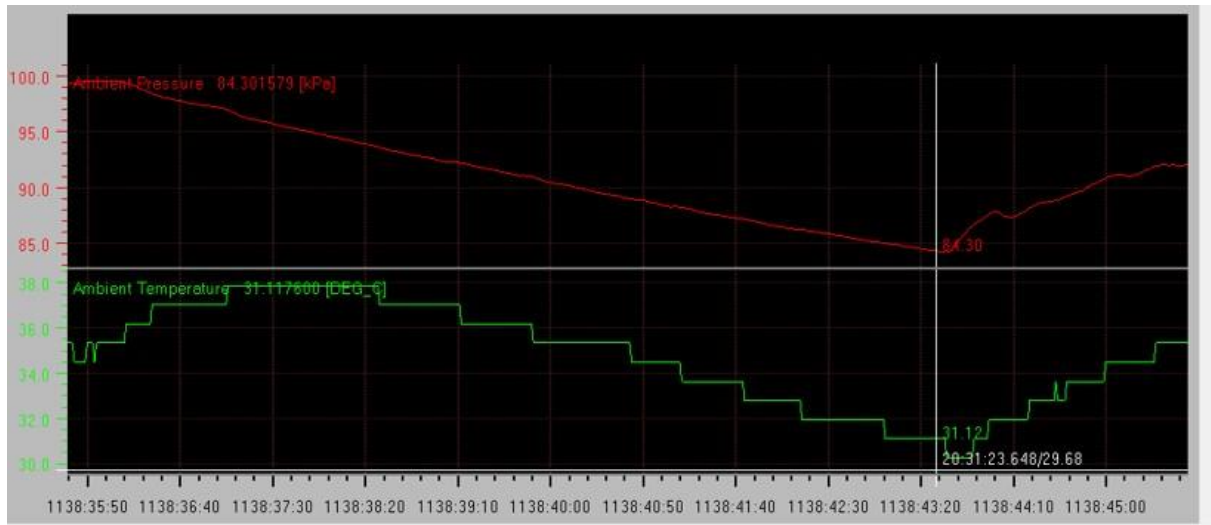
ENGINE COMPUTER

External Pressure (Kpa) decreases with altitude gain until the beginning of the descent. **Ambient Temperature** increases at the beginning of the climb and decreases as the climb continues.

There is a discrepancy between the Garmin data and the engine computer data. This difference is due to the placement of the sensors. However, even the engine computer data indicates a high ambient temperature reaching approximately 38 degrees Celsius during an inversion while climbing.

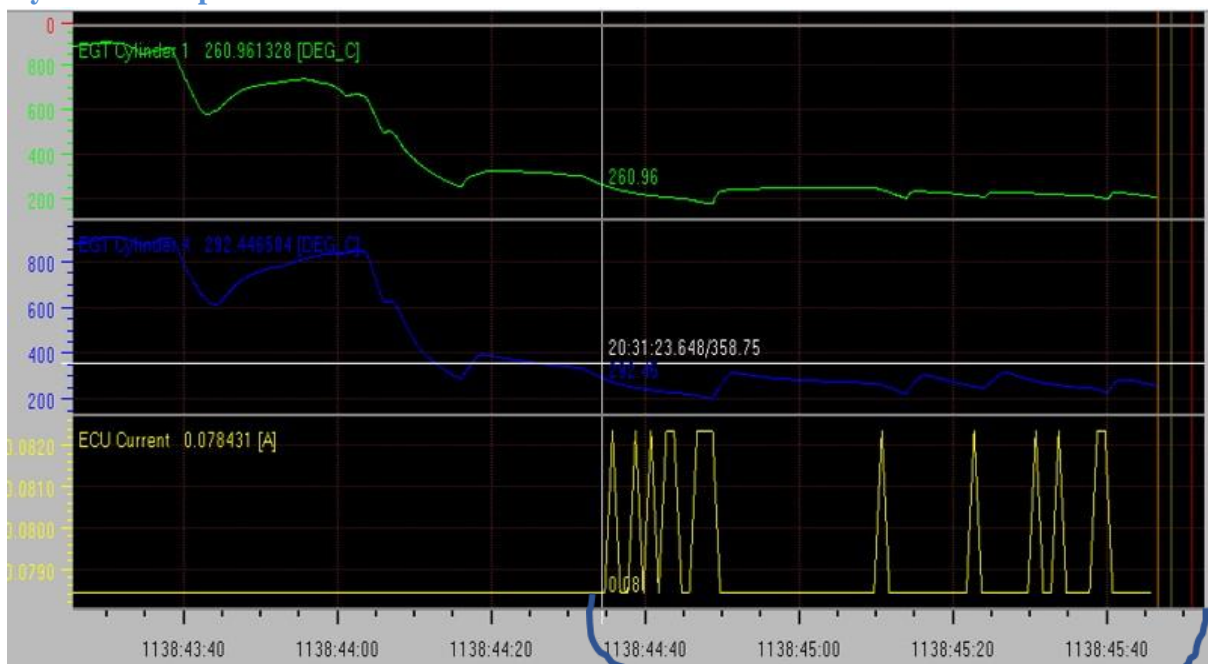
10 start attempts. The starter receives current (according to the GARMIN, the propeller only spins on the 9th attempt).
