# **Safety Investigation Final Report**

**Accident File No. 29-24**

## **Agricultural aircraft Accident**

| <b>Aircraft</b> | <b>Turbo Thrush S2R</b> |

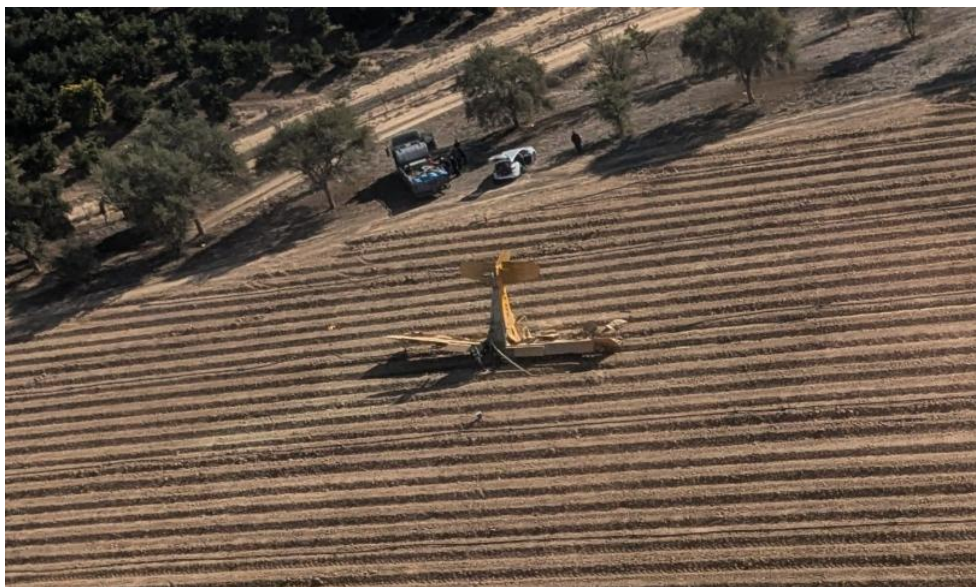
Figure 2 - The aircraft at the accident site

The aircraft came to rest within a single furrow, with both wings aligned parallel to the furrow's direction, indicating that the impact occurred perpendicular to the furrow orientation. No marks were observed on adjacent furrows, indicating there was no horizontal movement during or after ground impact (see Figure 2).

All major aircraft components were located within a confined area adjacent to the main wreckage at the accident site (see Figure 5). The landing gear collapsed, the wings were bent and deformed, the propeller sustained significant damage, and the propeller shaft was severed from the engine.

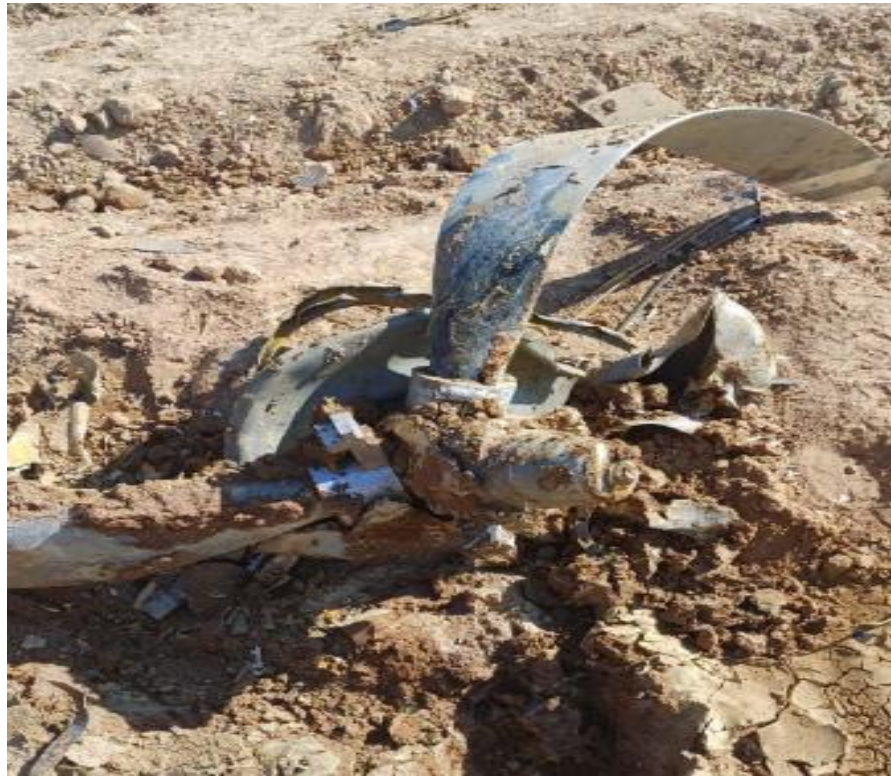
Figure 3 - **Propeller - pitch mechanism and blades**

Two of the three propeller blades were found bent. The third blade had separated from the hub and was located intact and straight nearby (see Figure 3).

At the accident site, the propeller was found with one blade bent forward, one blade with a damaged tip, and one blade separated without structural deformation. The propeller pitch control lever was found in the feather position. In order to determine the propeller condition at the time of the accident, an examination was carried out in accordance with the manufacturer's instructions.

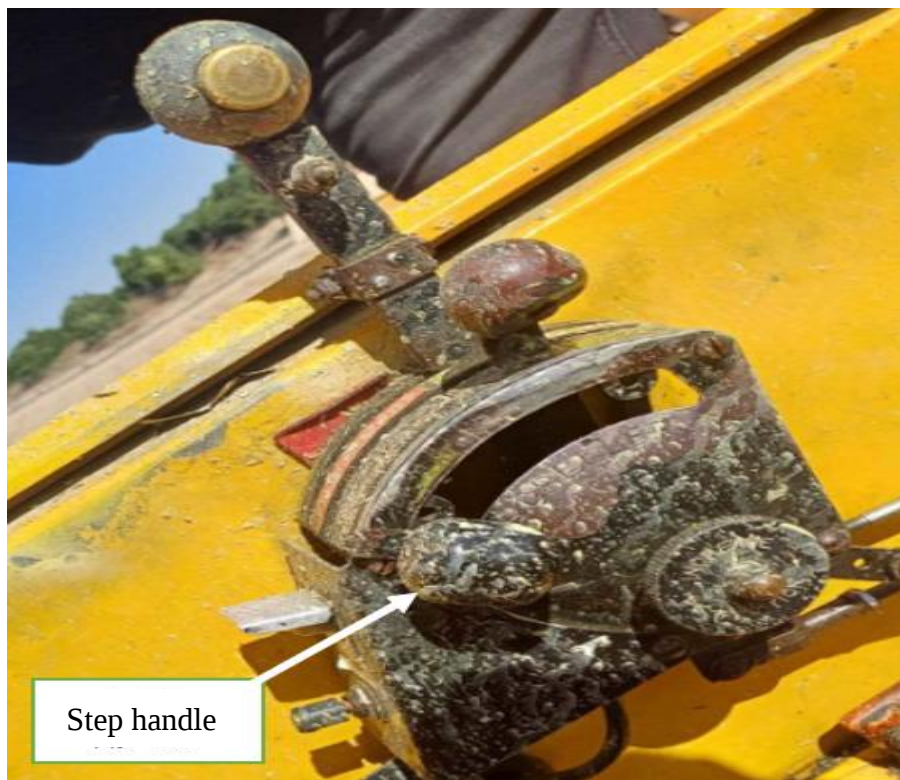
Figure 4 – **Engine control lever positions after the accident**

- ✓ The throttle and torque were found in a position consistent with high engine power during flight.
- ✓ The propeller pitch lever was found in the "feather" position (see Figure 4), however, the propeller blades were found in a fine-pitch position consistent with the flight condition in which the aircraft was expected to be (see Appendix 1 for details).

*Note: As a result of the accident, the control cables (throttle, torque, and propeller pitch) were severed; however, when the levers are positioned such that all cable fracture points align on the same plane, it is found that the pitch corresponded to a fine-pitch setting.*

The position of the Propeller Pitch Control Lever, which was found in the Feathered Position, is explained by the manner in which it is connected to the engine. The Lever is connected via a cable to a control mechanism (Governor) that regulates oil flow through the Engine Shaft connected to the Propeller, thereby pushing a Piston that is mechanically linked to the three Blades and moves them to the desired pitch setting. The separation of the engine from the aircraft during the accident caused tension and severing of the cable connecting the engine control mechanism to the Pitch Control Lever. This condition causes the lever to move to the aft position (Feather) and is a consequence of the accident.

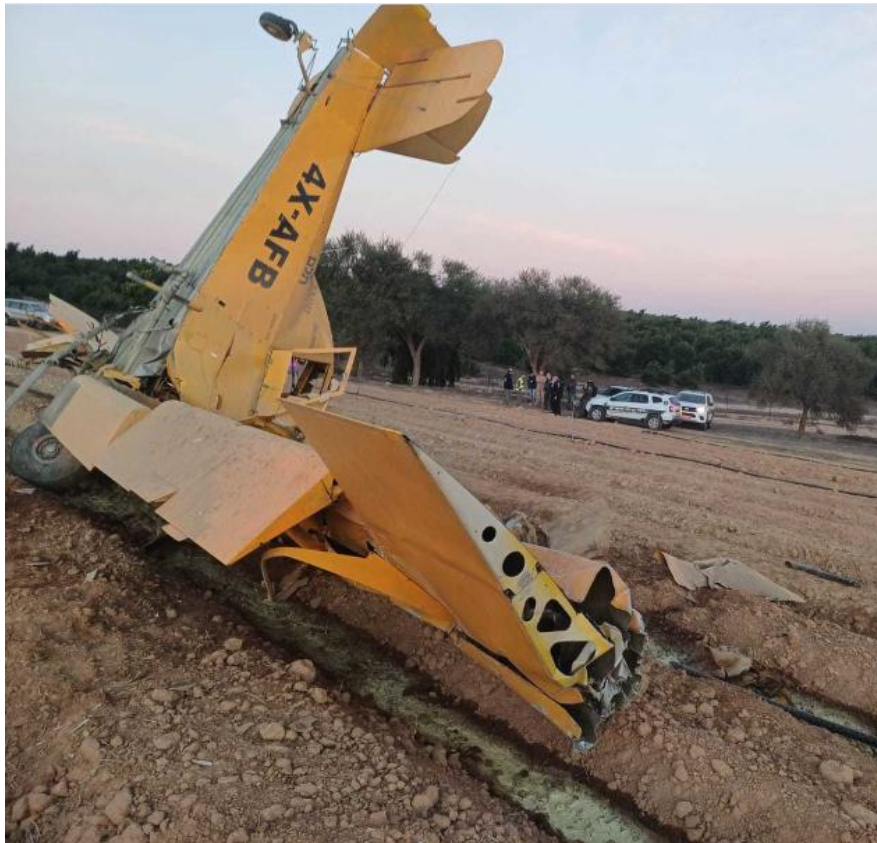
Figure 5 -Distribution of aircraft debris

The engine detached from the fuselage, disintegrated, and was significantly deformed. The aft section of the fuselage, including the tail assembly, fractured upward and separated at its attachment point to the fuselage. The flaps were found in the "down" position; the right-wing flap cable was torn, while the left-wing flap cable remained intact and connected to the actuation mechanism. The cockpit structure retained its overall integrity.

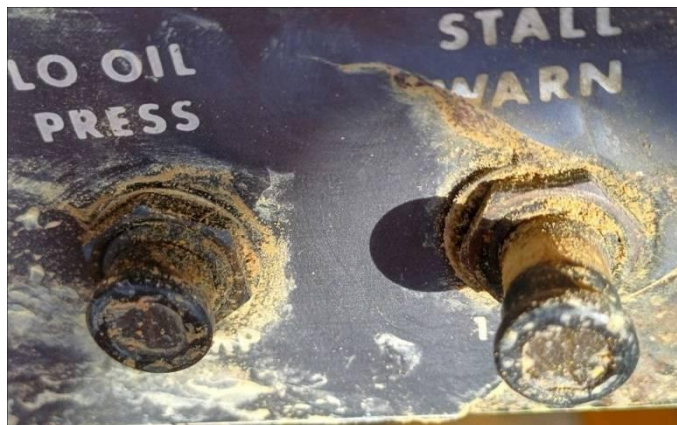
Figure 8 - Stall Warning System circuit breaker

- ✓ The stall-warning proximity circuit breaker (horn and light), which was found in the aircraft at the accident site, **was in the OUT position (disconnected)** (the right push-button in Figure 8).

- ✓ Checks performed on the circuit breaker after the accident indicated proper function.

1. *This circuit breaker was the only one found in the "Pull-out" position among all the other circuit breakers on the panel.*
2. *The pilot could not state what the position of the circuit breaker was during the flight, but noted that he had not changed its position when taking over from the previous pilot (the pilot changeover was carried out while the aircraft's engine was running).*
3. *Mud marks found on the circuit breaker indicate that it was in the "Pull-out" position at the time of the accident.*

- ✓ The investigation team found that many Turbo Thrush pilots in Israel fly with **the stall-warning circuit breaker in the "out" position (disconnected)** due to what some refer to as "false alarms". Some pilots also indicated that the frequent activation of the warning increases cumulative fatigue during spraying operations (tens or even hundreds of sharp turns per workday). This practice is known and **common primarily** among experienced pilots. According to the pilots, their aircraft handling experience is sufficient for recognizing when approaching stall, whereas the operation of the audible warning hinders them and contributes to cumulative fatigue throughout the workday during spraying flights.

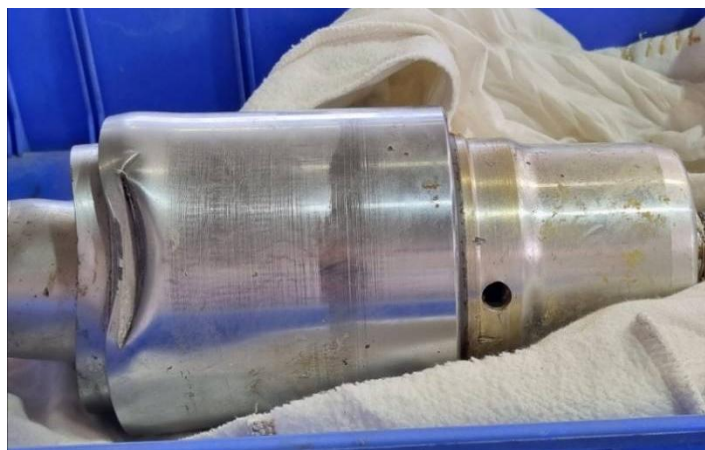
**Figure 15 - Imprint marks on the cylinder**

- ✓ The imprint marks found in the system indicate that the propeller was in fine pitch at the time of the accident (as during flight), and rule out a feathered condition.

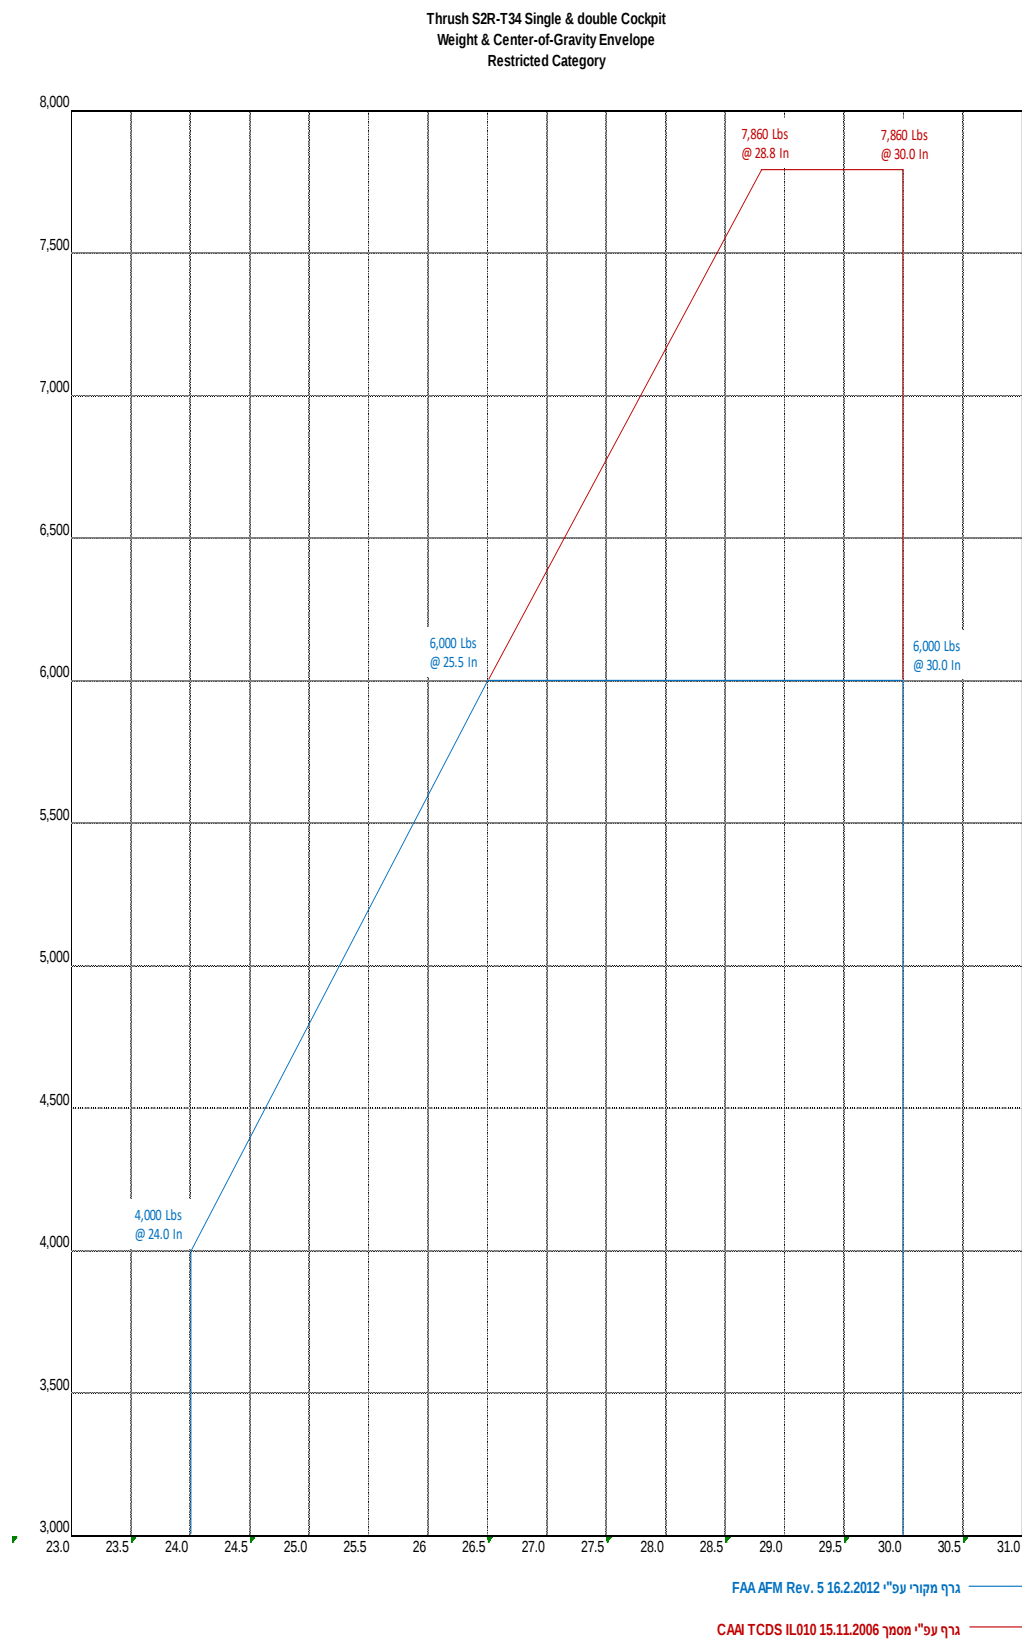
**Weight & Balance Chart according to the AFMS data provided by the CAAI**

- ✓ At weights of 4,000 lb and 7,860 lb: 30.0 inches aft of the datum.
- ✓ Maximum takeoff weight according to the aircraft manufacturer is **6,000 lb**. It follows that at a maximum takeoff weight of 7,860 lb, the weight-and-balance envelope is reduced by 65.7% compared to the manufacturer-defined maximum takeoff weight of 6,000 lb. At this weight, **the distance between the forward and aft envelope limits is 1.2 inches**.

It cannot be ruled out that the tendency of the stall warning horn to activate frequently during maneuvering **is a result of this condition**, potentially contributing to pilots disconnecting the system.
