Safety Investigation Report - Final **(Final Report)**

Accident File No. 53-17

VIBRATIONS DURING HOVER, DESCENT AND BREAKAGE ON GROUND

Date	28.8.2017
Aircraft	Schweizer 269
Registration	4X-BIM
Location	Herzliya Airport

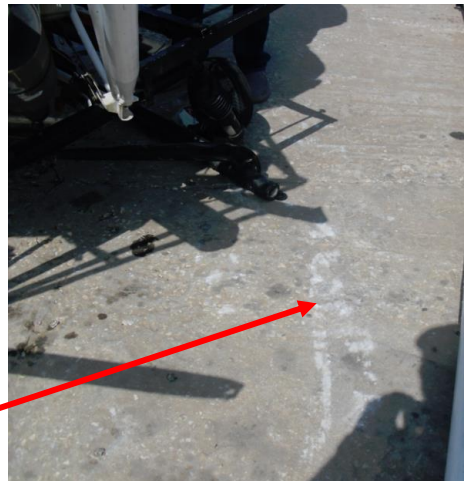
RH skid touching first

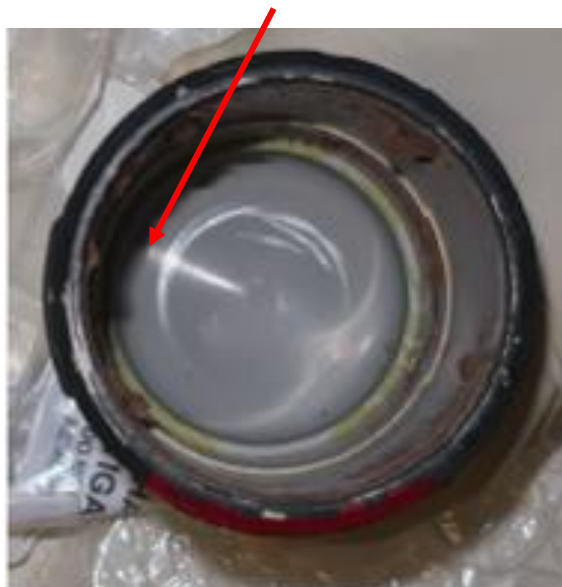
Figure 4- Interior of red damper housing showing semicircular witness marks.

Of the 3 dampers shipped for inspection, the red damper was found with the most significant witness marks, with linkage to its degraded performance, which could affect the phenomenon of blade lead/lag, which this aircraft has experienced in the past. The semicircular witness marks are a result of pressure contact of the damper's inside with the bottom of the cylinder, indicating an excessive blade movement in the horizontal plane (Lead-Lag). Both other dampers had such witness marks but they were slighter.

All 3 dampers were inspected and disassembled. The red damper exhibited evidence of corrosion, elastomer axial movement against the tube-form ring over an undetermined period of time resulted in the rolling of elastomeric material, and the elastomeric tube-form completely separated from the housing under an axial load.

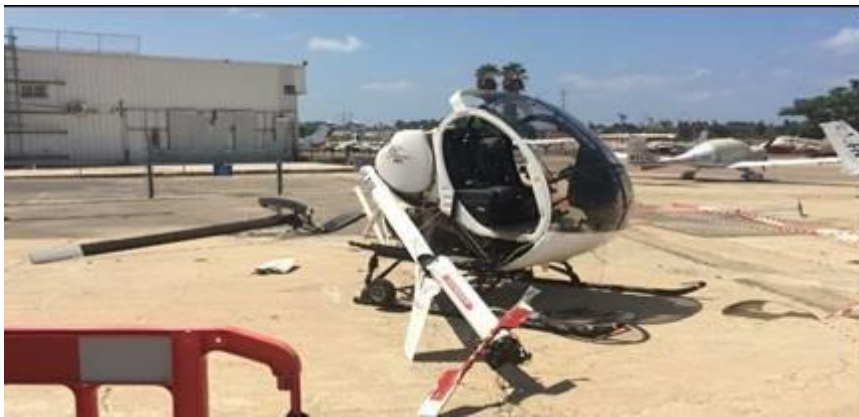
The accident helicopter, its boom folded on its RH side, the rotor behind, the cockpit intact

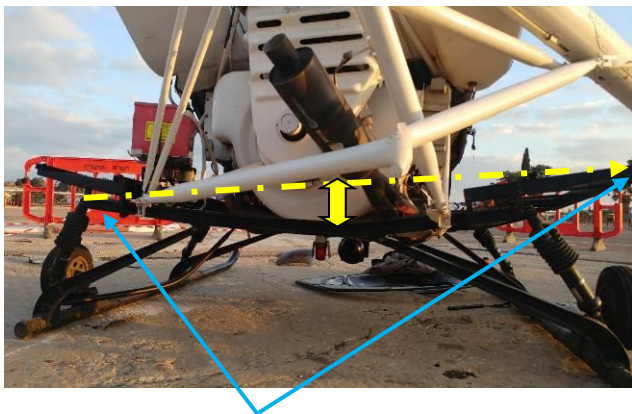
- ☒ Heavy landing – with a high probability, on one side (on one skid or on part of a skid, in this case the RH skid), which spreads the skids outboard and causes the cross bar to bend.
- ☒ Regular landing – Followed by initiation of aircraft bouncing ("dancing") due to entering the "ground resonance" phenomenon.

The investigating team inquired the helicopter's manufacturer about the cross bar bending and was informed that based on the cross bar damage data, the observed damage is an outcome of a heavy landing. They further added that substantial energy is required to bend this bar, well beyond the energy values for ground resonance, and that ground resonance will not bend the cross bar.

Accident helicopter with twisted cross bar

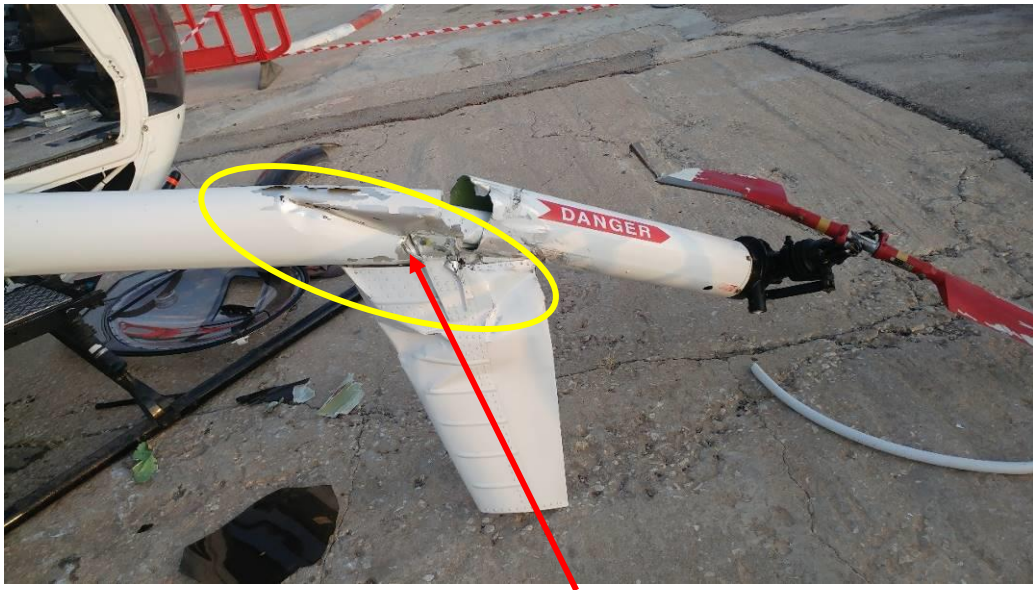
- ☒ Heavy landing, causing a main blade to sag on the helicopter's LH side and impact the tail boom.
- ☒ Aircraft bouncing ("dancing") due to entering ground resonance phenomenon.
- ☒ Blade Lead/Lag phenomenon, leading to rotor head unbalance, which in turn might cause one of the rotor blades to strike the tail boom.

Mark of main rotor blade impact on the helicopter tail boom

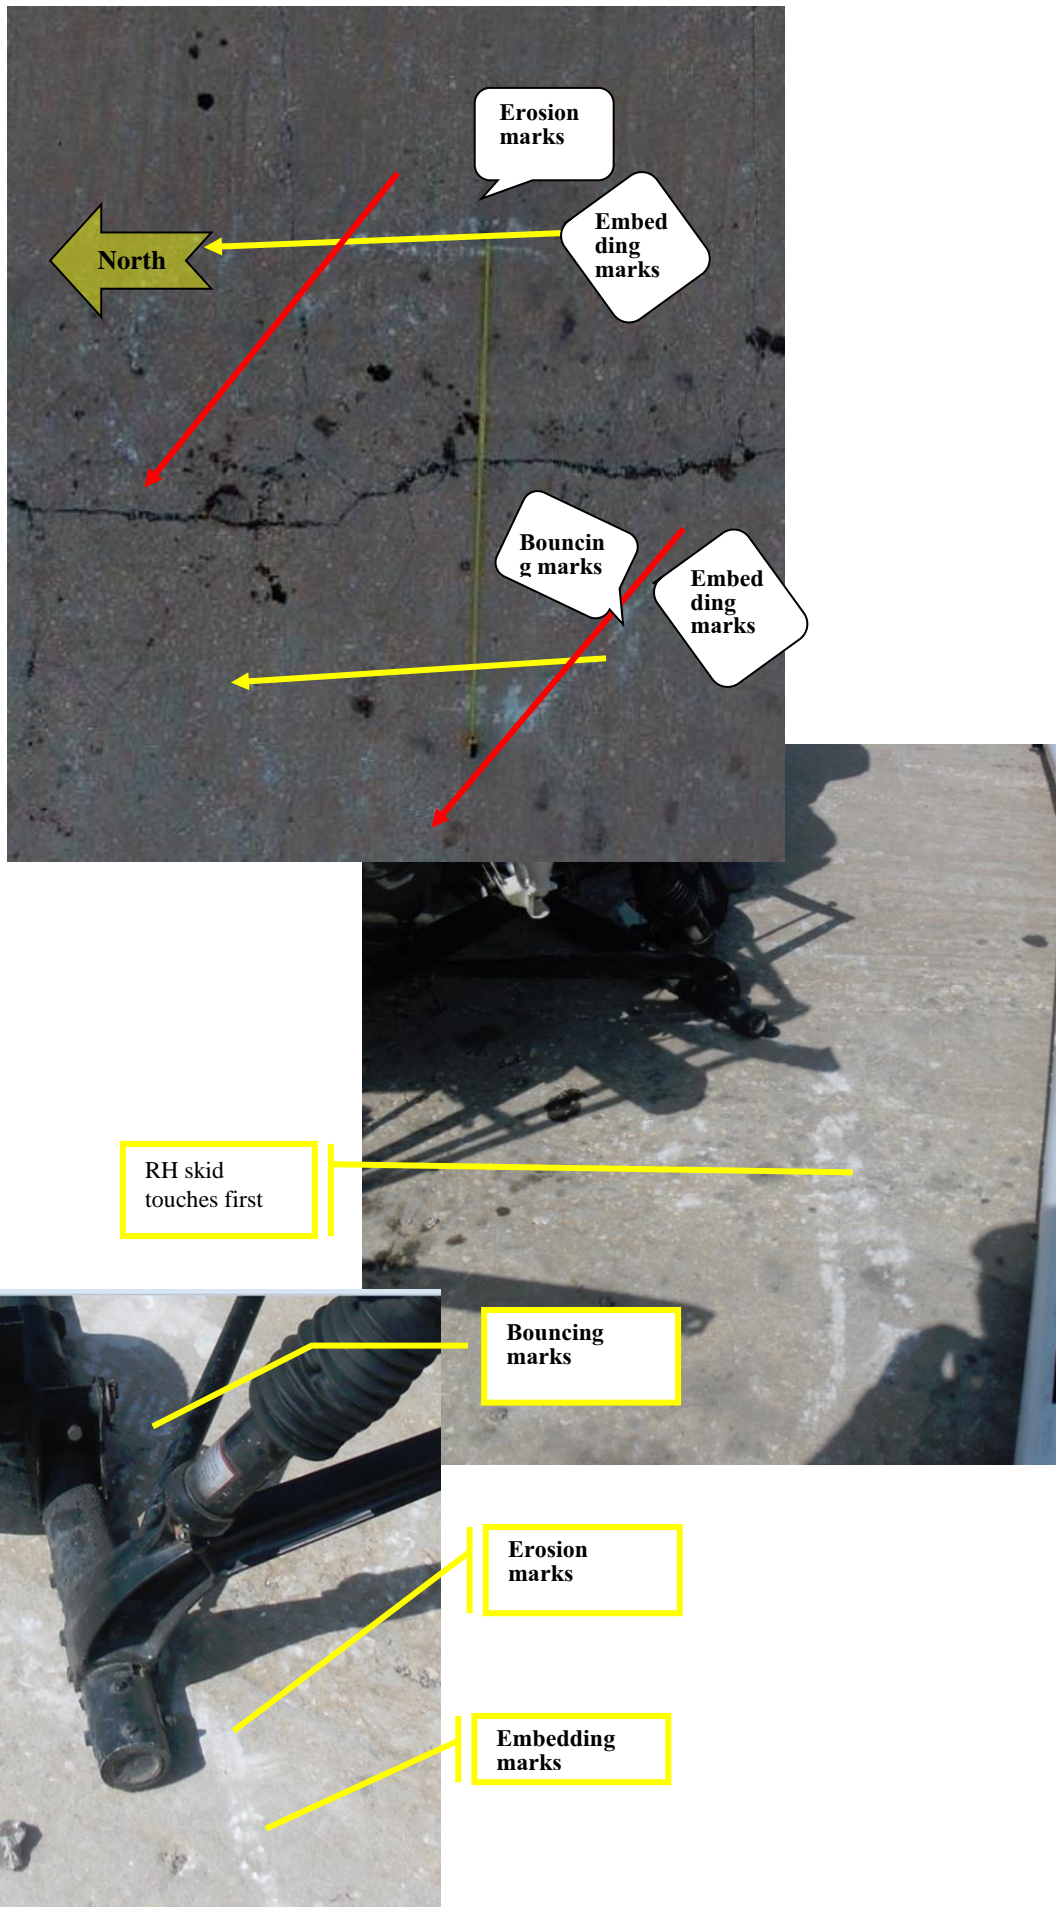
Analysis of these ground marks indicate, that the helicopter has impacted the ground with a rapid vertical component, touched down first with its RH skid, resulting in spreading of the skids. The helicopter was sliding slightly to the right, the rotor blade hit the boom, fractured it and caused a yaw accompanied by vibrations, with the helicopter breaking until coming to rest. The embedding marks are typical of a strong vertical sinking/falling, which is related to the skids' initial ground impact. The dragging marks (lateral) are typical to a secondary response, which followed the initial vertical motion and was driven by the momentum/acting forces such as rotor unbalance.

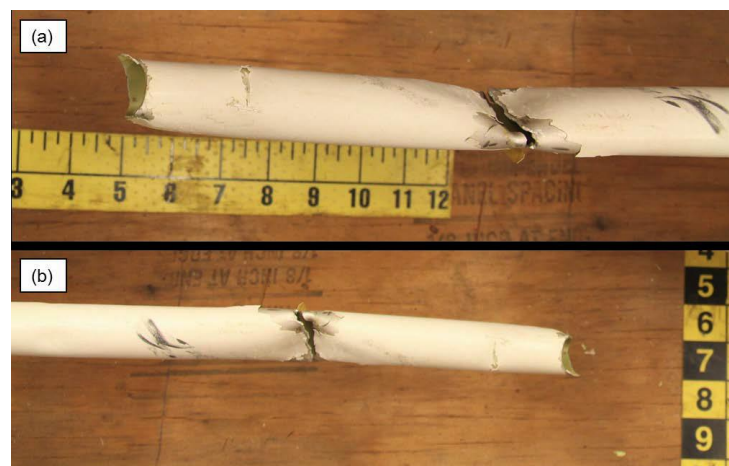
Figure 2 – One of the fractured pitch change links, as received

- ☒ The pitch change link in Figure 2 showed evidence of localized necking adjacent to the fracture surface. The fracture surface at this point also exhibited an approximately 45° orientation, with a dull luster and rough surface texture. NTSB lab conclusion: *These plane-stress fracture features are consistent with tensile overstress fracture of thin-walled structures.*

- ☒ Approximately 5 inches (about 127 MM) from the fracture surface, the link exhibited another fracture. This fracture (also shown in Figure 2a and 2b) exhibited buckling on both sides of the part. NTSB lab conclusion: *This fracture was consistent with compressive crushing at this location.*
- ☒ In the other fractured pitch change link, this fracture surface exhibited brown-colored corrosion product, consistent with iron oxide (rust). The link material adjacent to the fracture surface exhibited randomly-oriented out-of-plane deformation. The mating side of this link fracture surface, illustrated to the left in Figure 4, also exhibited inward buckling, along

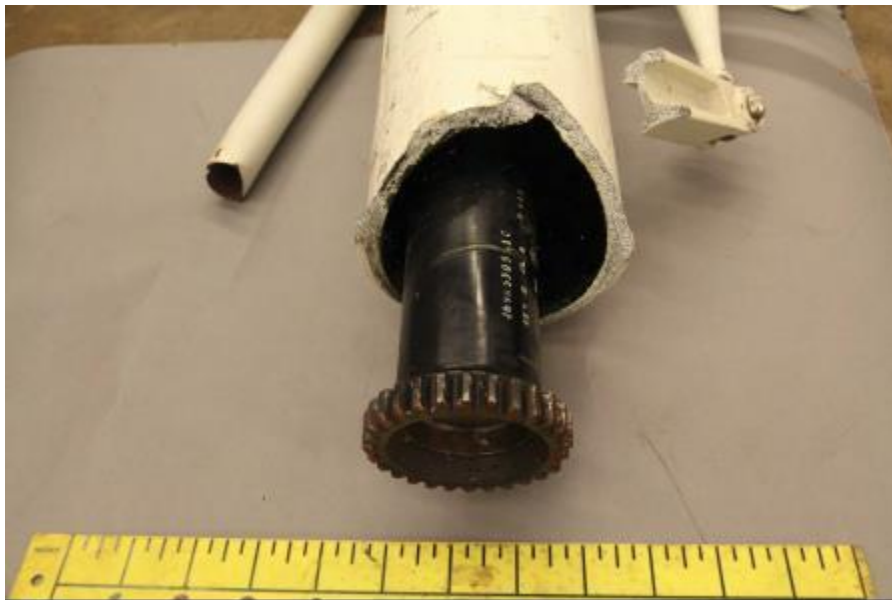
Figure 4 – The fracture surface of the main rotor mast, viewed from an oblique angle

with necking or thinning adjacent to the fracture surface. NTSB lab conclusion: *These features are consistent with overstress fracture on components subjected to multiple loads and loading directions, such as during ground impact.*

- ☒ The fracture of the main rotor system outer shaft, along with an aforementioned link fracture (left) and a pitch support fracture (right). The support fracture on the right exhibited a general dull luster with a rough surface texture. NTSB lab conclusion: *These features were consistent with fracture from tensile overstress of the part.*

The investigating team conclusion regarding the fractures examined, is that these fractures are consequential to the ground impact and are not defined as a direct cause of the accident.

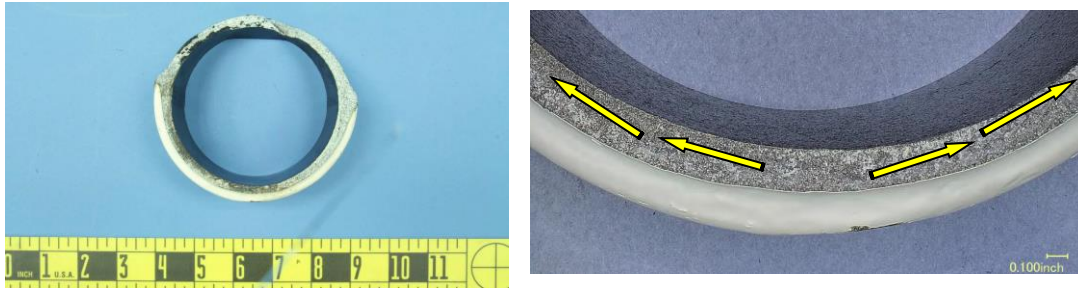
Figure 8 – Closer view of the bottom of the fracture surface shown in 7. The yellow arrows denote the general fracture direction.

- ☒ The main outer shaft of the main rotor system had fractured about the entire circumference. The fracture surface showed a generally rough and tortuous texture. The fracture surface exhibited chevron marks and river patterns. These features are consistent with the fracture having initiated on the flat portion and having advanced around and upward, completing the fracture 180° on the opposite side. The orientations of the chevron marks and river patterns on the fracture surface were consistent with fracture emanating from the location in Figure 8 (as denoted by the dashed yellow arrows).

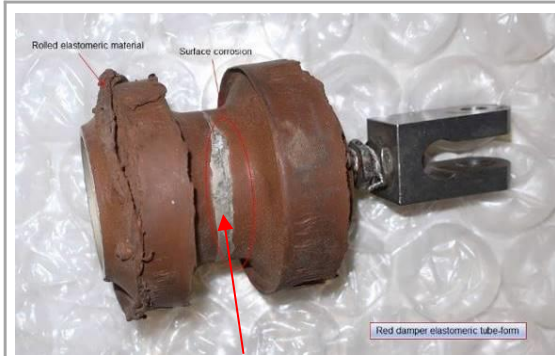
**Figure 2 - Red damper tube form.
Corrosion at seam between disks**

- ❖ Corrosion was observed in one quadrant of the aluminum tube-form inner core seam where the upper & lower disks meet. The corrosion is due to exposure to humidity, or associated with the damper housing duration of exposure after the accident.

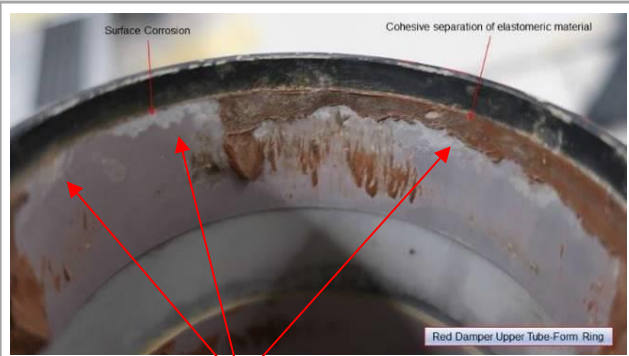
Figure 3 - Red damper tube form housing interior.

- ❖ Optical microscope examination of the interior side of the red damper housing revealed areas of corrosion along the upper edge of the tube form ring.

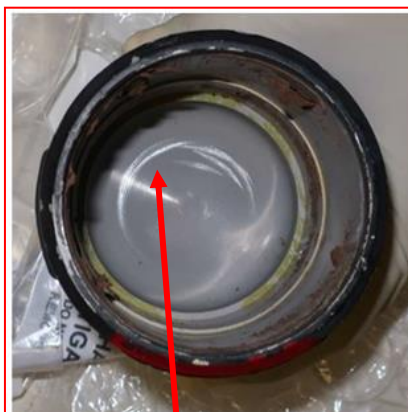
**Interior of red damper housing
With semi-circular witness marks**

- ✓ The damper housing end cap had multiple semicircular witness marks that match the end of the aluminum tube form core.
- ✓ Note: Such witness marks, though slighter were also found on the two other dampers.

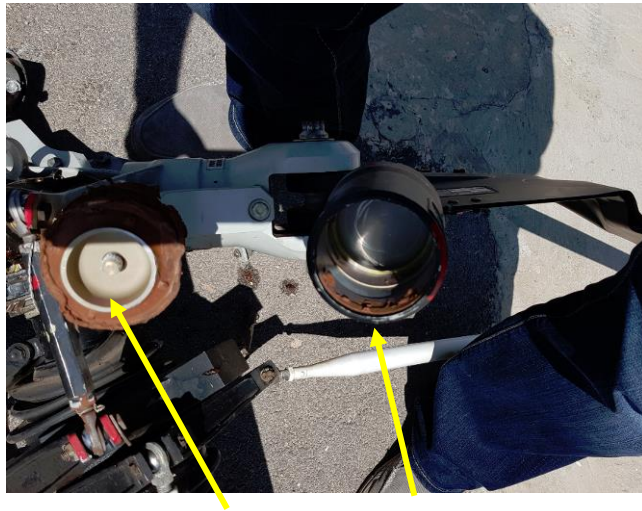
The helicopter components maintenance records showed that the dampers have accumulated only 1,973 hours, and therefore an extension check was not required, nor was there an evidence for performing it. Yet in accordance with NTSB lab finding, it was determined that the red damper performance was inferior, compared to the other dampers.

Red damper housing and separated elastomeric material

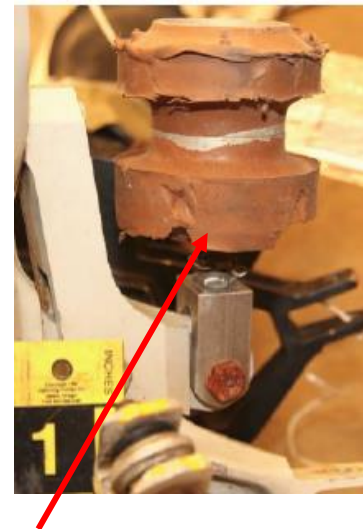
- ❖ The elastomeric material on the lower tube-form had a ring of rolled elastomeric material along the lower circumference. This ring is most likely a result of the entire tube-form outer circumference rubbing back and forth longitudinally against the lower tube-form ring of the housing over a period of undermined amount of time.

The fatigued elastomeric material
