State of Israel  
Ministry of Transport and Road Safety  
Aviation Incidents and Accidents Investigation

**Safety Investigation Report**  
**(Final Report)**

**Accident File No. 62-15**

**- UNCONTROLLED TAXI INTO DRAIN DITCH -**

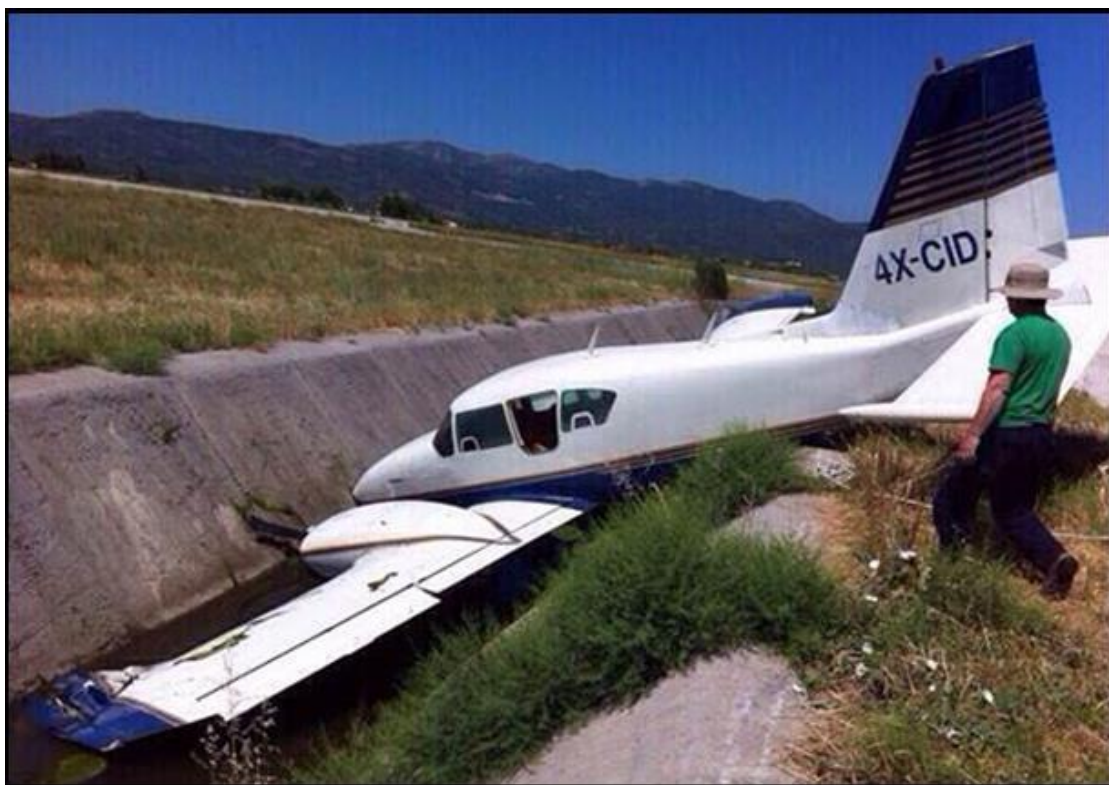
**The aircraft inside the drain ditch**

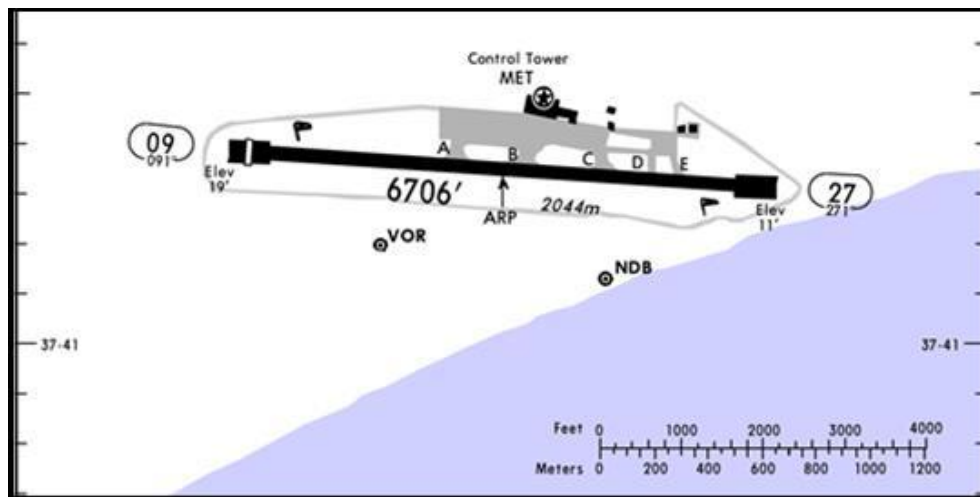
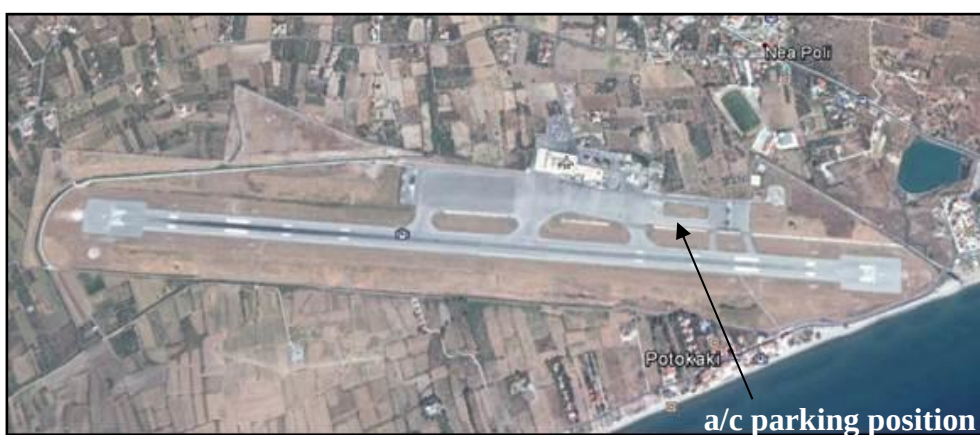
The pilot, in compliance with the instructions which he had received, parked the aircraft on the edge of an unmarked asphalt area connecting the Hellenic Air Force Fire Brigade Apron with the Civil Aviation Apron, between runway connection lane ‘TWY C’ and runway connection lane ‘TWY D’ in a perpendicular way with its nose facing south.

The site of the accident is located in the eastern section of the Samos International Airport, containing a paved area that extends between connection taxiway C and D. In the northern section is an unpaved zone, beyond, which extends a paved zone facilitating the parking of ground handling equipment. In the north-east is the main terminal building with the airport tower. The southern section, contains a rainwater drainage channel, separated from the asphalt by a 3 meter wide grass verge. To the south of the drainage channel, is an unpaved area which extends the strip and then the main runway.

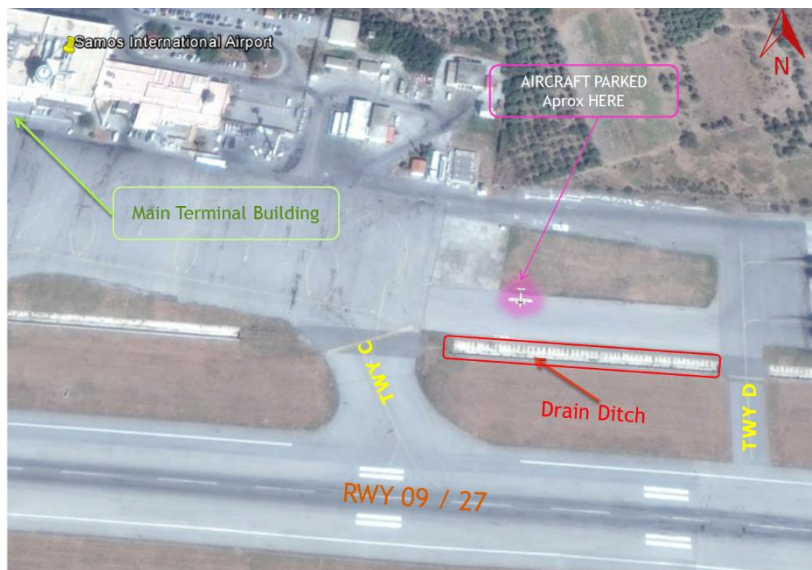
The used parking area is an asphalt paved area which is unmarked and connected the Civil Aviation Apron with the Fire Brigade Aircraft Apron and during the summer high load traffic months is used as parking for general aviation light aircrafts. The paved section of the area, from north to south, is 24 meters long, beyond which extends 3 meters of weeds adjoining the drainage channel.

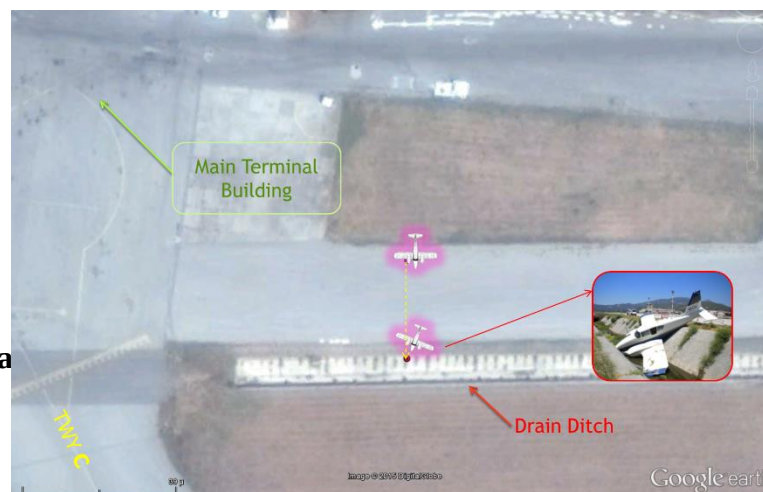
The width of the upper section of the drainage channel, is 6.7 meters wide and its lower section, 2.45 meters. It is approximately 3.4 meters deep, and at its base runs a stream of water approximately 30 centimeters in height. The channel is lined with concrete, and the upper section of the verge of the channel, is approximately half a meter wide.

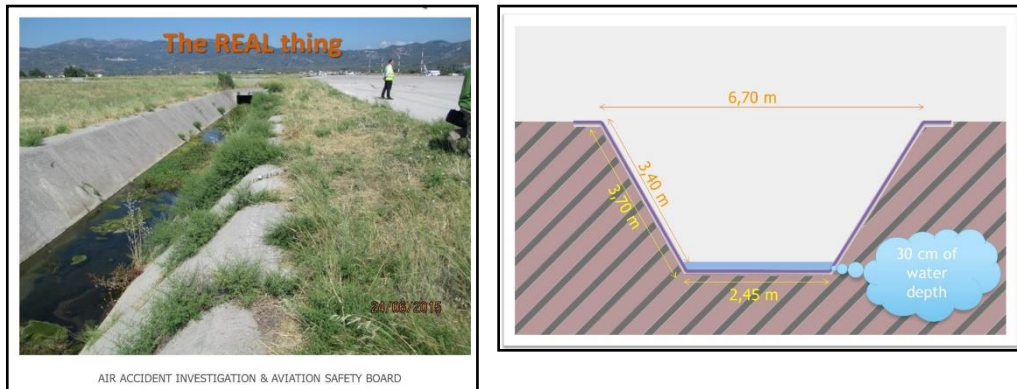
On the surface of the paved area from the place where the aircraft was parked, to the place where it fell into the channel, are engine oil marks, made by the tire of the right wheel during the aircraft movement, which was doused with engine oil and was spotted during the preflight inspections. The marks charted precisely the route along which the aircraft progressed.

On the northern wall of the drainage channel (the point where the aircraft fell into it), are notch marks which were made by the right propeller of the aircraft, indicating a slow rotation speed.

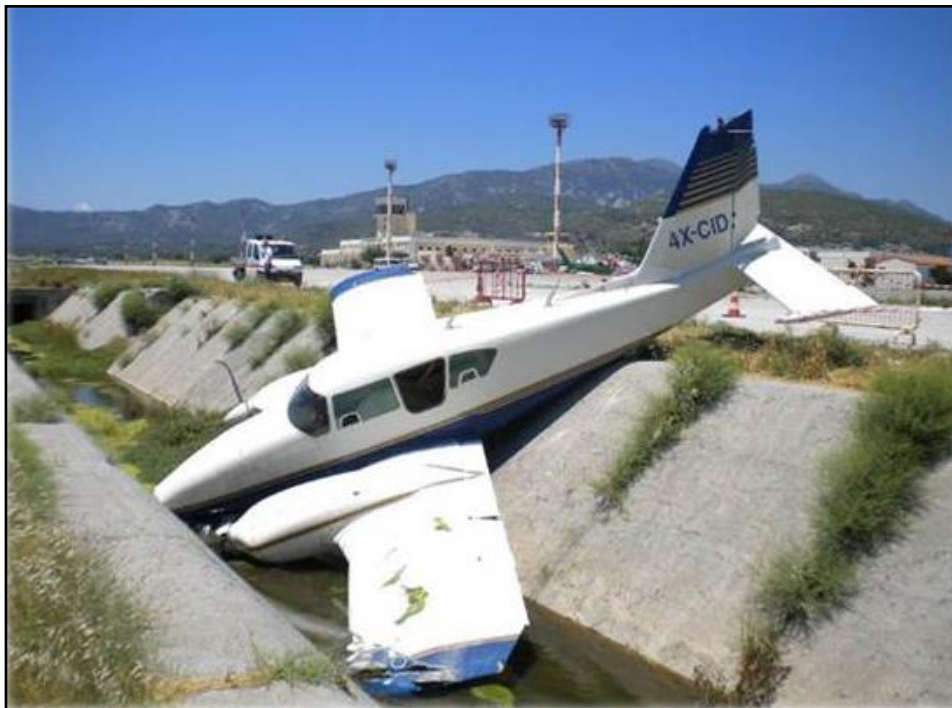
An investigator from the Greek investigation authority, together with a mechanic from the aircraft's inspection institute, who took part in the investigation at the request of the Israeli Chief Investigator, and in coordination with his Greek counterpart, inspected the aircraft, with the emphasis on the brakes system, and found no technical malfunction which could account for the accident, including in the brake system, which was found to be in good working order. The only noticeable was poor parking brake action in the left hand wheel but satisfactory on the other one.

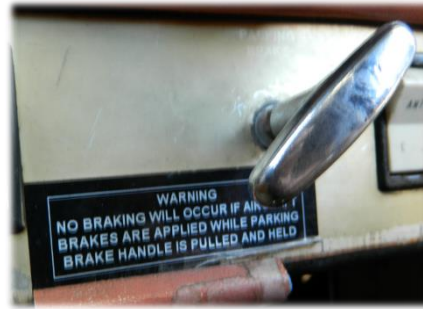
The aircraft is equipped with a handbrake, which is operated through a handle, which is located in the cockpit beneath the left side of the instrument panel. The warning sign regarding the effect of the handbrake on the aircraft's brake system, is located beneath the handbrake handle, in the cockpit of the aircraft and states 'NO BRAKING WILL OCCUR IF AIRCRAFT BRAKES ARE APPLIED WHILE PARKING BRAKE HANDLE IS PULLED AND HELD'.

During the investigation, the possibility was raised, that the handbrake system may have been partially responsible for the accident.

However, during the examination, it became clear, that pulling on the handbrake completely, neutralizes the aircraft's brakes, and an attempt to brake using the pedals would not succeed.

According to the aircraft's instruction manuals, in order to operate and/or neutralize the handbrake system, it is necessary to press on the brake pedals, and pull on the handle. A test that was performed by the investigation team, on an identical aircraft to the one which was involved in the accident, found, that even without pressing on the brake pedals, the act of pulling the handle of the handbrake completely neutralized the brake system operated by the aircraft's pedals.
