## FIVE WHY INVESTIGATION

### GALLEY GREASE FIRE

| <b>Facility (Leviathan/Tamar/AOT):</b> | Leviathan | <b>Operator Name:</b> | NBL |
| <b>Doc Number:</b> | LPP-OP-NEM-OPS-RPT-0058 | <b>TAG Number:</b> | [תיג] |

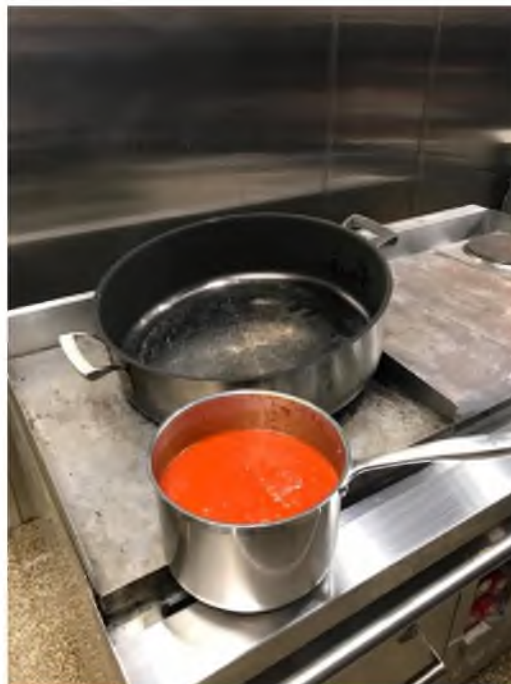
| | Root Cause/ Five Why | Notes/Comments |
|---|---|---|
| <b>Why 1</b> | Why was there an incipient grease fire in the galley? | While preparing a dish, a cook in the galley left a metal pot on the stove unattended for about 20 minutes. Upon returning to the empty metal pot, the member of the galley staff added room temperature cooking oil to the pot which initiated a grease fire. |

Figure 1 (above) shows the metal pot following the grease fire.

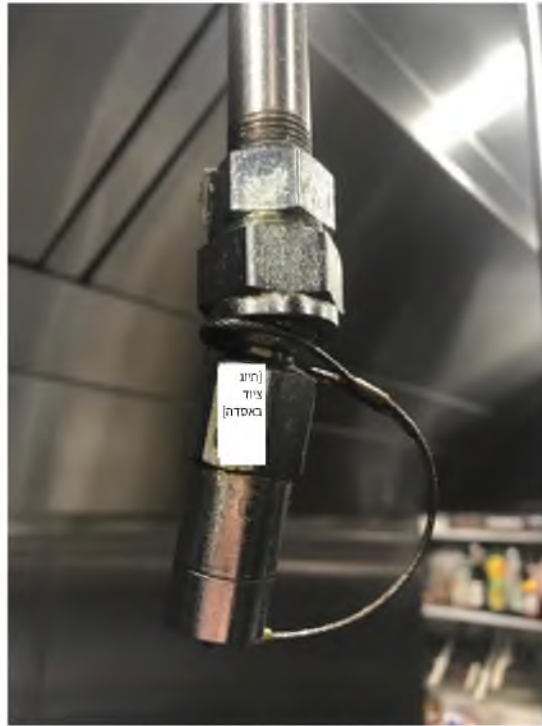
Figure 2 (above) shows overhead fire suppression system.

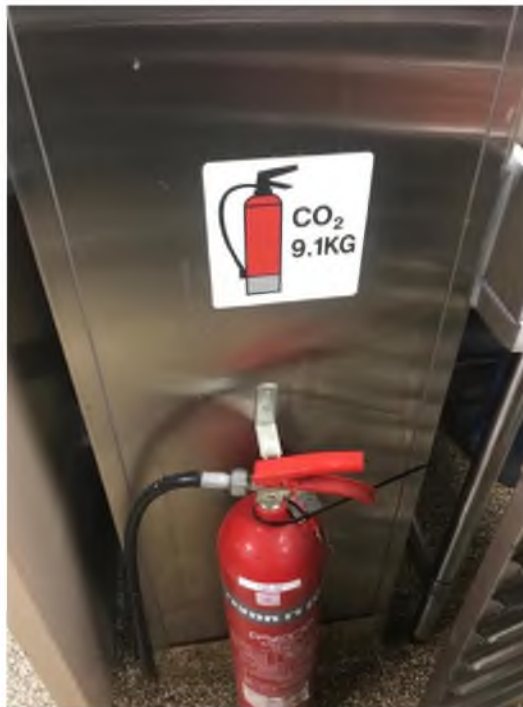
Figure 3 (above) shows the CO2 extinguisher next to the stove.

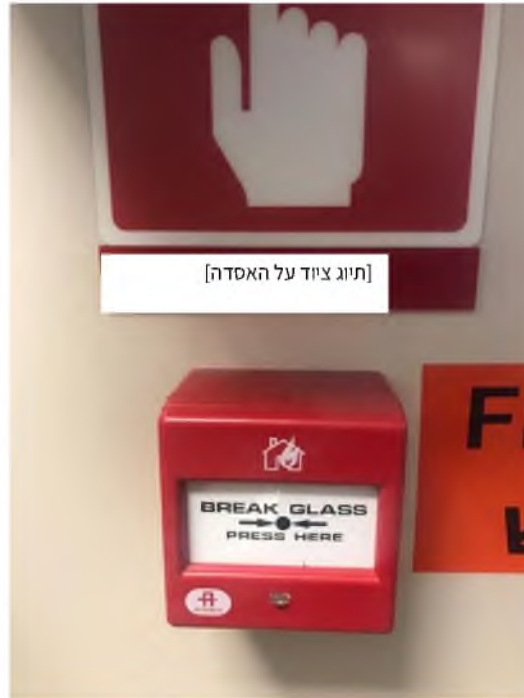
Figure 4 (above) shows [תיוג ציוד על האסדה] following activation.
