**Safety Investigation Report**  
**(Final Report)**

**Serious Incident Case No. 52-14**

**Go-around as a result of a failure to deploy landing gears**

| <b>Registration mark</b> | <b>4X-EKL</b> |

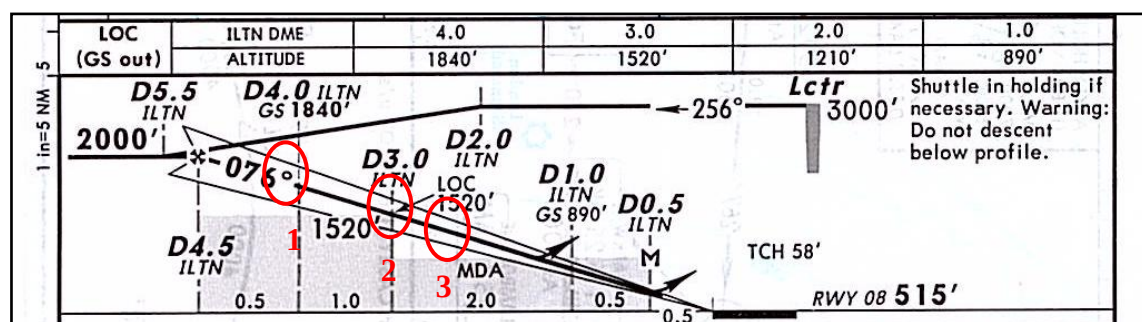
### Approach Profile View

1. Checkpoint - OM replacement.
2. Additional checkpoint chosen by the flight crew (1,000 feet AGL).
3. 2.3 mile (800 feet AGL) - at this point the crew received a warning that the landing gears were up at low altitude.
