הוראת כושר אווירי ISR E-2022-0168R2

AD No.: 2022-0168R2

EC135, EC635 and MBB-BK117 helicopters

ATA – Rotorcraft Flight Manual – Section Emergency Procedures – Amendment ATA 42 – Integrated Modular Avionics – Ethernet Network – Inspection

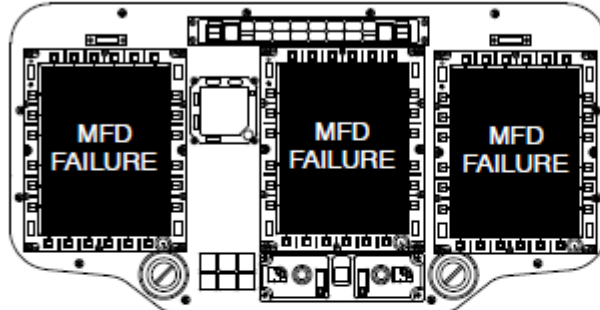
- MFD FAILURE displayed on all MFDs
- If autopilot upper modes were coupled, they may decouple after 10 seconds (indicated by an „autopilot decouple“ voice message).
