**THE SHARON ESCARPMENT (MEDITERRANEAN COAST, ISRAEL):  
STABILITY, DYNAMICS, RISKS  
AND ENVIRONMENTAL MANAGEMENT**

**Itamar PERATH and Gideon ALMAGOR**

This report was commissioned by  
Israel Oceanographic and Limnological Research, Ltd.  
as part of the  
Coastal Area Management Project (CAMP)

Report GSI/6/97  
Jerusalem, 1997

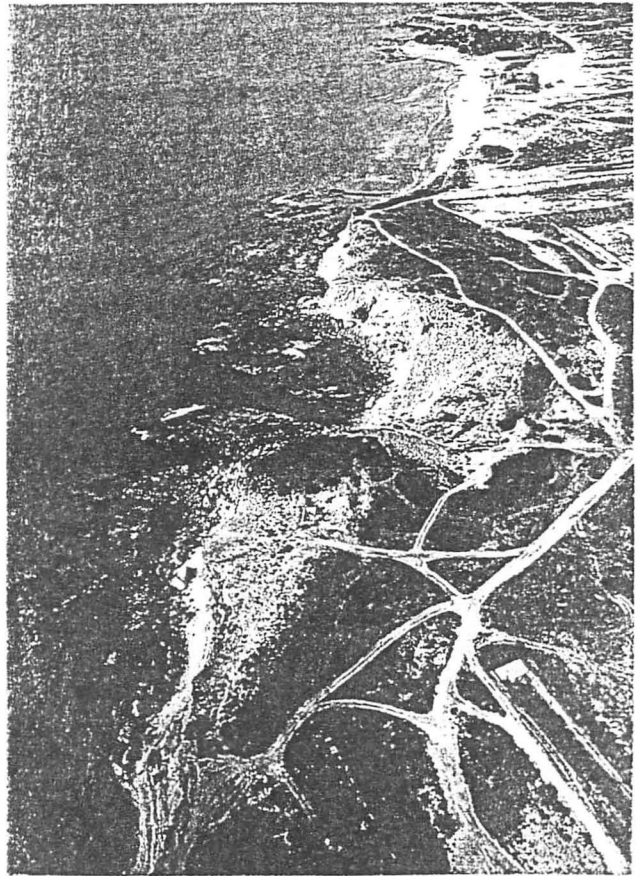
Fig. 4. The Sharon Escarpment between Tel Gador and Hadera Creek. Note headlands and embayments ("Albatross Air Photography").

Viewed meridionally from overhead, the cliff's rim forms an almost straight, slightly sinusoid line, projecting a wave-line front with a horizontal frequency of several hundred meters, and swinging no more than 20 m landward or seaward (Fig. 3). Indentation and embayment are slightly more pronounced along the northern section of the escarpment (Fig. 4), yet the overall linearity of the cliffline is preserved. Slump scars cause seaward-concave serration along the rim. The foot of the cliff is nonserrated, shaped by wave notching and collapse, and aproned by sandy talus over long stretches. Most of the rim is west of the ridge crest and truncates the west slope with a sharp nickpoint. The combination of sigmoid linearity and serration occasionally produces small local headlands and inlets along the upper part of the cliff. Back-cutting erosional gullies, however, intensify the serration, and in places produce a belt of badlands (see below, 2. Erosion, paragraph 5).

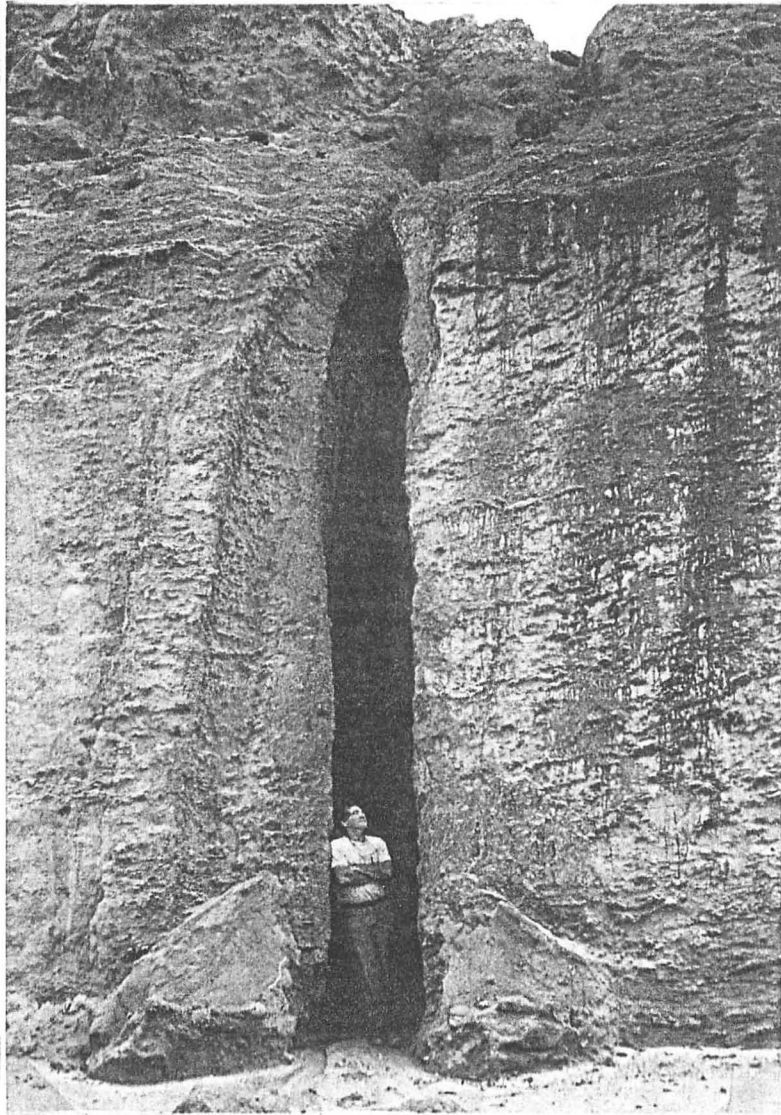
Fig. 8. A cylindrical scour pipe.

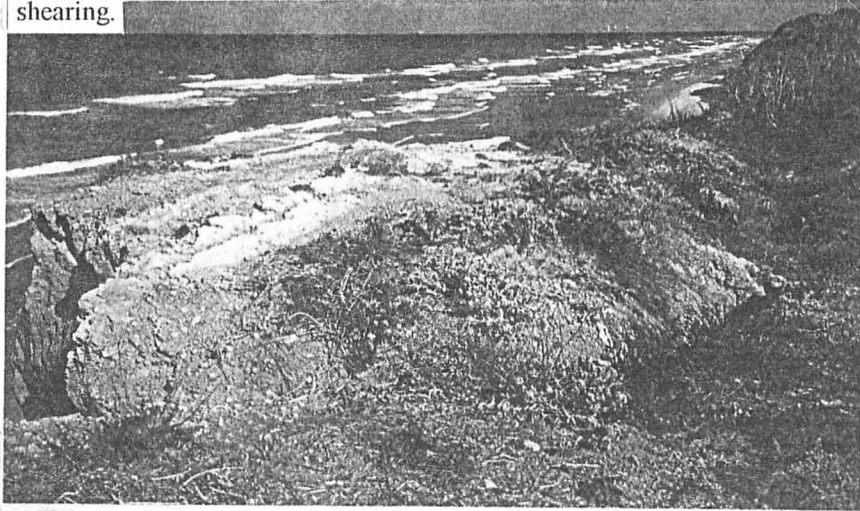
A. Crevasse in calcarenite ledge, back of the cliff's rim, precursory to shearing.

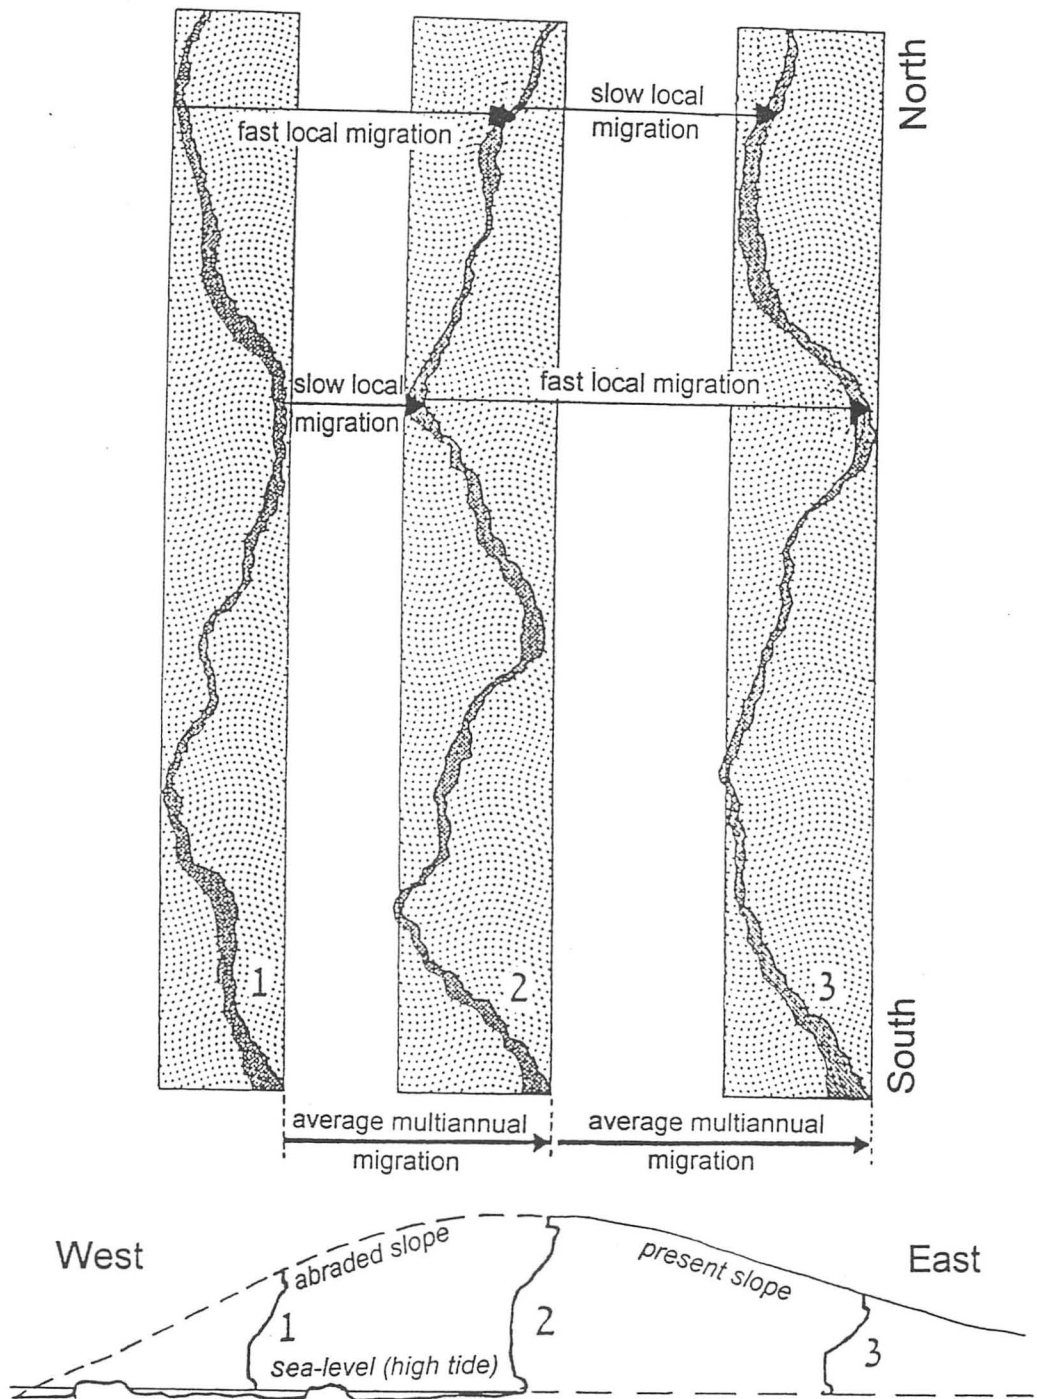
Fig. 12. Stages of the process of cliff retreat.

Cross Section: (1) Past - submerged and abraded kurkar reefs - remnants of the western part of the ridge; (2) Present - the Sharon Escarpment approximately coincides with the ridge line; (3) Future - ridge abrasion will reach the western trough.

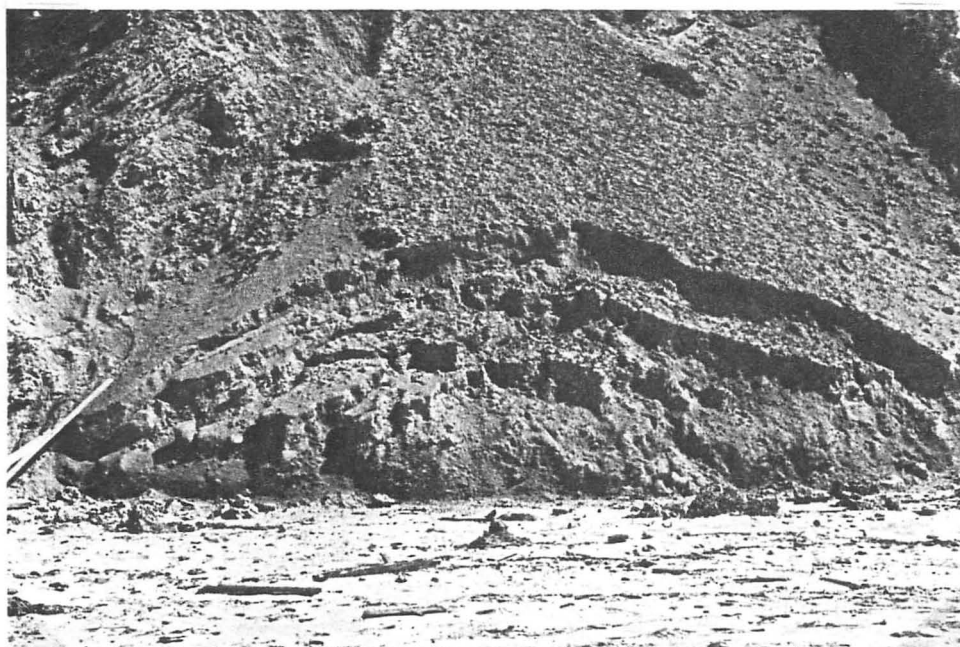
Fig. 15. Repeated removal of the apron toe causes serial step faulting across the apron.

(c) The talus apron is removed in stages by wave swash. Collapsed waves running up the beach get close to the cliff at high tides, and wash away the toe of the talus apron. A vertical step is formed across the base of the apron, initially stable because of capillary water and carbonate bonding, but soon drying out and collapsing (Fig. 15). Subsequent toe removal causes repeated series of step faulting across the apron, with repeated collapse until all talus is removed, after which the base of the cliff is again exposed to wave action and notching, as described above.

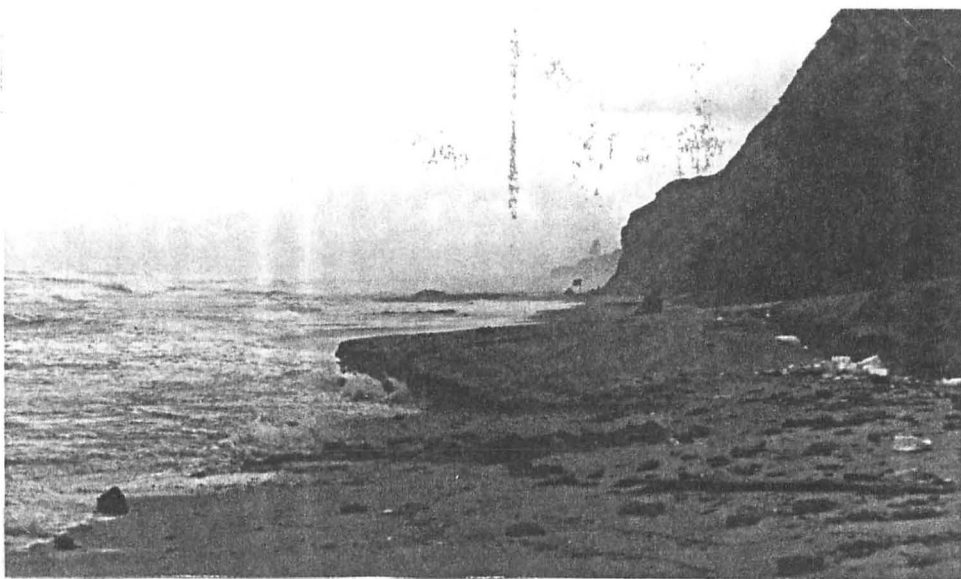
Fig. 18. Storm waves in the process of abrading the front of an alluvial fan.

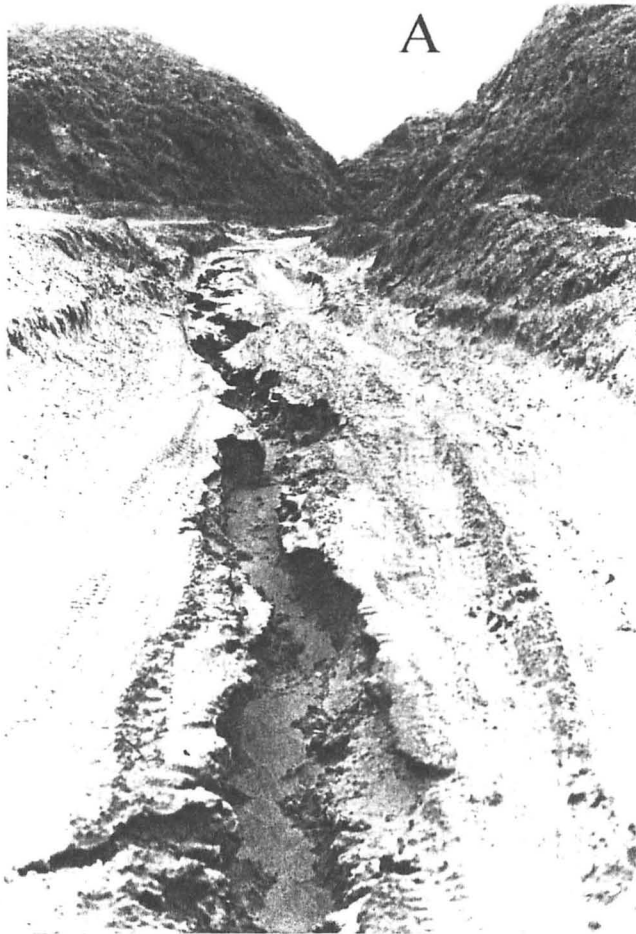
Fig. 22. A. Heavy erosion of a beachward descending road excavated at right angle to the cliff.  
← B. Back-cutting erosion of the road in A creates badlands and gorges back of the kurkar ridge.

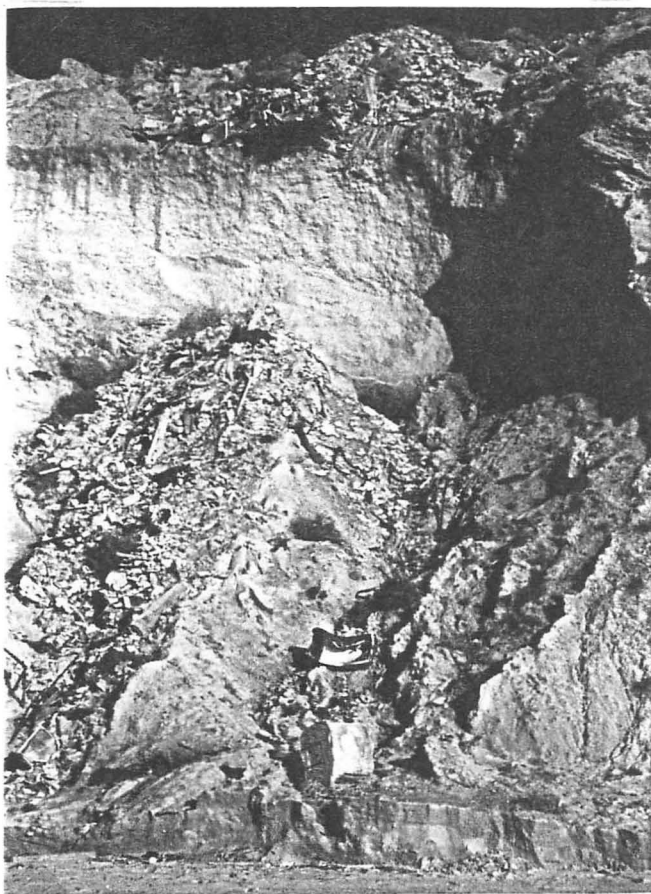
Fig. 27. Talus consisting of urban garbage.

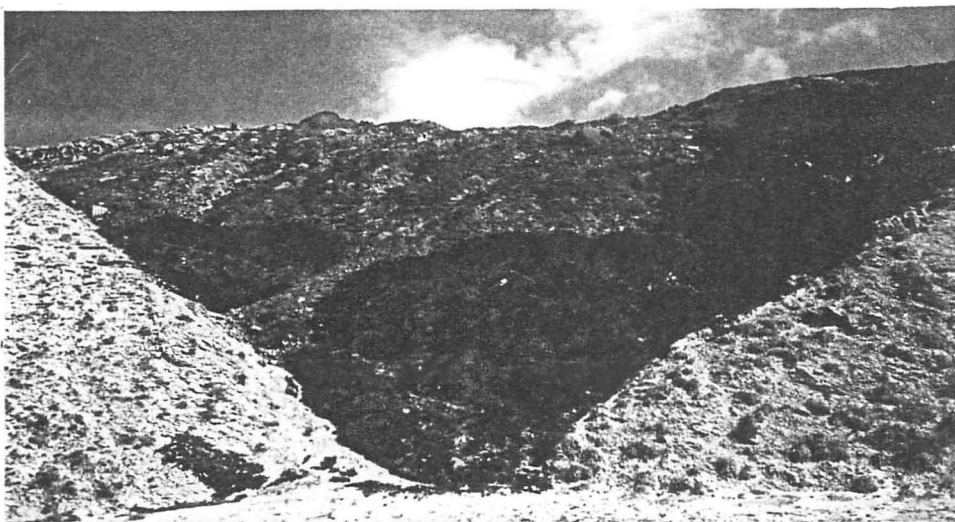
Fig. 28. Stable garbage filling in a V-shaped gorge restores the cliff. The garbage porosity prevents erosion by runoff, and supports a lush vegetation.

Garbage dumping - aesthetics aside - efficiently repairs the damage of accelerated man-caused erosion (Fig. 28). Nevertheless, garbage cliffs are different from calcarenite and kurkar, and of unknown instability. The components of garbage scree (which include metal machinery and automobile wrecks) are dangerously bulky, unstable and unpredictable - each slump is a system by itself. Perched slumps are a beach hazard, and the landed scree may have a long beach life.

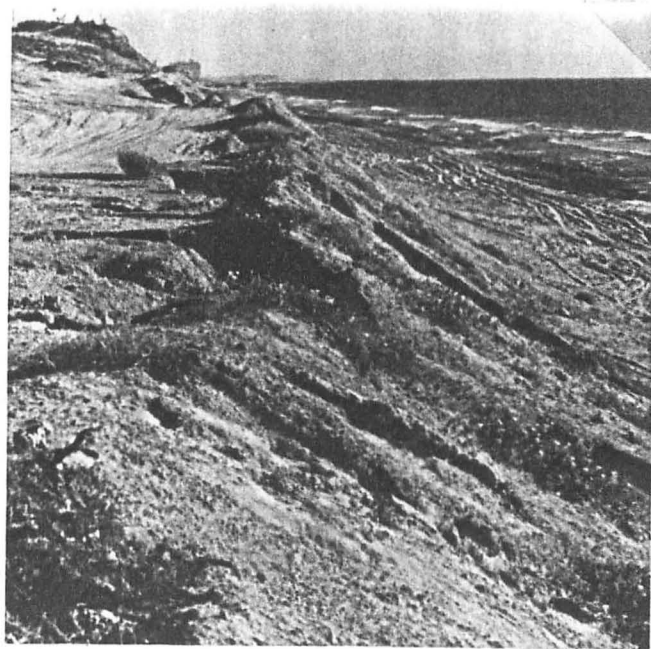
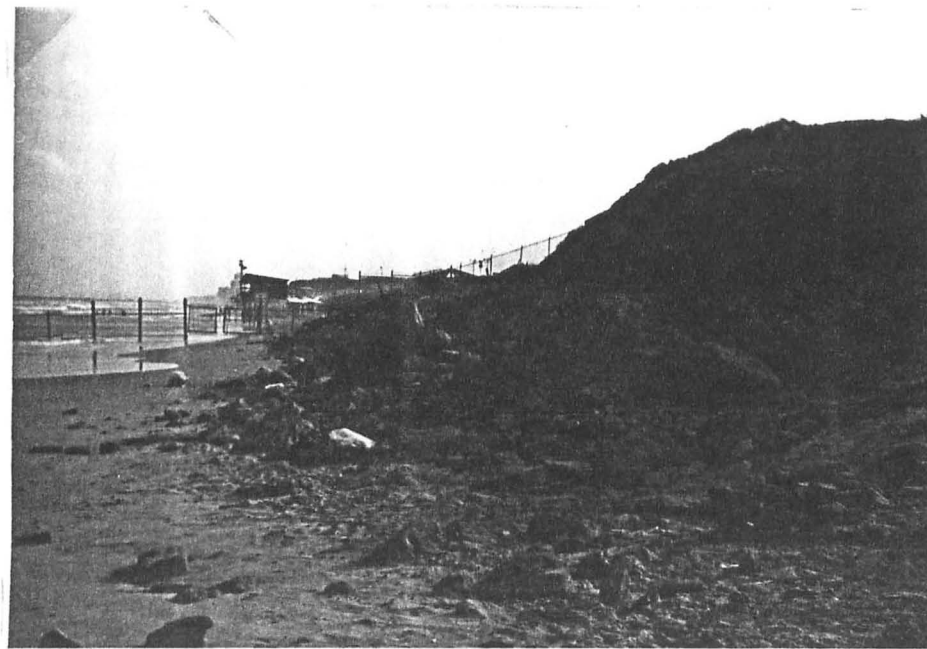
Fig. 29. A. Artificial talus, heavily scoured by rills subjected to rapid runoff gullyng. B. Talus was completely removed by wave swash.

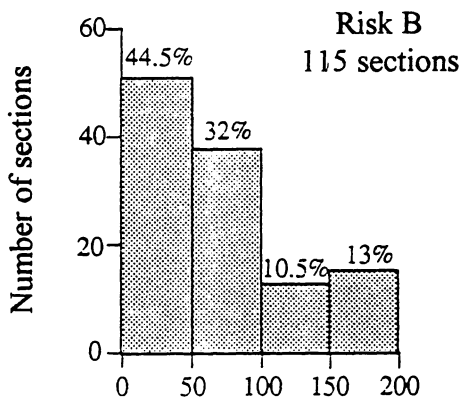
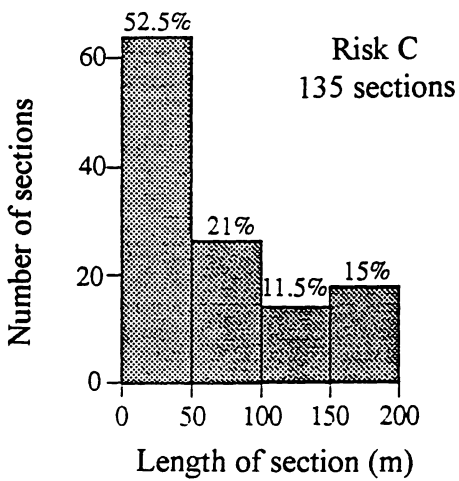
Fig. 35. Distribution of risk according to length of risk sections.

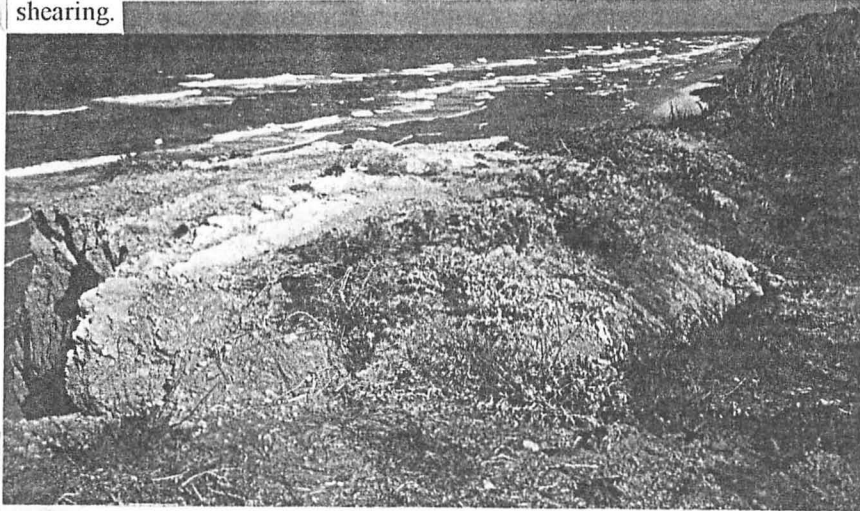
A. Crevasse in calcarenite ledge, back of the cliff's rim, precursory to shearing.

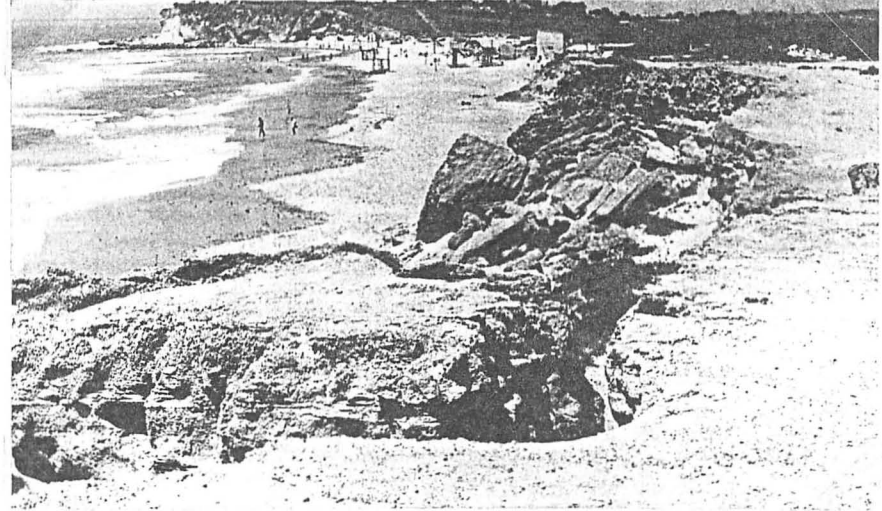
B. Sheared-off blocks of calcarenite reclining a slope of Upper Hamra.
