# **Safety Investigation Final Report**

**Accident File No. 3-25**

## **Complete Engine Power Loss after Takeoff and Execution of a Belly Landing**

| <b>Aircraft Registration</b> | <b>4X-HYX</b> |

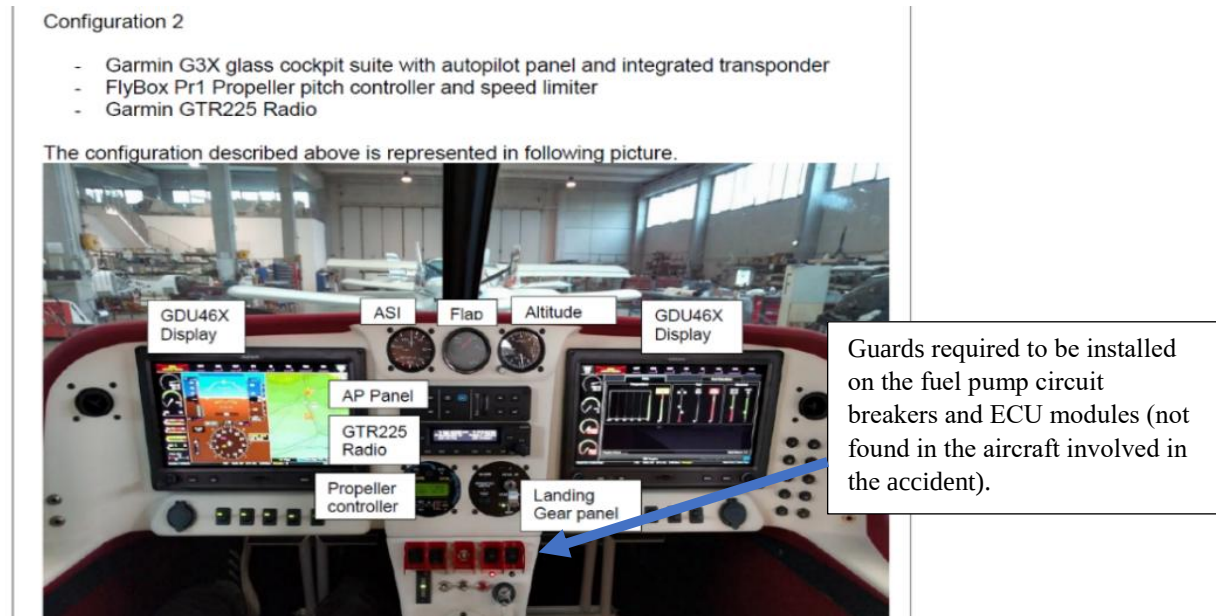
Picture 13 – Required cockpit configuration as presented in the AFM

Contrary to the image shown in the AFM, the aircraft was found to have only a single GDU46X screen, and the red guards were removed from above the fuel pump switches and the ECU module switches - Lane A and Lane B.

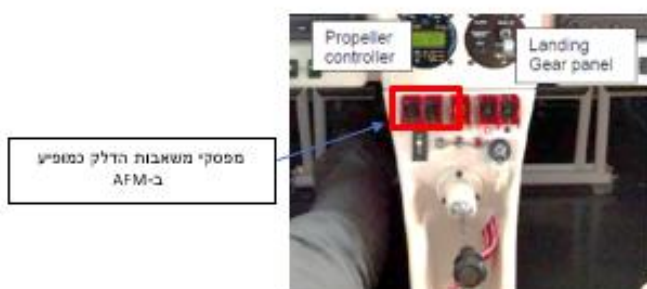
תמונה 3 – הקונסולה המרכזית בתא הטייס של מטוס נשוא האירוע

ד. מפסקי משאבות הדלק החשמליות מצויות בצמידות אחת לשנייה (ראה תמונה 2).

ה. בפרק 7.14 שבספר המטוס נשוא האירוע (Aircraft Flight Manual – AFM) מופיעה תמונה של תא הטייס כאשר מפסקי משאבות הדלק החשמליות מוגנים.
