State of Israel
Ministry of Transport and Road Safety
Aviation Incidents and Accidents Investigation

Safety Investigation Report
(Final Report)

Ground Accident No. 7-12

Severe structural failure in main landing gear in preparation for flight

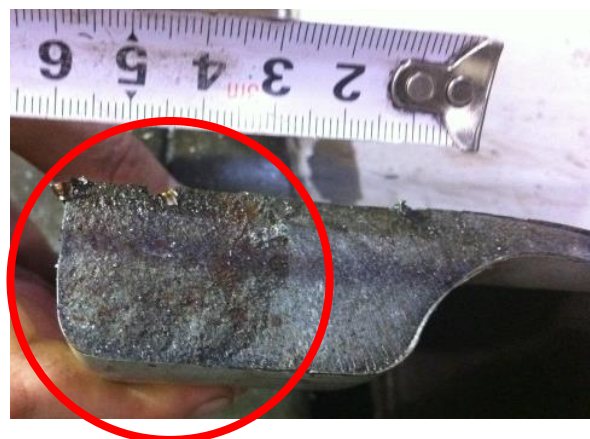
Surface of the crack

3.1 The accident is attributable to a failure in the landing gear resulting from defective reconditioning by a foreign maintenance facility. An initial crack within a gap in the security spring of one of the landing gear cylinder bushings developed over time due to the non- removal of all corrosion spots from the surface of the part before it was coated, in a cracking mechanism between two brittle cores, until the final failure occurred.

1.5 On the interior walls of the cylinder, surrounding the area of the crack, **investigators saw evidence of abrasion-erosion generated surface disintegration,** which had caused such surface damage to the material that micro fractures were created, one of which developed into the crack that was found in the cylinder. Within this process a certain small degree of freedom between the bushing and the cylinder covering it was created.

1.6 Apart from a gap in the layer of cadmium coating around the area of the crack, no other irregular findings were identified on the surface in the micro-structure of the material or in its mechanical properties (strength). Traces of cadmium were found within the crack, but not on the cylinder wall.

2.1 To revise and provide more detailed inspection and work instructions for Boeing aircraft landing gear maintenance facilities, while specifying the means and methods to be utilized when undertaking reconditioning work. It is also suggested that the method for identifying corrosion spots on surfaces designated for coating should be altered to incorporate the use of a device and/or processes which are customarily used in non-destructive examinations, such as optical magnification equipment, instead of relying on an unaided visual inspection only as specified in the manufacturer's current reconditioning instructions, in a way which shall guarantee the complete and absolute removal of corrosion spots, before the coating is applied.
