# **Interim Statement**

**Accident File No. 19-23**

## **Ground Accident During Pushback**

| <b>Aircraft</b> | <b>B747-400F &amp; B757-200F</b> |

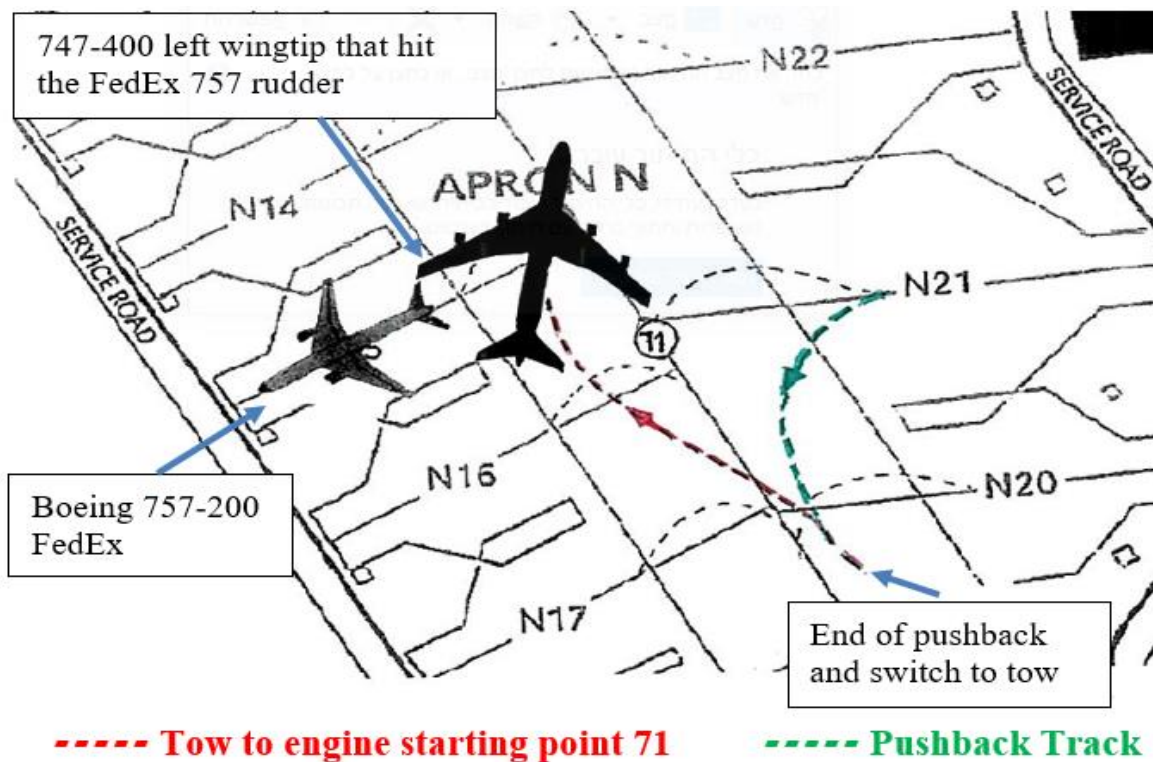
Rudder damage of the parked FedEx aircraft

The 747-400 aircraft sustained damage to its landing gear, landing gear doors, aircraft belly, tires and left winglet. The parked FedEx cargo aircraft sustained damage to its rudder. The tug damage was beyond repair and was removed from service.
