Ministry of Transport and Road Safety  
Aircraft safety Investigation Authority of Israel (AIAI)

# **Safety Investigation Report**

**Accident File No. 19-23**

**Ground accident during pushback while  
engine starting**

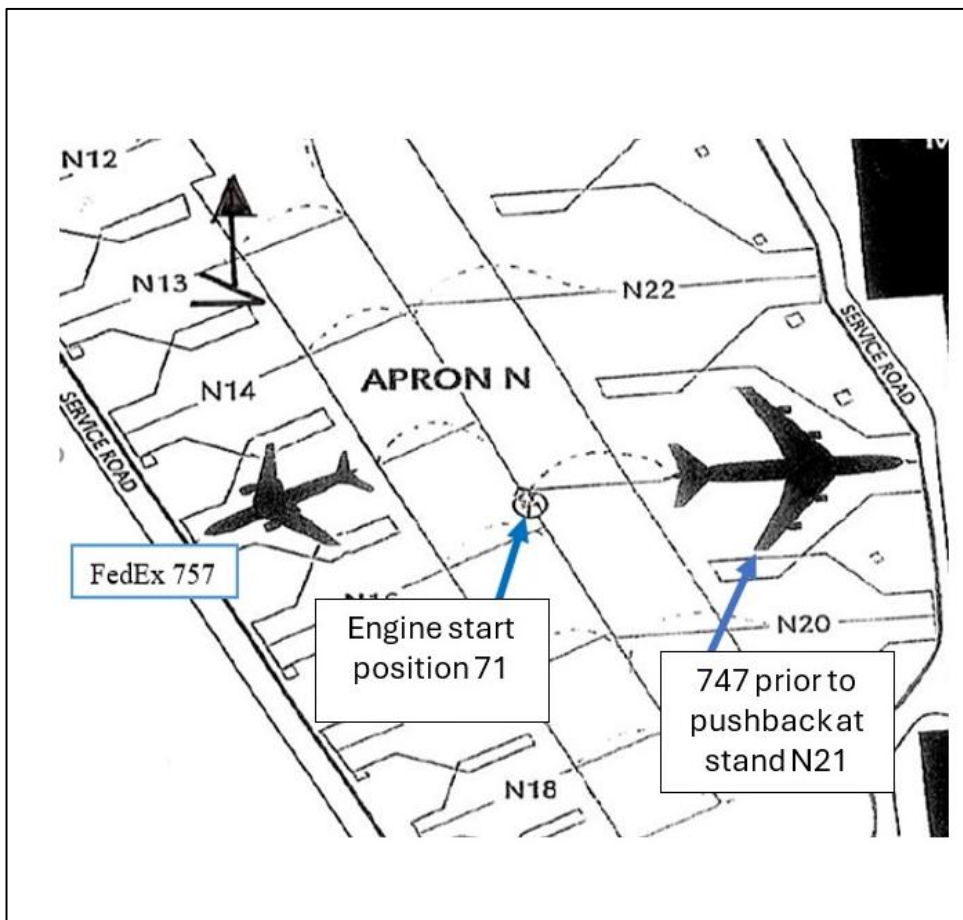
Figure 6 - Diagram of Aircraft Position on the apron

1.1.22 The pushback was performed very slowly. The aircraft was pushed to a position several meters east of and at a converging angle to the taxiway centerline (Under Turn). See Diagram in figure 6.

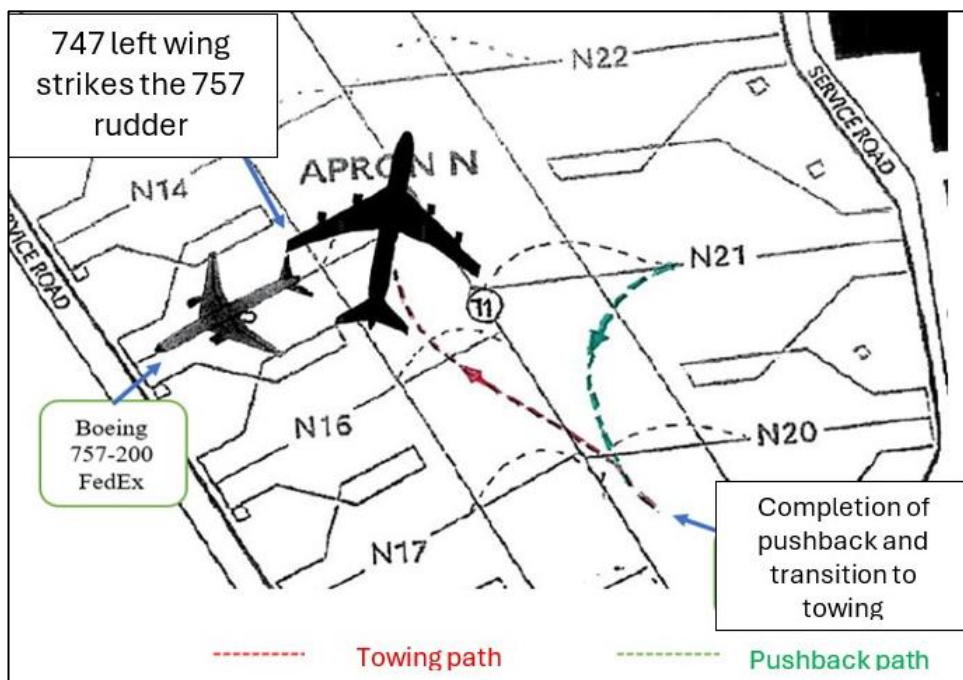
Figure 7 - Diagram of the Cargo aircraft position after the accident

1.1.39 The accident resulted in no physical injuries. The driver's evacuation from the tug prevented him from being physically injured. Damage was sustained to the body gear, belly, and wingtip of the cargo aircraft. The parked FedEx Boeing 757-200F aircraft sustained damage to the rudder and tail cone. The tug was damaged and permanently decommissioned.

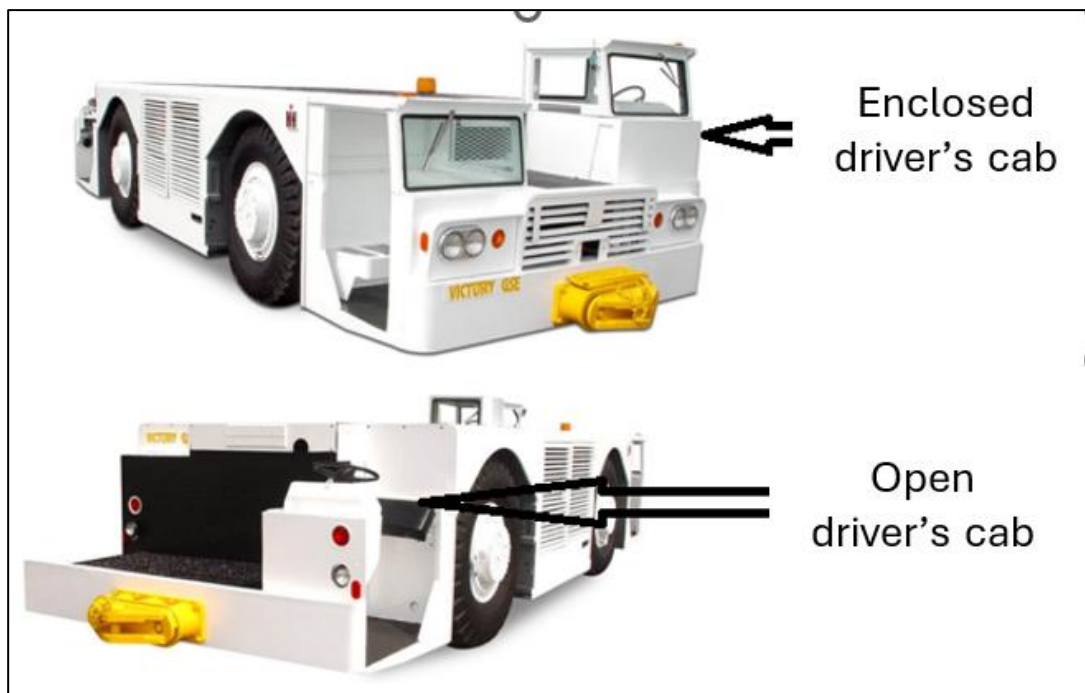
Figure 9 - T-500 Tug

1.4.1 Damage to the T-500 tug - The driver's cabin was crushed as a result of impact with the aircraft's landing gear door.

Additional findings included: drag marks on the left tires, impact marks on the right side and front of the tug, wear marks on the parking brake discs, a broken wheel axle, and a jammed control selector. The tug was permanently decommissioned by IAI.

- Manufacturer: USA HOUGH-PAYMOVER
- Year of manufacture: 1978 (the tug was 45 years old at the time of the event)
- License number: 200629, license valid until 21 February 2024, diesel engine
- Towing capacity: 380,000 kg
- Empty weight: 50,000 kg
- The manufacturer ceased operations in 1983. Currently, several companies still sell or lease refurbished tugs of this model. There are difficulties in obtaining spare parts due to the discontinuation of production approximately 20 years ago.

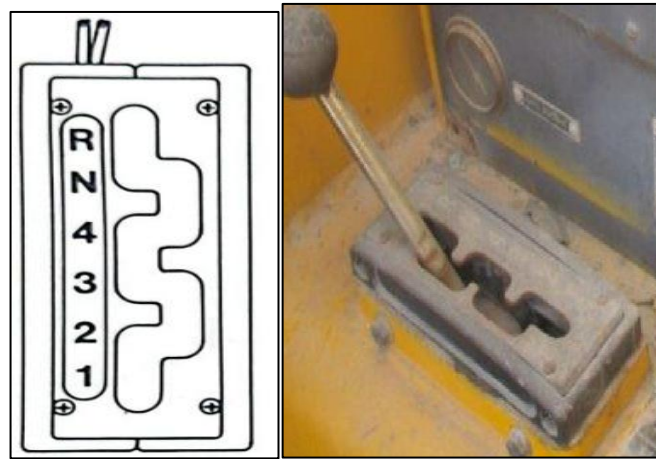
Figure 10 - **Gear shift lever in the cabin**

- The tug is equipped with two driving positions: one enclosed (cab) and one open, located on the opposite side (see Figure 6). The open position also includes an additional seat.
- It is not possible to operate the tug from both positions simultaneously.
- A pneumatic control unit, which includes a compressor and air tank, provides command control over the main systems of the tug.
- In the cabin, there is a gear lever with four forward gears, neutral, and reverse. In the open driving position, the lever provides only forward, reverse, and neutral. **The transmission system does not include a “Parking” position.**

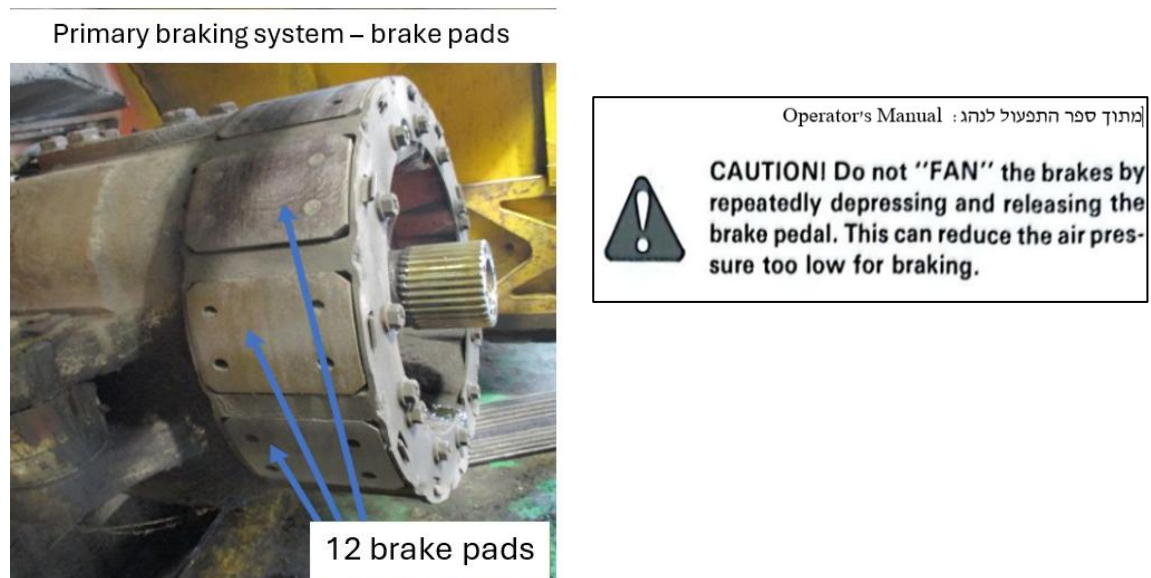
Figure 11 - Main brake pad system

- Each wheel is fitted with 12 brake pads (48 in total), which receive pressure from the hydraulic system. The pads are in direct contact with the wheels.
- Control of the hydraulic system is performed via the brake pedal and depends on the presence of air pressure in the pneumatic unit.
- Low air pressure in the pneumatic control system can result in an inability to operate the primary brakes. Pressing the brake pedal releases compressed air from the tank into the environment. Simultaneously, when the engine is running, the tank is refilled. When rapidly pumping the brake pedal, a situation may occur where the air depletion rate exceeds the replenishment rate. This can lead to loss of braking capability (see operational paragraph for the driver Figure11).

- **The contact area of the parking brake pads is less than 2% of the main brake pad area.** This substantial difference in braking capability is reflected both in the placement of the pads and in the fact that the main system pads grip the wheels. The parking brake discs were found worn and scored after the accident.

- Based on the findings, no visual brake pad inspection was performed during the last 15 years.
- Parking brake documentation: No record of periodic parking brake pad inspection was found.

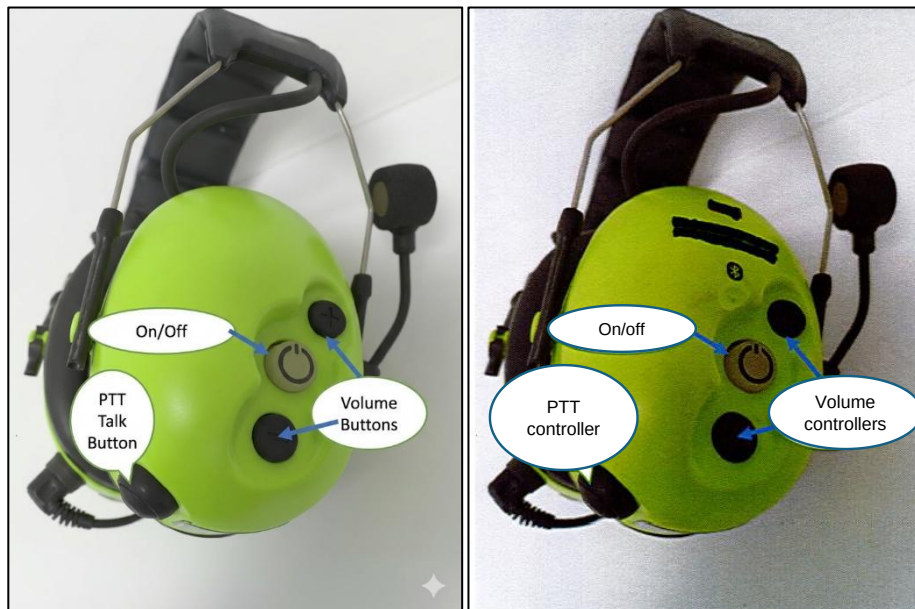
Figure 18 - Headset controllers' layout

The headphones have two types of alerts: battery status and wireless connection status.

An audio alert is played in the headphones (only) when the wireless connection with the transmitter unit on the nose gear strut is lost. There is no alert in the cockpit when this communication is lost.

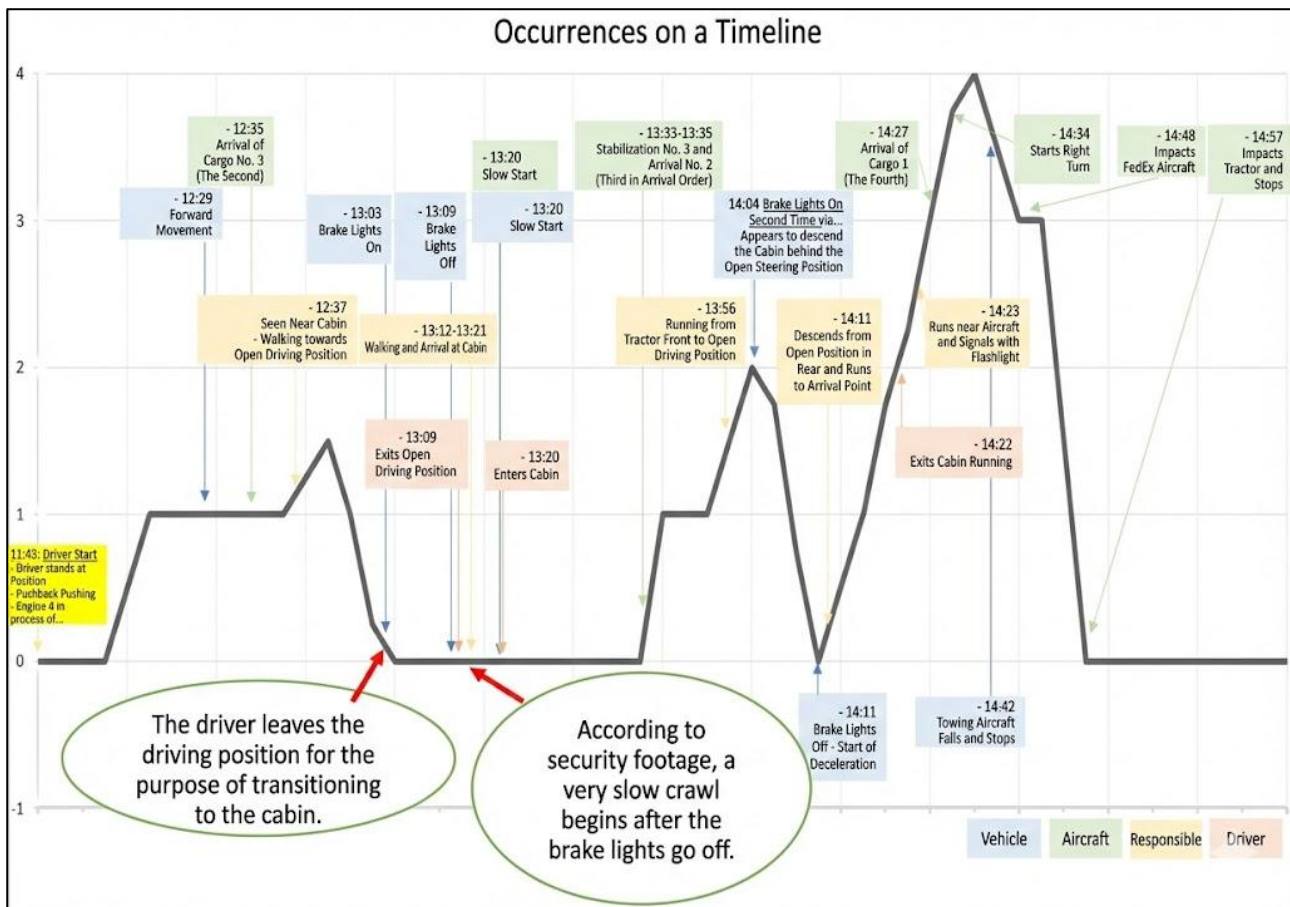
Figure 25- Timeline events

Important note: The aircraft's data recording system is not designed to capture very low taxi-speed resolution. The very slow creep during the driver's transition between the two driving cabins appears as "stationary," but according to security cameras, after the brake lights went off (the driver releases the brake pedal and applies the parking brake), slow creep begins. When the driver attempts to stop from the cab, the aircraft is already "creeping." In this situation, the driver (who entered the cab) cannot transfer the control selector to the cab, meaning braking from there is not possible. Control remains in the open driving position, and the braking (momentary, until the pneumatic air tank is depleted) performed from there by the crew chief confirms this fact.
