Safety Investigation Report - Final

Serious Incident File No. 25-23

Engine failure and belly landing

Date	8.9.2023
Aircraft	TEXAN Top Class 2 RG
Registration	4X-HYT
Location of event	Near Hatzor Air Force Base

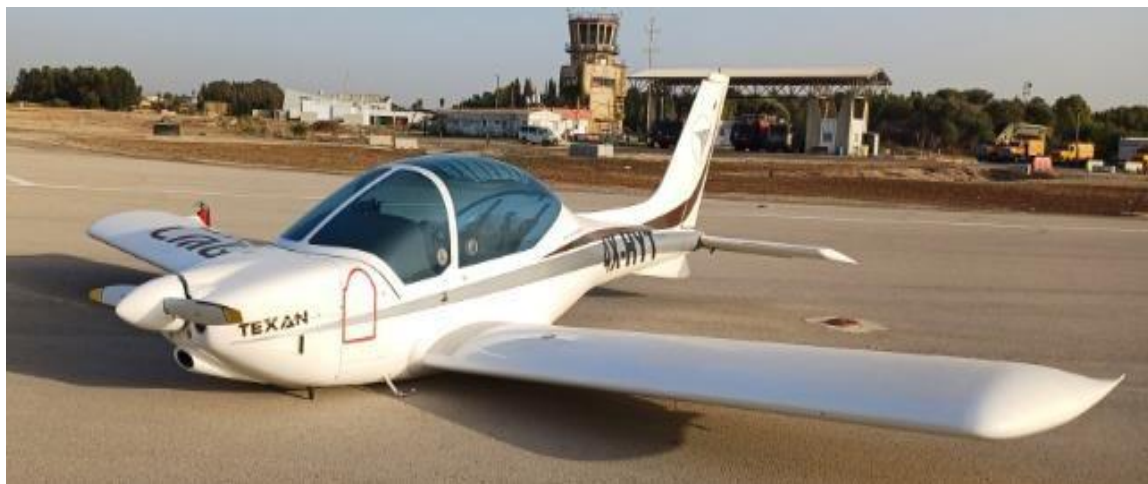
Minimal damage occurred to the aircraft following the landing – the front wheel was worn (the wheel protrudes outward in the raised position), the wingtip flaps and belly of the aircraft were slightly scraped.

Figure 1 - The aircraft subject to the investigation

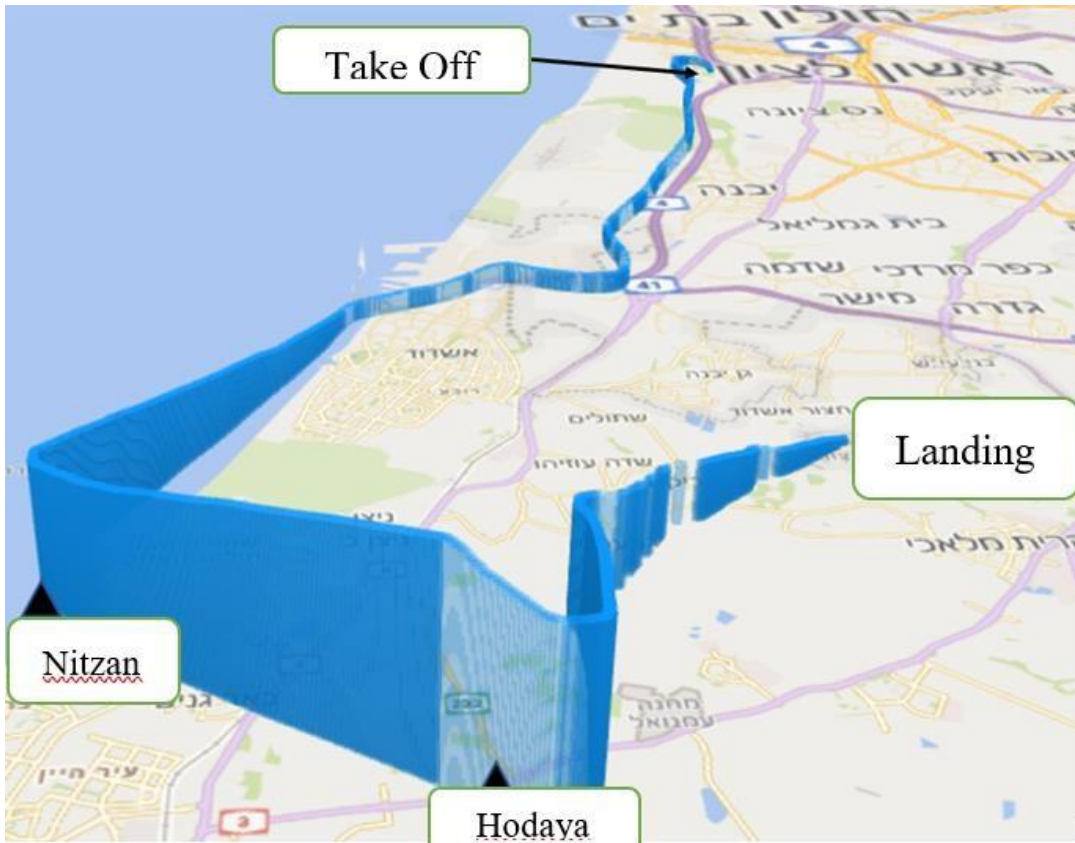
- The takeoff for the incident flight occurred around 15:30. The takeoff and climb were conducted using 95-octane automobile fuel.
- As directed by the air traffic controller, the airplane climbed from Nitzan to Hodaya (waypoints on the map) to an altitude of 7,000 feet (Image 2).

Figure 2 - Flight Path

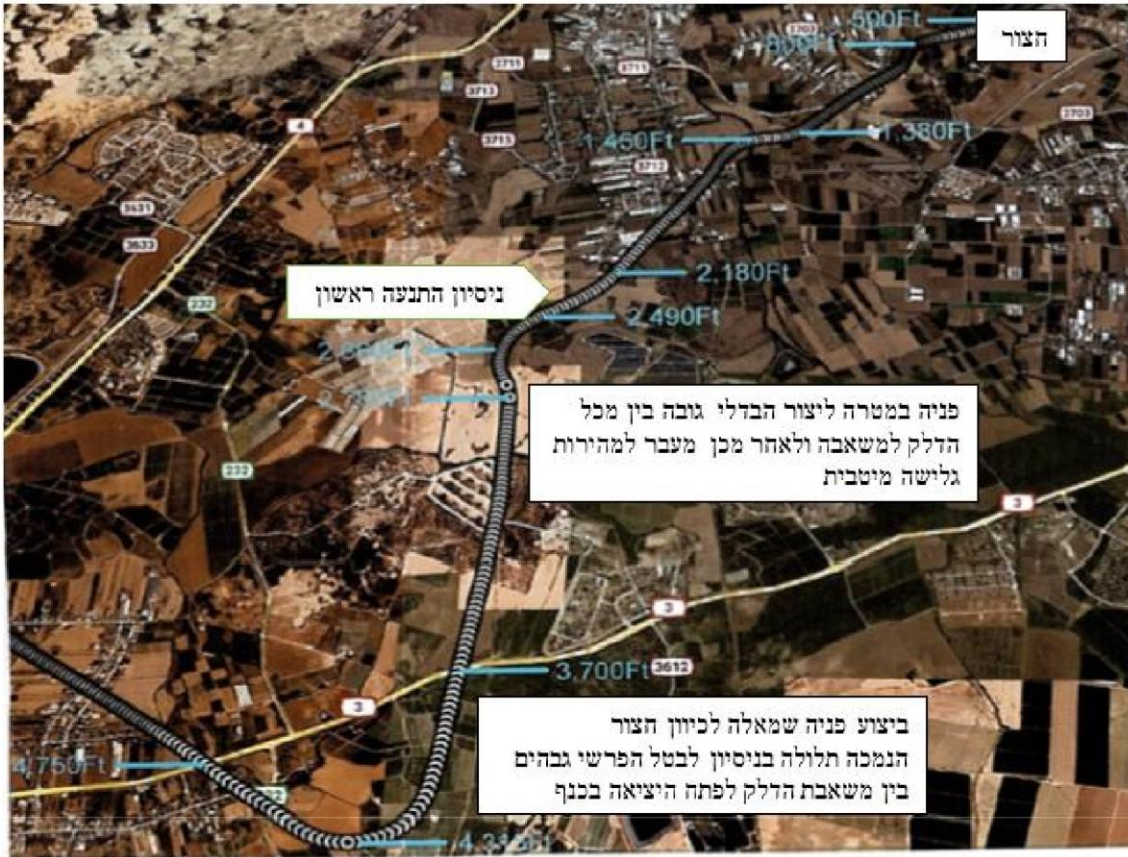
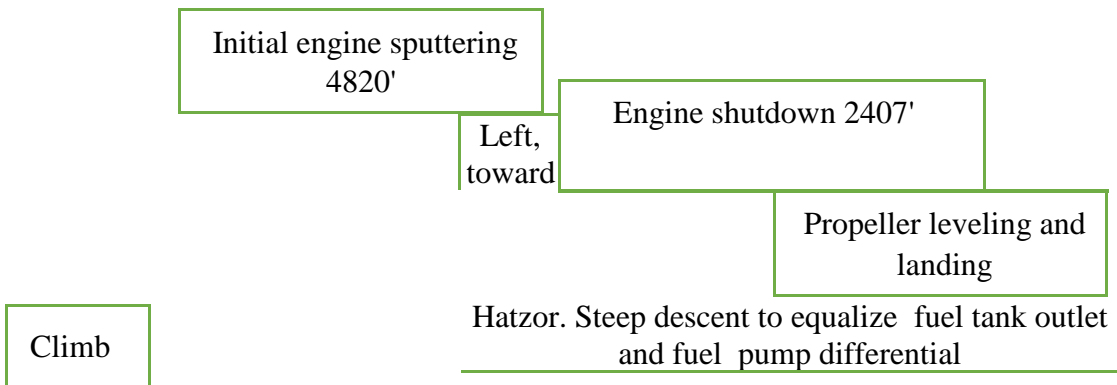
First starting attempt

Maneuver to create a fuel tank to pump head differential, followed by transition to best glide.

Figure 3 - Flight Path Towards Landing

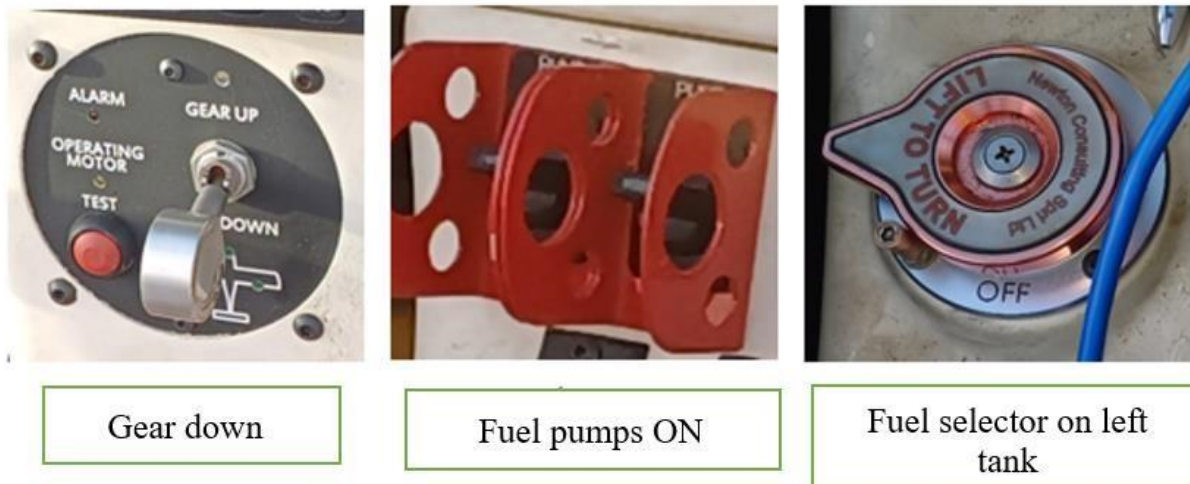
- Investigators from the AIAI who arrived at the scene found the fuel selector on the left wing, the fuel pumps in the "ON" position, and the landing gear switch in the "DOWN" position.

Gear down

Fuel pumps ON
