# **Safety Investigation Final Report**

**Accident File No. 29-24**

## **Agricultural aircraft Accident**

| <b>Aircraft</b> | <b>Turbo Thrush S2R</b> |

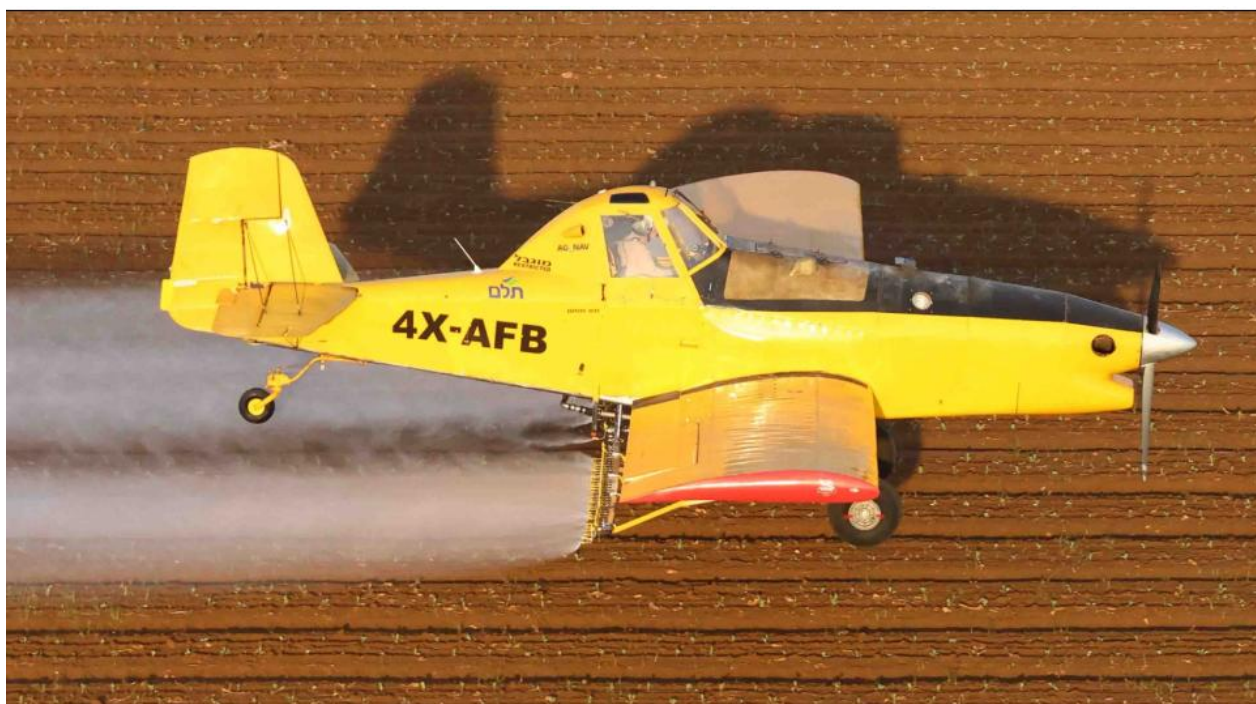
Figure 1 - The aircraft involved in the accident

On the afternoon of Thursday, 5 December 2024, the agricultural spray pilot (hereinafter: **"the pilot"**) began an agricultural spraying operation over a potato field near Kibbutz Shoval in the Negev. As part of the preparation for the spraying operation, the pilot conducted an initial inspection pass over to assess the terrain and to evaluate wind direction and intensity. It is presumed that during this inspection pass over, the Turbo Thrush S2R agricultural aircraft (hereinafter: **"the aircraft"**) crashed near the intended field for spraying. The pilot sustained serious injuries, and the aircraft was destroyed.

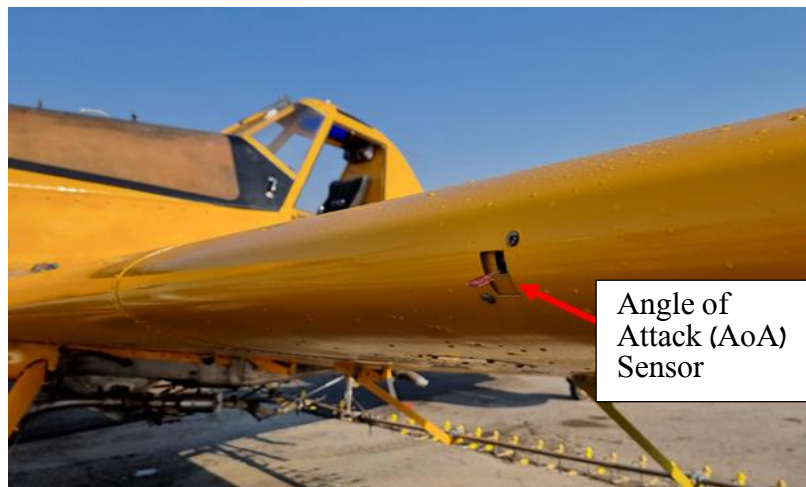
Figure 6 - Stall Warning System

The aircraft is equipped with a stall-warning system. An angle-of-attack sensor is installed on the left wing (see Figures 6 and 7) and is connected to a unit containing an electrical switch that transmits a warning signal to a horn and an indicator light located on the cockpit instrument panel, which illuminates when a high angle of attack is detected.

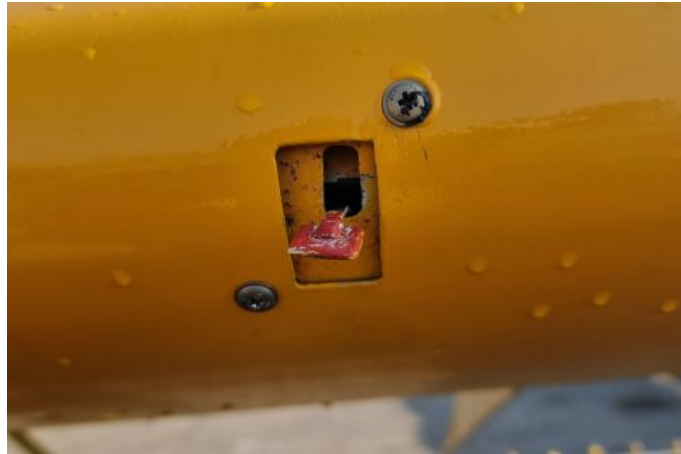
Figure 7 - Angle of Attack Sensor

As the angle of attack increases, the airflow lifts the "red tab" (see Figure 7), which closes an electrical circuit and activates the stall warning; that is, it operates in an ON/OFF manner.

In straight and level flight, the system is calibrated to provide a warning approximately 5 MPH prior to the actual stall.

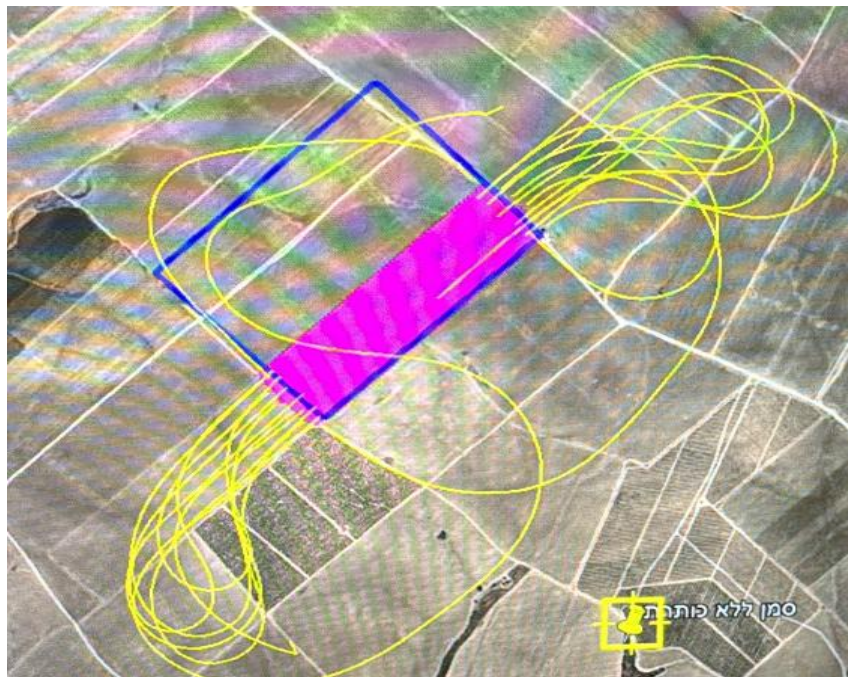
**Figure 10 - Flight profile of the flight preceding the accident flight**

- ✓ During the accident flight, the GPS system was not activated, in accordance with the chief pilot's instruction that GPS activation is performed only after completion of the field inspection phase. However, during the spraying flight preceding the accident flight, which was conducted by the pilot, tight turns were documented. Such turns are defined by senior professionals in the field as characteristic of pilots with at least three years of operational experience.

*Note: According to senior instructors, this flight profile, which was flown one day prior to the accident by the accident pilot, is indicative of a flight profile characteristic of an experienced pilot.*

The accident occurred during the fourth sortie of that day. In the absence of structured documentation regarding the flight profile of the accident flight, the preceding flight was examined (see Figure 10). That flight demonstrates a flight profile characteristic of an experienced pilot, including tight turns and operation of the aircraft close to its limits. The flaps in the down position and the stall warning switch in the "off" position indicate the execution of a tight turn based solely on the pilot's "feel" of the aircraft. The post-accident condition of the aircraft indicates, **with high probability, a low-altitude stall** followed by near-vertical trajectory.

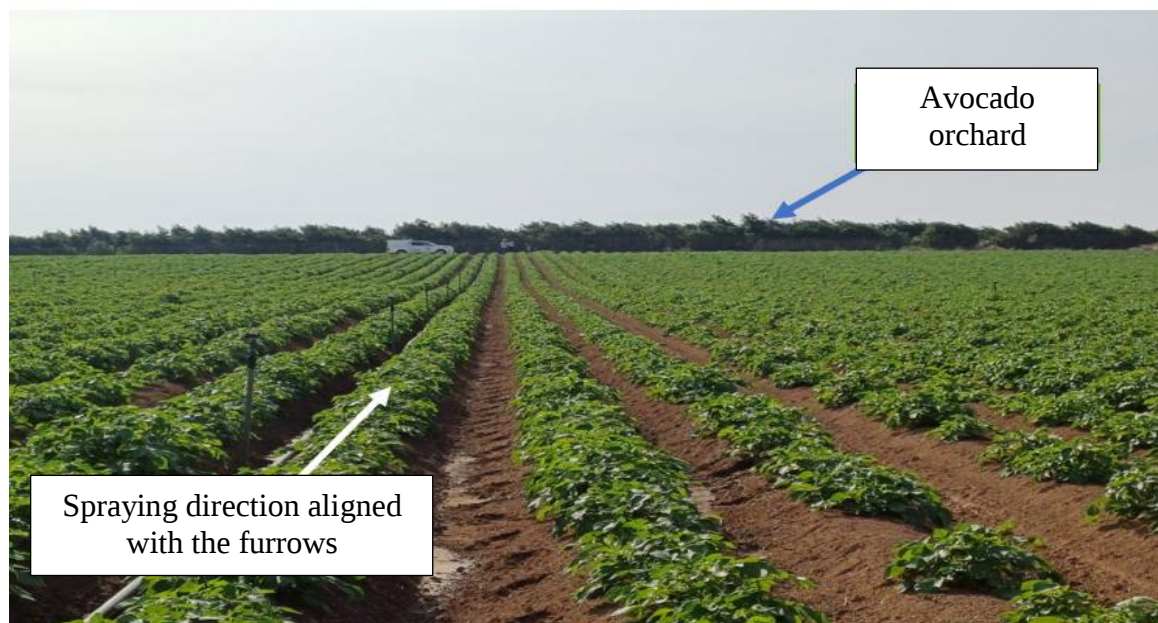
Figure 11 - The Spraying Field

A ground-following spray pass in this direction is performed with a slight climb and concludes with a crossing over the avocado grove prior to initiating the return turn (see Figure 11).

No traces of the spraying substance were identified (the pesticide typically appears as a white residue on vegetation).

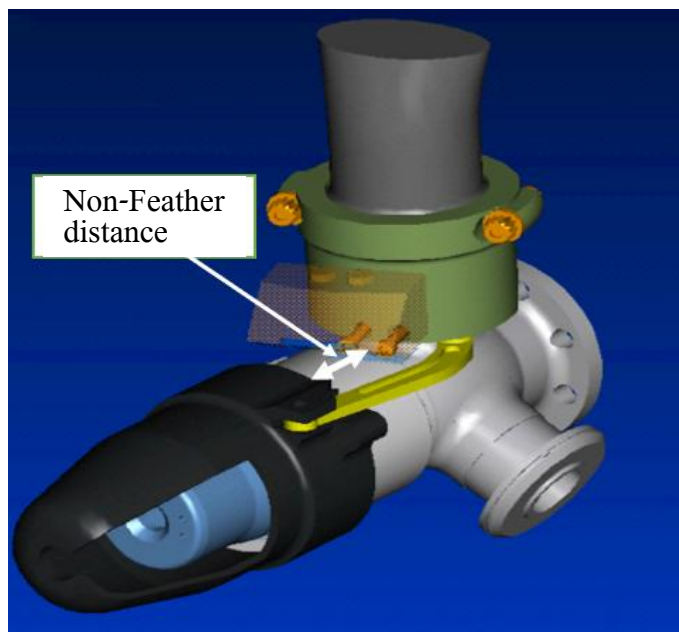
**Figure 13 - Engine Blade Pitch Condition at Power Setting**

- ✓ The imprint marks found in the system indicate that the propeller was in fine pitch at the time of the accident (as during flight), and rule out a feathered condition.

- ✓ The position of the Propeller Pitch Control Lever is explained by the manner in which it was connected to the Engine, which separated from the aircraft during the crash, causing the lever to be displaced to the Feathered Position.
