**Safety Investigation Report**  
**(Final Report)**

**Serious Incident Case No. 52-14**

**Go-around as a result of a failure to deploy landing gears**

| <b>Registration mark</b> | <b>4X-EKL</b> |

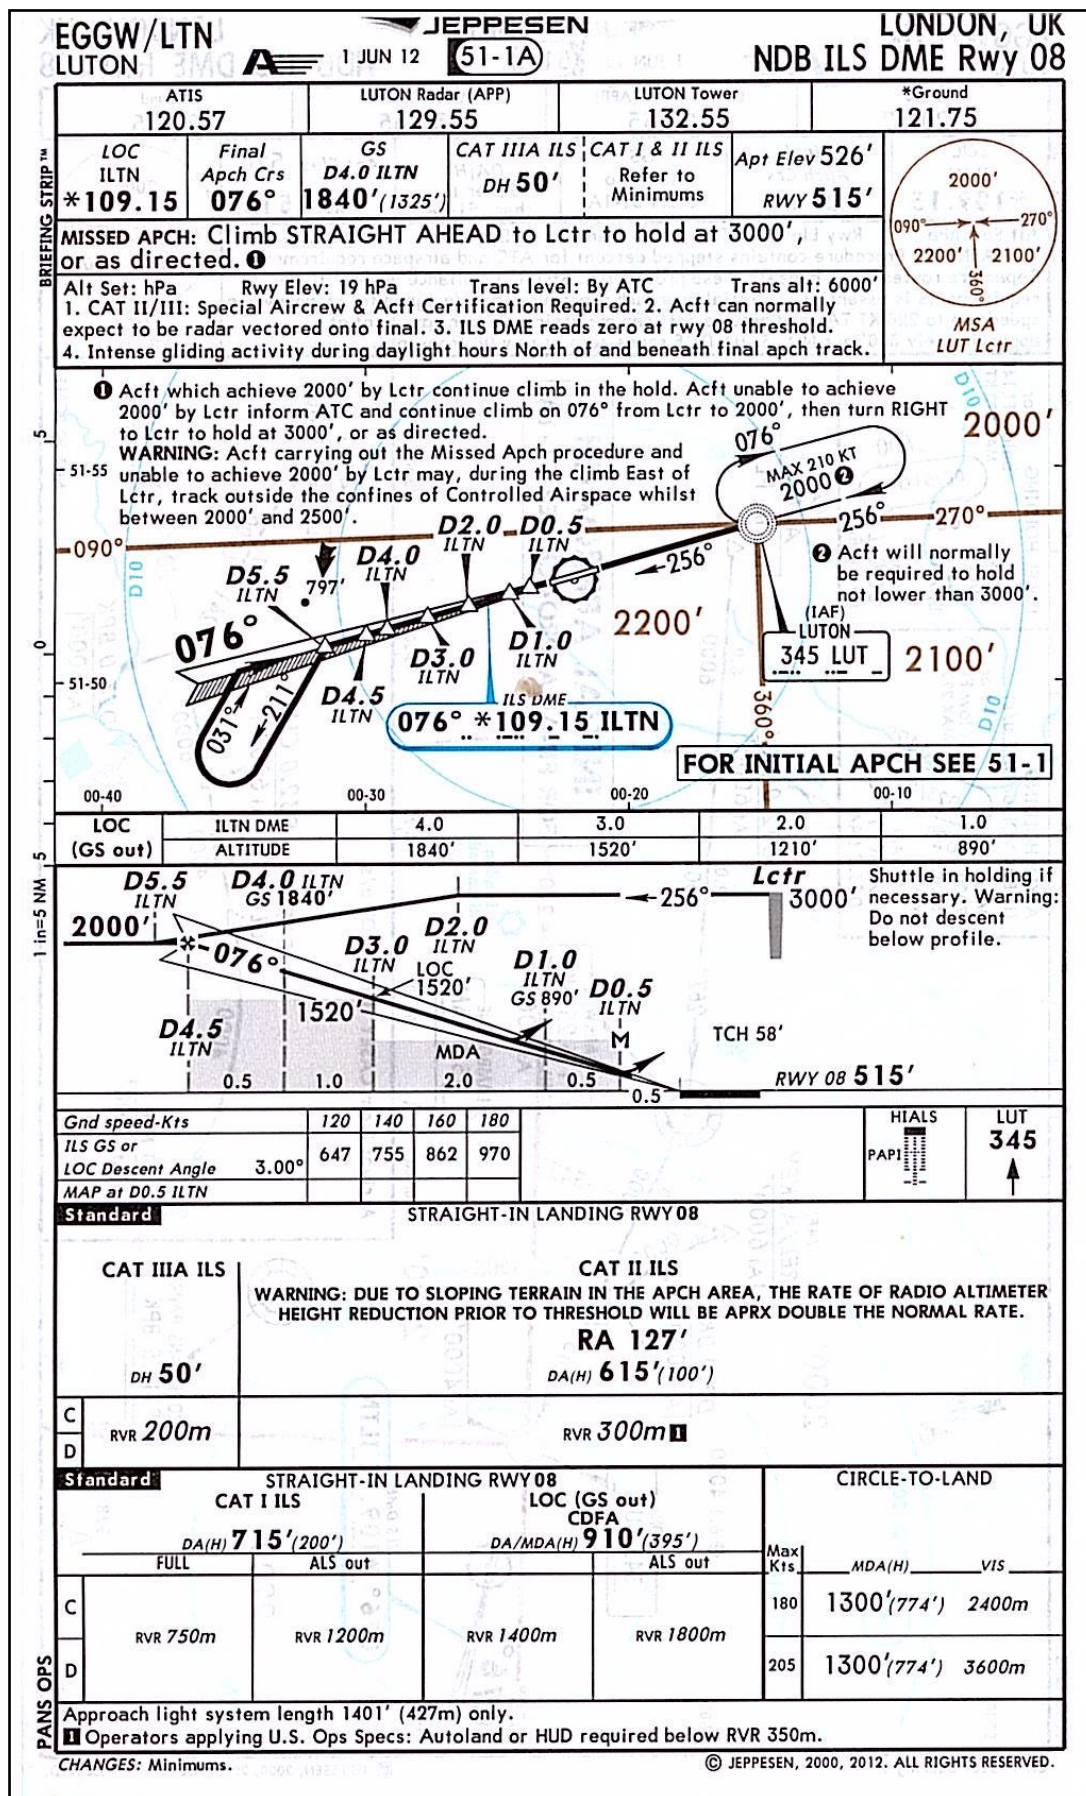
# The approach chart used in the incident

During the landing briefing, the Captain briefed to intercept the G/S at 2,000 feet, based on the procedure chart, and defined 2 checkpoints in the Approach Profile: The first at 4 miles/1,840 feet and the second at 3 miles/1,520 feet. No checkpoint was assigned to replace the Outer Marker (OM).

- ☒ London's Luton Airport is located on a hilly terrain. The aerodrome elevation is 526 feet above sea level.
- ☒ The Airport has a single, relatively short runway - 7,093 feet.
- ☒ The runway is equipped and approved for CAT II/III approaches.
- ☒ The approach is standard with a 3 degree angle and a DME range for the beginning of the runway.
- ☒ The approach does not have an OUTER MARKER ("OM"), and a point at 4NM/1840' appears at the top of the approach chart as a checkpoint in the process.
- ☒ In the approach chart to runway 08, there is a, remark indicating that due to the sloping terrain in the approach area of the ILS to runway 08, the rate of radio altimeter height reduction prior to the threshold will be approximately double the normal rate.
