Safety Investigation Preliminary Report

Accident File No. 19-23

Ground Accident During Pushback

Date	July 17th, 2023
Aircraft	B747-400F & B757-200F
Registration	OE-LRG & N918FD
Location of event	Ben Gurion Int. Airport, N Apron

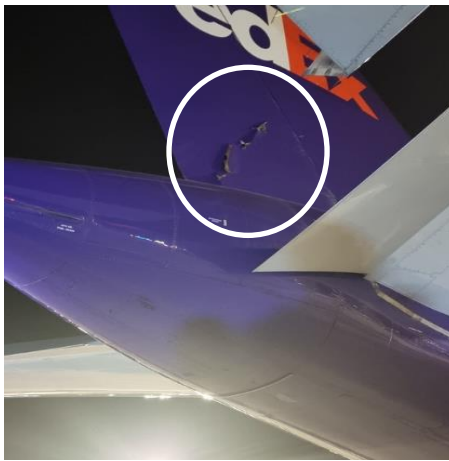
The Damaged Cargo Aircraft

The cargo aircraft – damage to the aircraft rudder.

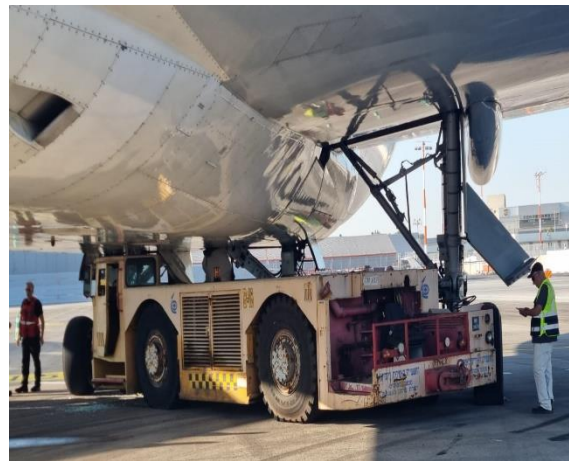
During its motion, the aircraft overtook the vehicle, pushed it sideways while its left wingtip hits the rudder of the parked cargo aircraft. The pins of the tow-bar sheared and the vehicle stopped and got stuck underneath the aircraft's belly, between the left main and body landing gears.

The Vehicle Underneath the Aircraft

The vehicle – damage to the forward passenger cabin and right-hand body exterior structure.
